440 Maiden Lane (Building 35)

This is a two-story multiple-family Colonial Revival built in 1938. It is on the east side of Maiden Lane, four lots north of its intersection with Maple Street (NW¼ NW¼ of Section 5, T. 14 N., R. 45 E., Pullman quadrangle, 1:24,000, 1964/1975). The building is on Lot 8 of Block 6 in Reaney’s Third Addition (Whitman County tax parcel 112400001080000). It is currently owned by Ralph Westermeyer of Bellevue, Washington. The address prior to 1972 was 1204 Maiden Lane.

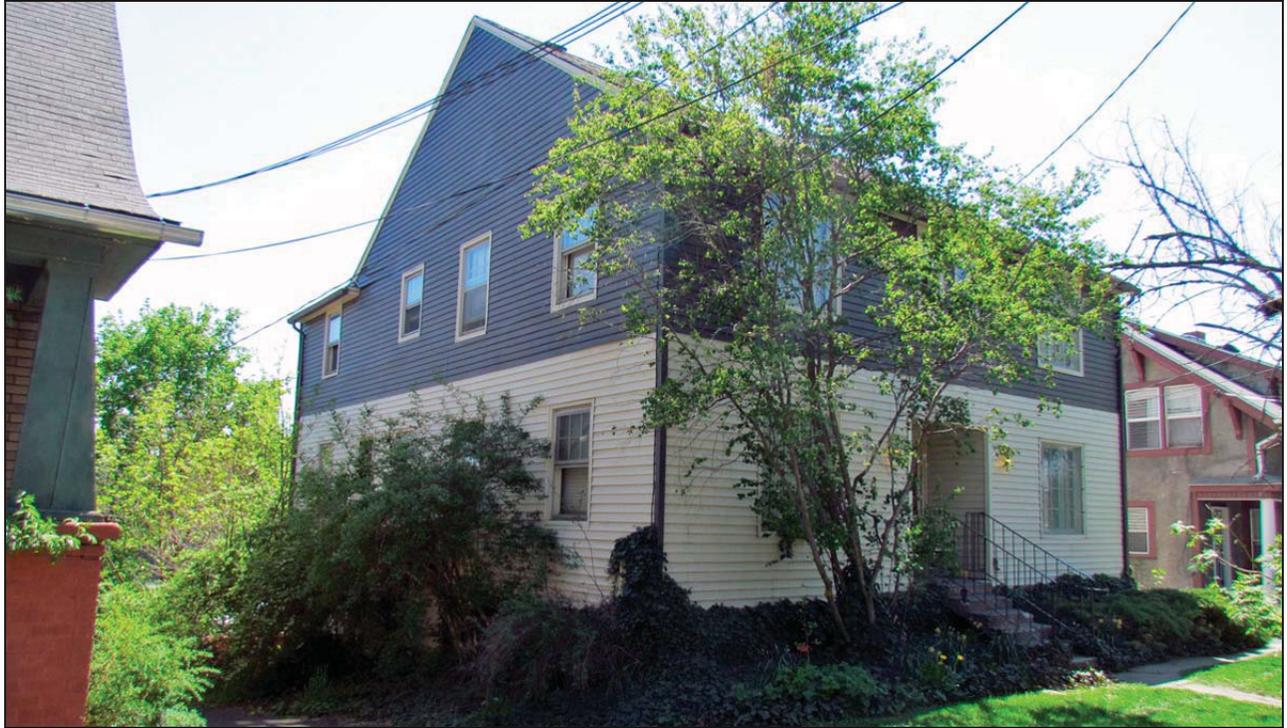
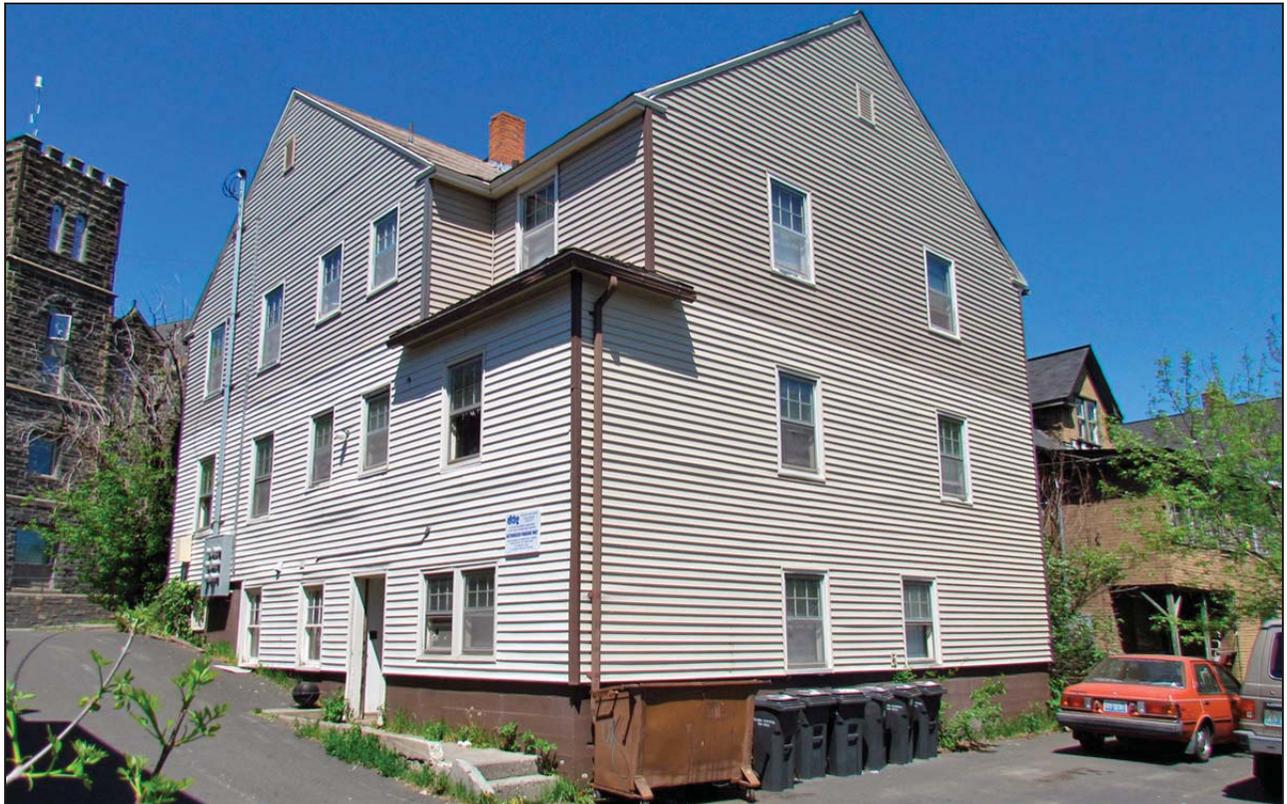
The primary, northwest, elevation faces Maiden Lane (Figure 49a). The foundation of this elevation is obscured by dense ivy. A single-leaf door with twelve lights and plain trim recessed approximately two feet into the elevation is in the center of the first story. This creates a covered entryway with a poured concrete stoop and stairs down to a concrete sidewalk. The door is flanked on either side by flush side panels with five lights each. There is a large single-sash twenty-light window on each side of the recessed entryway. All windows have simple wood trim. The second story contains two twenty-light windows and two eight-light windows that open on vertical hinges.

On the southwest elevation, the first one-third of the foundation is exposed poured concrete, while the back two-thirds are fronted by vinyl cladding (Figure 49b). In the foundation, there is one single-sash six-light window and two single-hung windows, along with a single-leaf door with nine lights and an additional pair of single-hung windows with mullion. The first story contains three large and two small single-hung windows, each with six lights in the top sash. The second story has two large and two small single-hung windows, each with six lights in the top sash, and there is a vent under the open gable. The right end of this elevation features a cutout on the second story, with a hip roof over the first story, and a single-hung window on the recessed portion of the southwest elevation.

The southeast, rear, elevation contains two single-hung windows in the foundation, two on the first level, and two on the second level; all but one of these windows has six lights in the top sash. There is a vent under the open gable (Figure 49b).

In the foundation of the northeast elevation, there are three single-hung windows with six lights in the top sash, one single-hung window, and one window that has been replaced by boards to accommodate a vent (Figure 49a). The first story contains four single-hung windows with six lights in the top sash, one slightly smaller than the others, and one window that has been boarded up to accommodate a vent. The second story contains four single-hung windows with six lights in the top sash, one smaller than the others. A poured concrete sidewalk runs along the right side of the northwest elevation.

Changes to the original windows in this buildings appear to be moderate. Most of the windows are covered with aluminum screens, though some of the original windows remain behind the screens. Changes to the cladding have been extensive. In 1989, a permit was issued to owner J&B Enterprises of Pullman to replace the gas water heaters. That same year, a permit for residing was issued to Janice and Robert Miller. The house was re-roofed in 2006. In 2008, present owner Ralph Westermeyer of Bellevue, Washington was issued a permit to demolish a detached garage on the property. Therefore, we recommend that the building is not eligible for listing in the National Register of Historic Places.

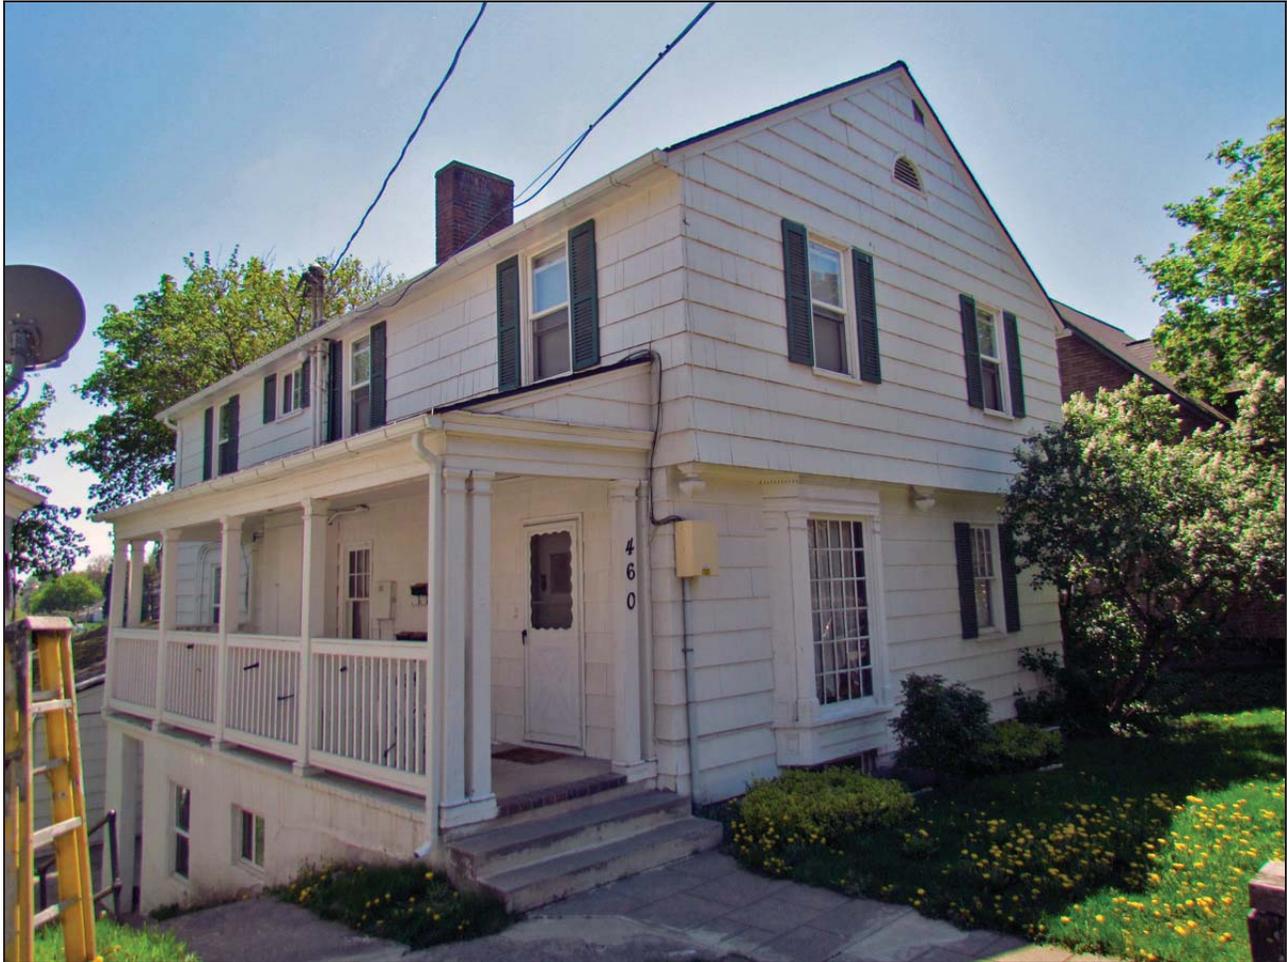
The primary, northwest, elevation faces Maiden Lane (Figure 50). A modestly decorative poured concrete sidewalk leads to a partially enclosed porch at the left end of the northwest elevation. This porch is actually part of the northeast elevation, but is open at the northwest end. To the right of the porch opening, in the foundation level of the northwest elevation, there are two replacement horizontal sliding windows. The windows are mostly below the ground surface and open into subterranean alcoves with poured concrete retaining walls. The first story of this elevation has a slightly projected bay with a thirty-light window and an ornate wood surround. To the right of the bay is a single-hung window with six lights in the top sash. All windows on this elevation except for the bay window feature decorative wood shutters and simple wood trim and sill. The second story contains two single-hung windows and a vent under the gable.

Figure 50. Three-quarter view of the northeast and northwest elevations of the large, multi-family house at 460 Maiden Lane, view to azimuth 180°.

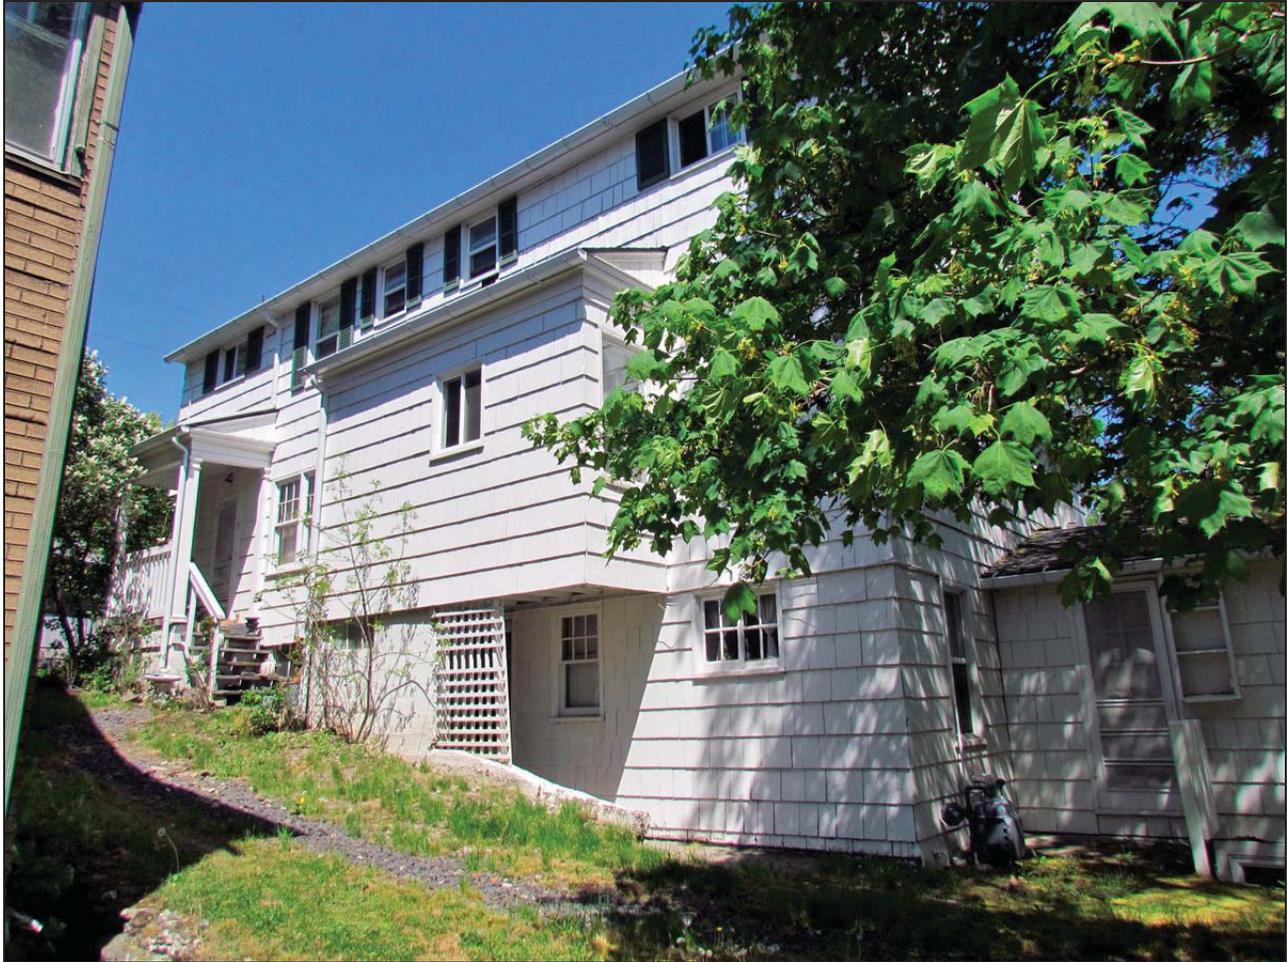
Figure 51. Southwest elevation of the original building at 460 Maiden Lane, view to azimuth 10°.

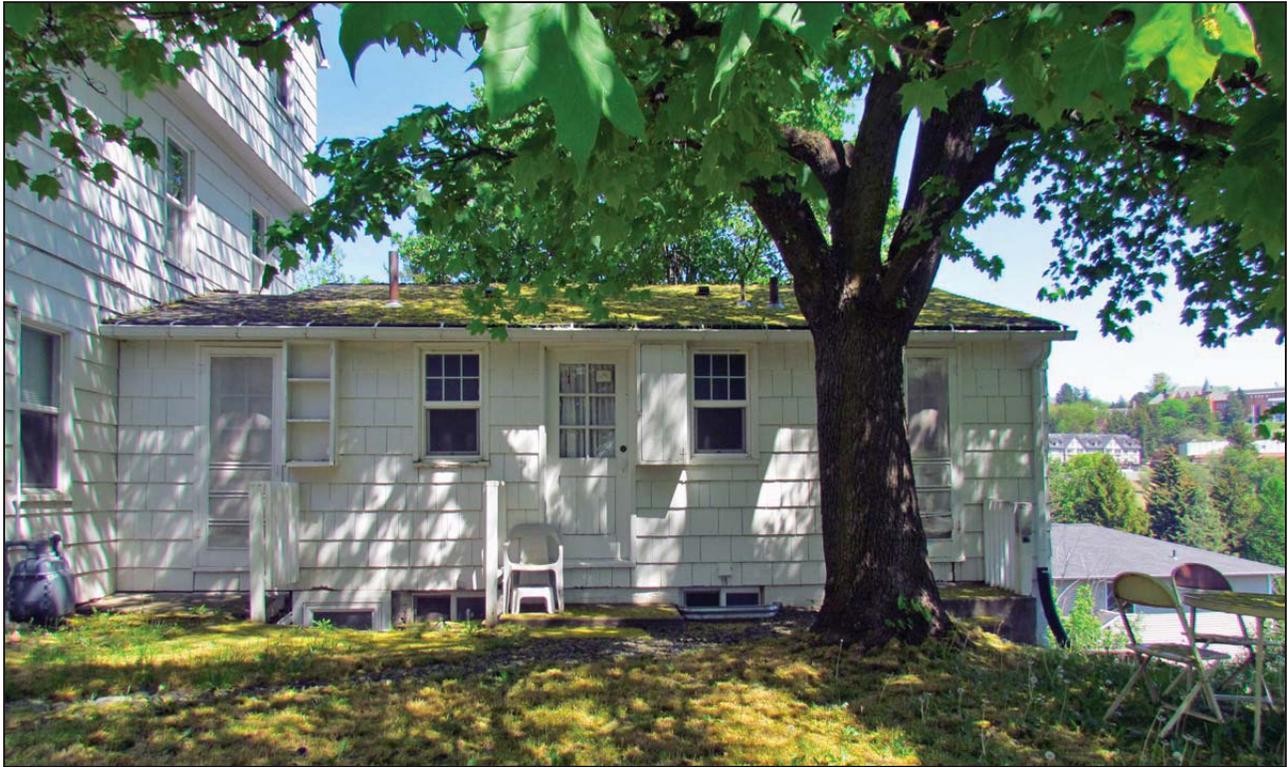
Figure 52. Southwest elevation of the addition at 460 Maiden Lane, view to azimuth 60°.

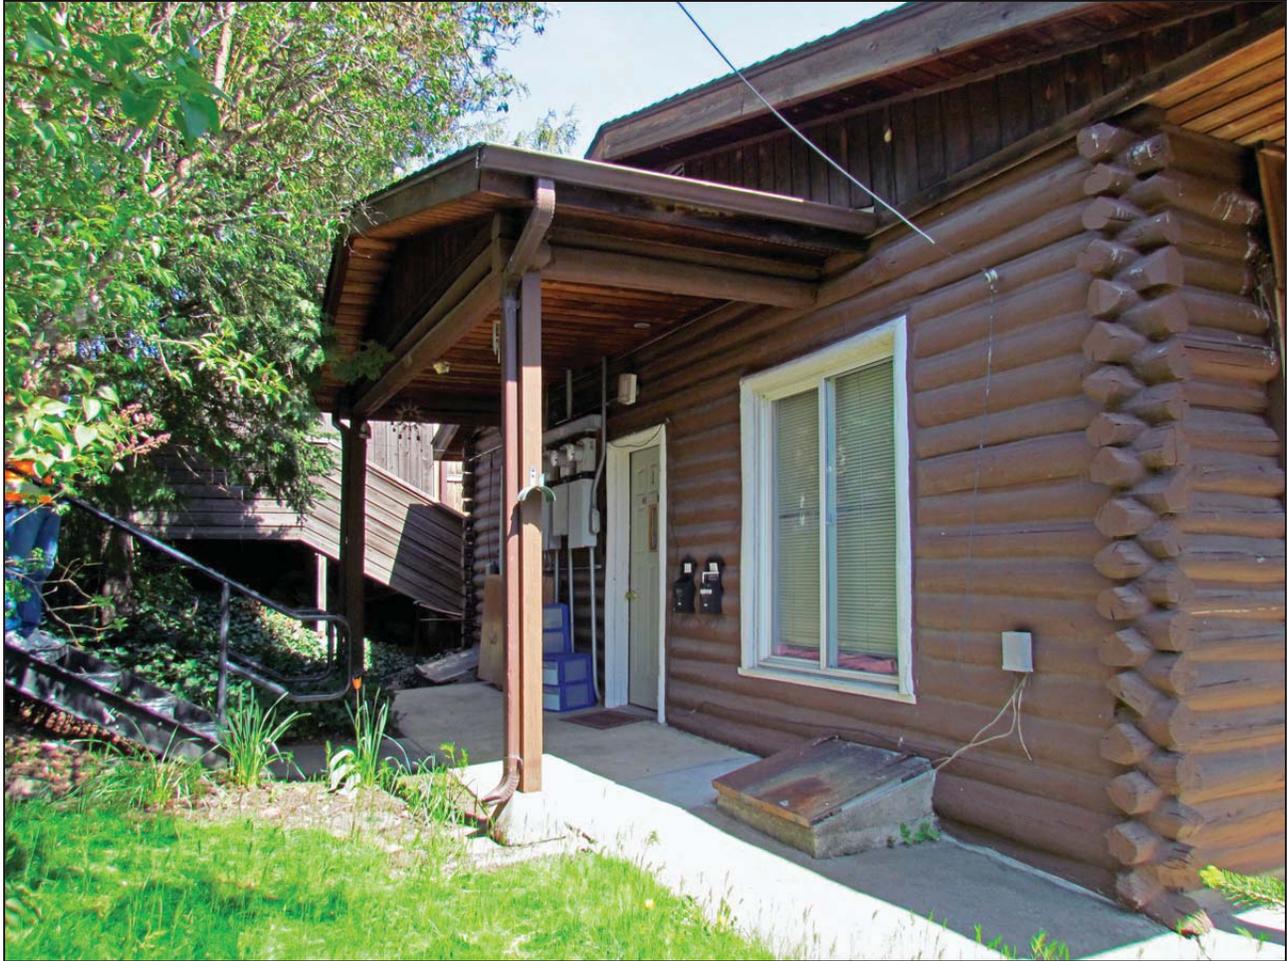
The primary, northwest, elevation faces Maiden Lane (Figure 54). The front yard is 3–4 feet below the street and sidewalk level, and is shored up by a poured concrete retaining wall. A poured concrete sidewalk and steps lead to a concrete patio that is partially covered by a low gable porch with a shiplap ceiling. The porch beneath the roof incorporates logs that are consistent with the logs that front the elevation. The patio is flanked with two poured concrete crawl space access points that have metal coverings. The front entrance is a replacement single-leaf door. Flanking the door on the right are two single-hung windows with log trim. The windows are replacements.

Figure 54. The northwest elevation of the building at 530 Maiden Lane, view to azimuth 95° (the front of the building is largely obscured by vegetation from a more direct angle).

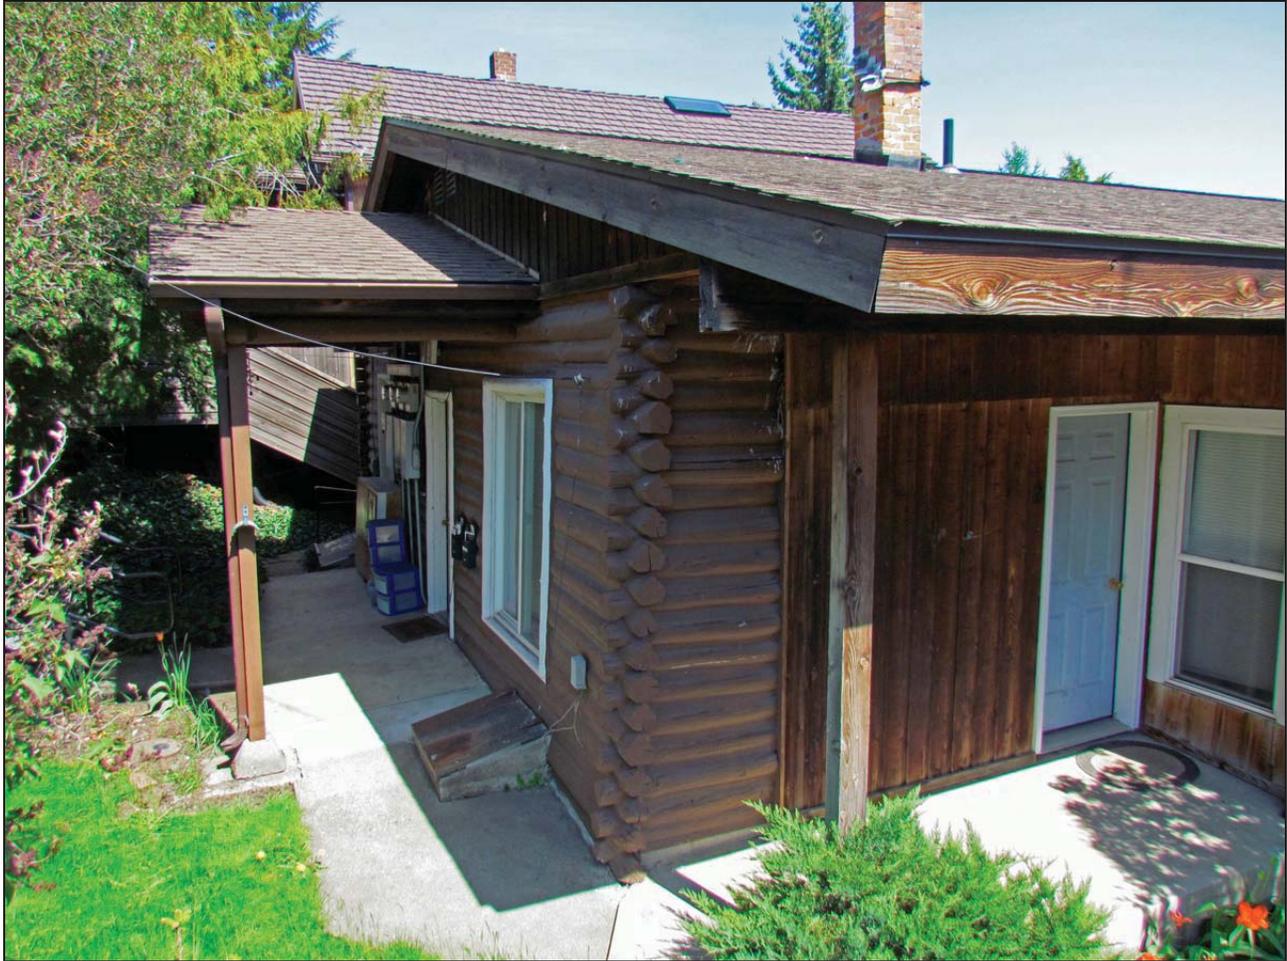
The southwest elevation, at the foundation level, has a single-sash window. The first story has an added doorway with a single-leaf door with plain trim (Figure 55, Figure 56). Below the door is a small covered poured concrete patio with a shiplap cladding overhang. The major support beams are exposed. To the right of the door is a projection that is probably an addition. A new single-hung window with plain trim is present on the northwest facing elevation of this project, next to the door. To the right of this is a two-sash horizontal sliding window. The rear half of the first story is a foot wider than the foundation, creating different depths on this elevation.

Figure 55. The northwest and southwest elevations of the building at 530 Maiden Lane, view to azimuth 70°.

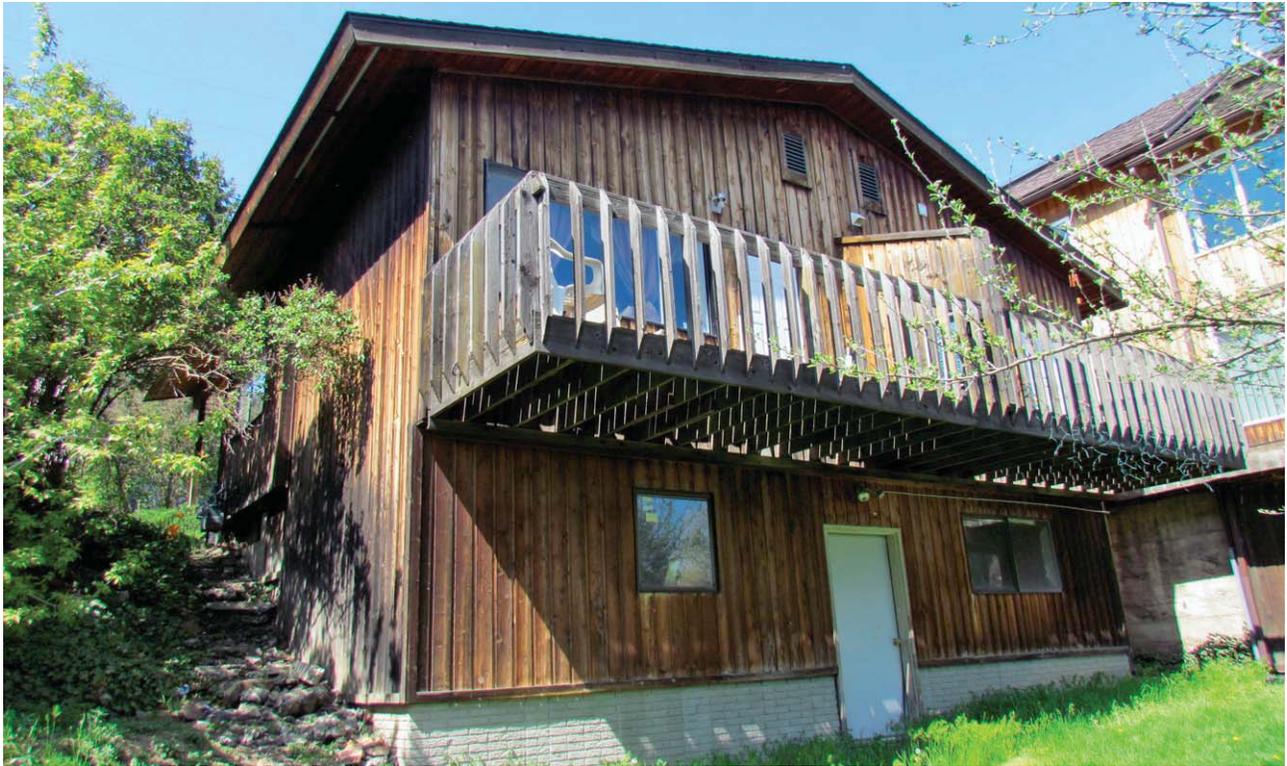
Figure 56. Three-quarter view of the southwest and southeast elevations of the building at 530 Maiden Lane, view to azimuth 360°.

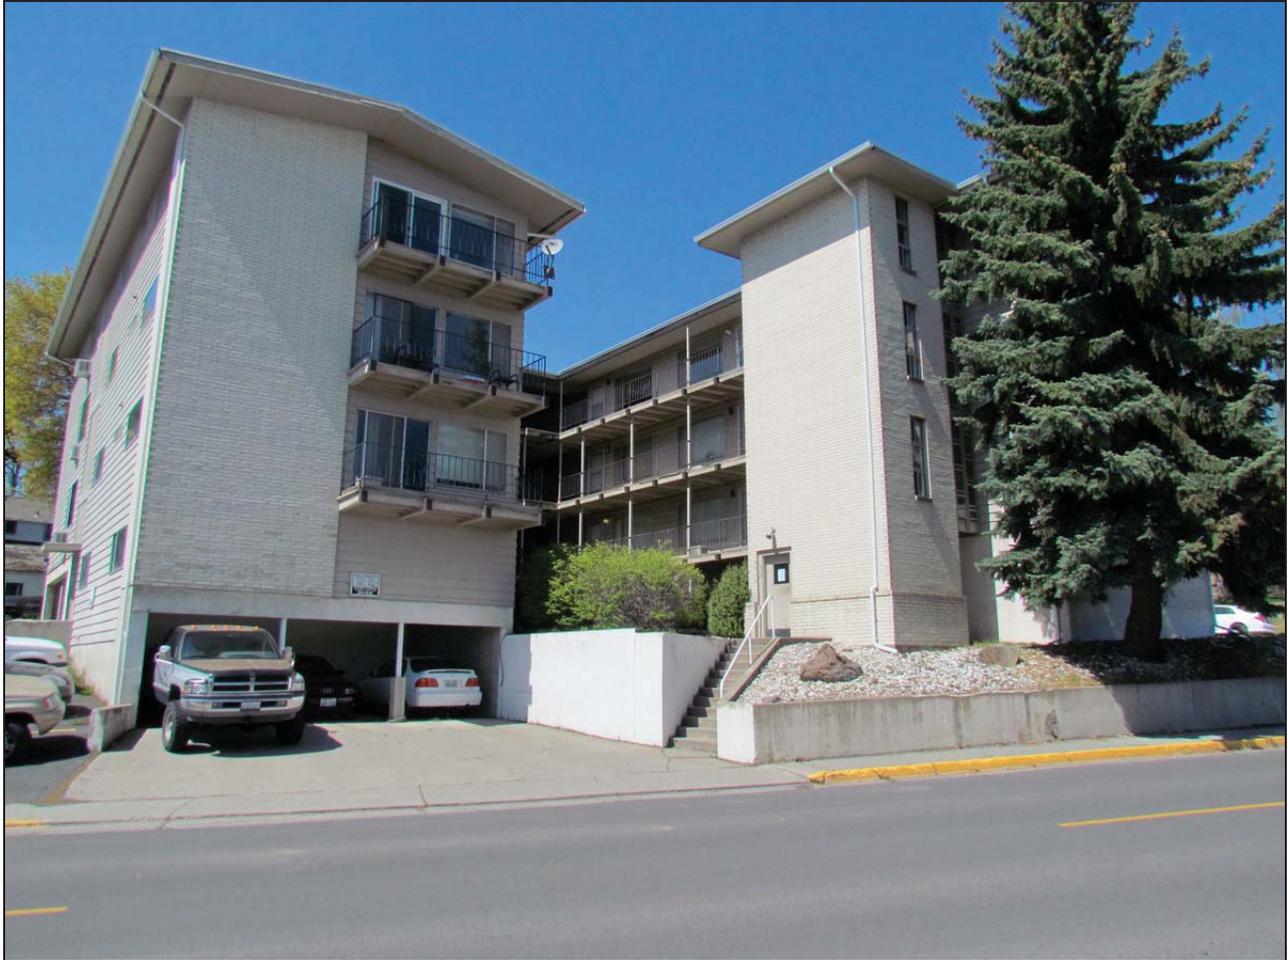
Figure 57. College Hill Apartments: three-quarter view of the southwest and southeast (facing Maiden Lane) elevations of the southwest wing (left) and the northeast wing (right) with a courtyard between the wings, view to azimuth 335°.

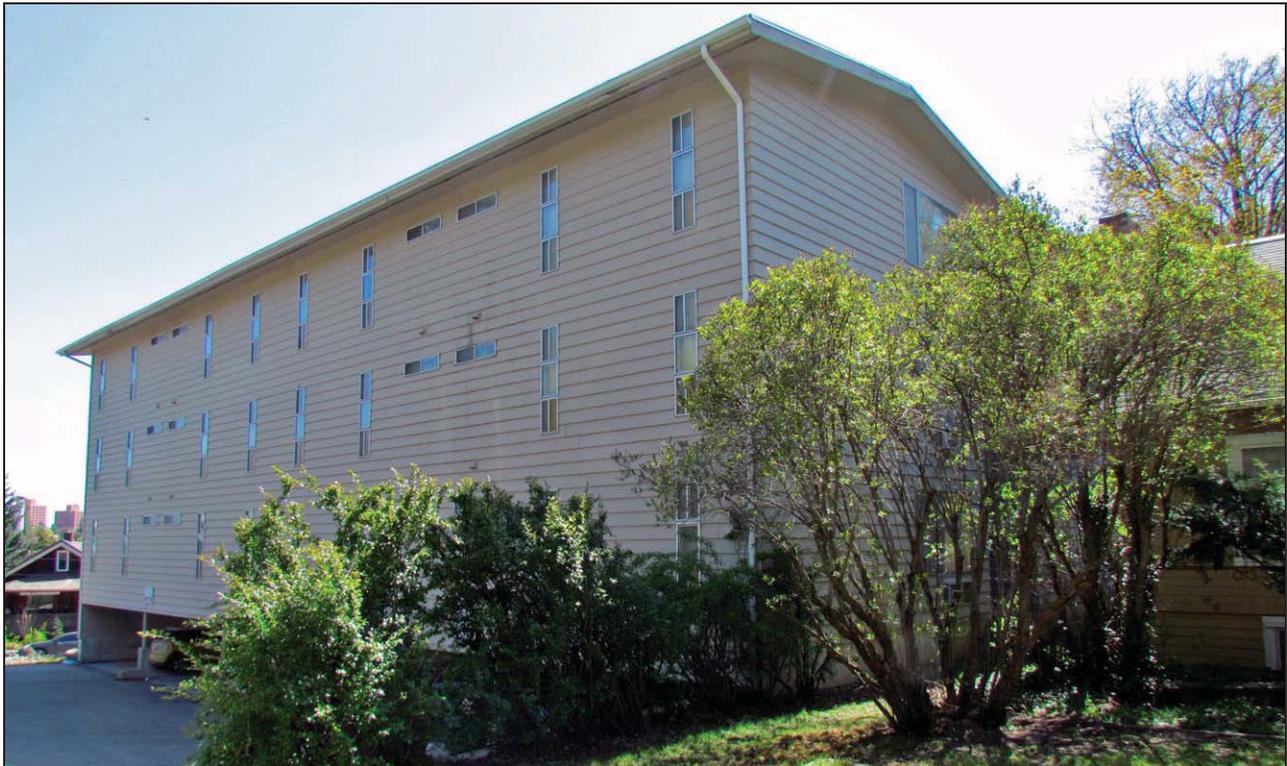
The northeast elevation of the northeast wing faces Ash Street and features two styles of windows (Figure 58). The first is a tall, narrow window with a fixed sash in the middle and horizontal sliding windows above and below. The second type is a narrow horizontal sliding window. The three levels of this elevation are identical and feature the following pattern: two tall windows, two horizontal windows, four tall windows, two horizontal windows, and two tall windows. The foundation of this elevation is open for parking and is supported by simple metal pillars.

Figure 58. College Hill Apartments: three-quarter view of the northeast (facing Ash Street) and northwest elevations of the northeast wing, view to azimuth 155°.

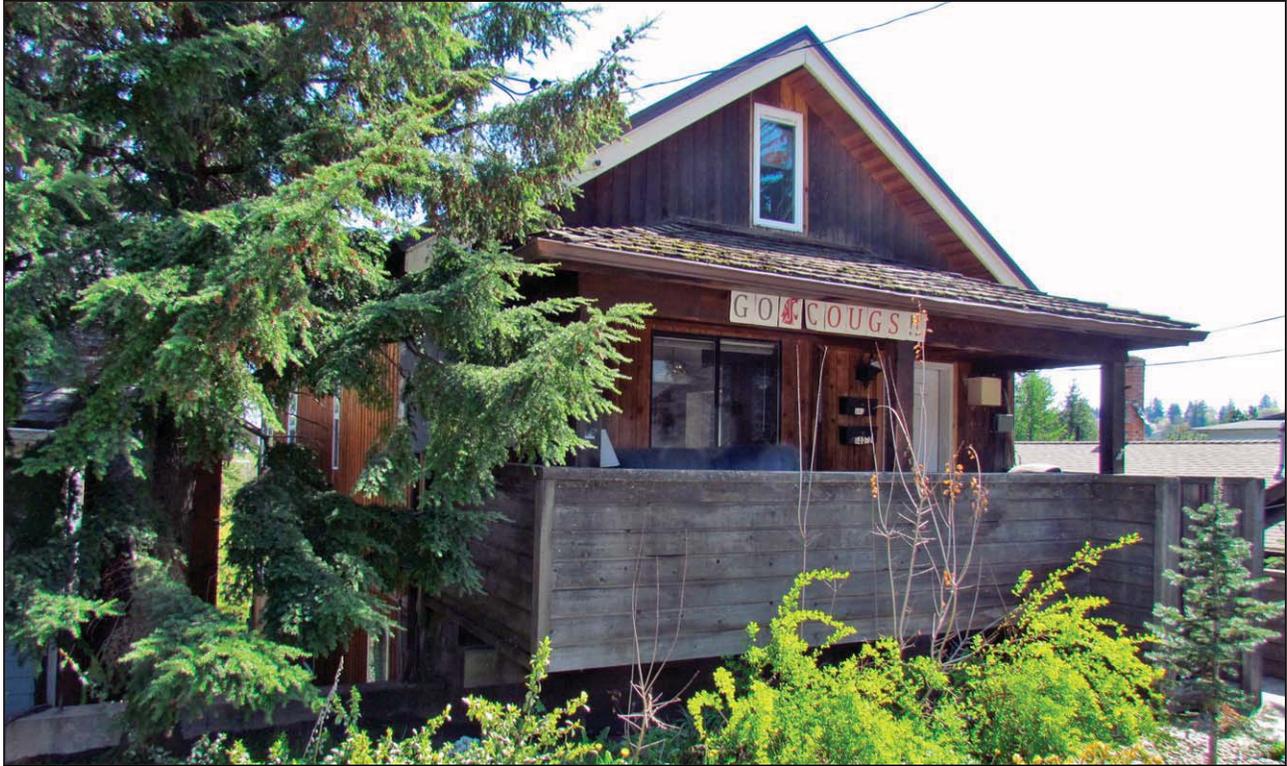
Figure 59. 540 Maiden Lane: three-quarter view of the northeast and northwest elevations, view to azimuth 175°.

On the northeast elevation there are no notable features in the foundation level (Figure 59). The first story has a horizontal sliding window, a small single-hung window, and two slightly larger single-hung windows. The second story has a horizontal sliding window, a single-hung window, and a slightly smaller single-hung window. From this elevation there is no access to the street because a poured concrete retaining wall reaches up to the top of the first level of the home.

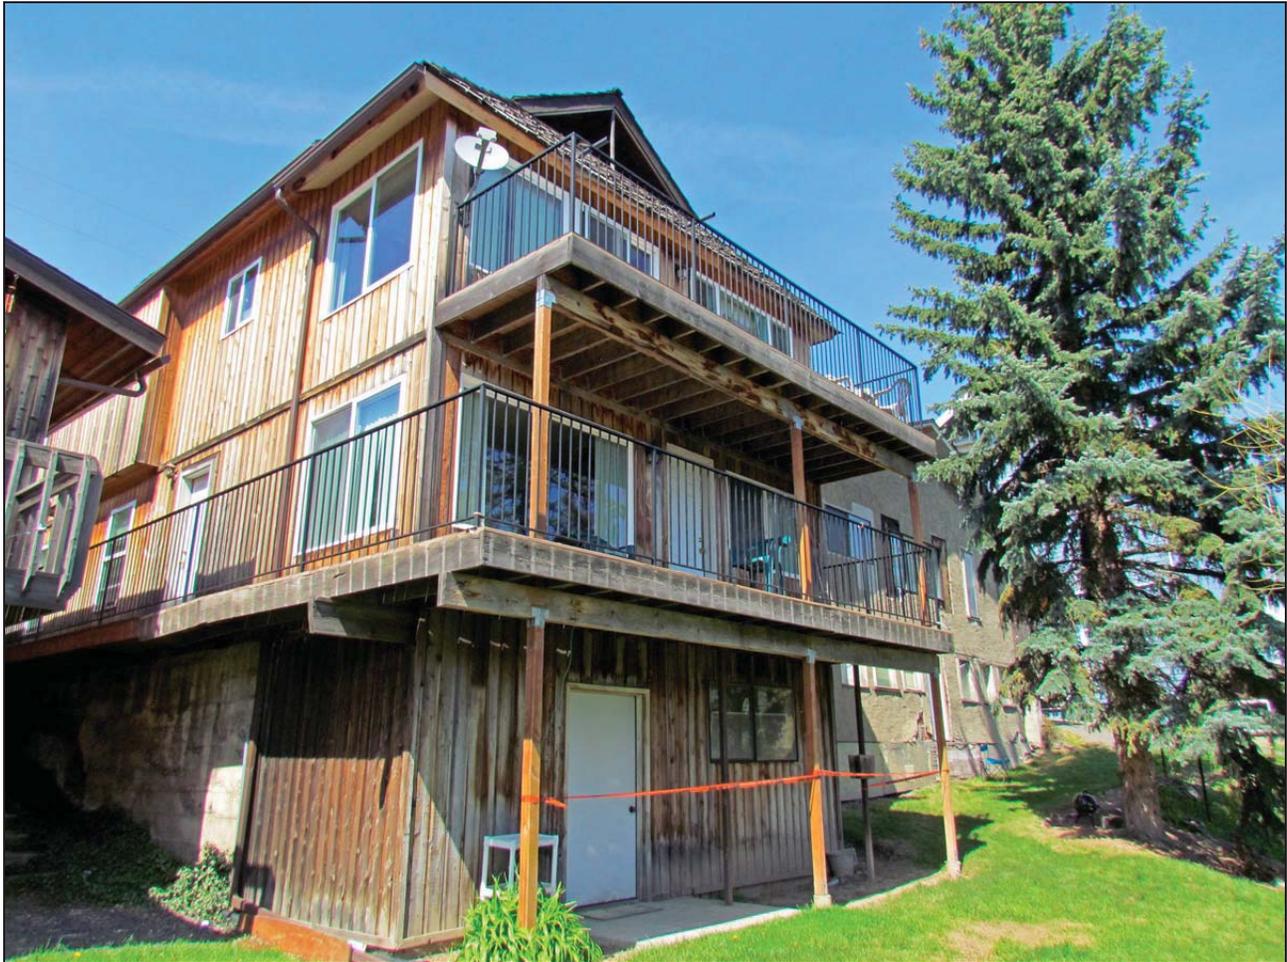
The southwest elevation reveals that there has been an addition attached to the rear portion of the building (Figure 60). At the foundation level, the original building has a bare concrete foundation while the addition level has been fronted by the wood cladding. On the first level there has been an elevated walkway made of wood planking added, which wraps around the elevation and connects to a back porch. The first level also features two single-hung windows, a single-leaf door, and a large horizontally sliding window. On the upper level there is a small projection in the middle of the elevation. There is a small horizontal sliding window to the left of the projection, a three-sash window in the projection, and two more horizontal sliding window to the right of the projection.

On the southeast elevation there is a single-leaf door and a horizontal sliding window in the foundation level (Figure 60). Porches supported by simple wood beams and surrounded by metal railings have been added to the first and second stories. The first story has centrally located single-leaf door flanked on each side by horizontal sliding windows. The second story has a horizontal sliding window, a two-leaf sliding glass door that enters on to the porch, and a three-sash window. All of these features are part of the addition to this elevation, which is covered by a low hip roof. The open gable of the primary roof line is still visible.

Figure 60. 540 Maiden Lane: three-quarter view of the southwest and southeast elevations, view to azimuth 10°.

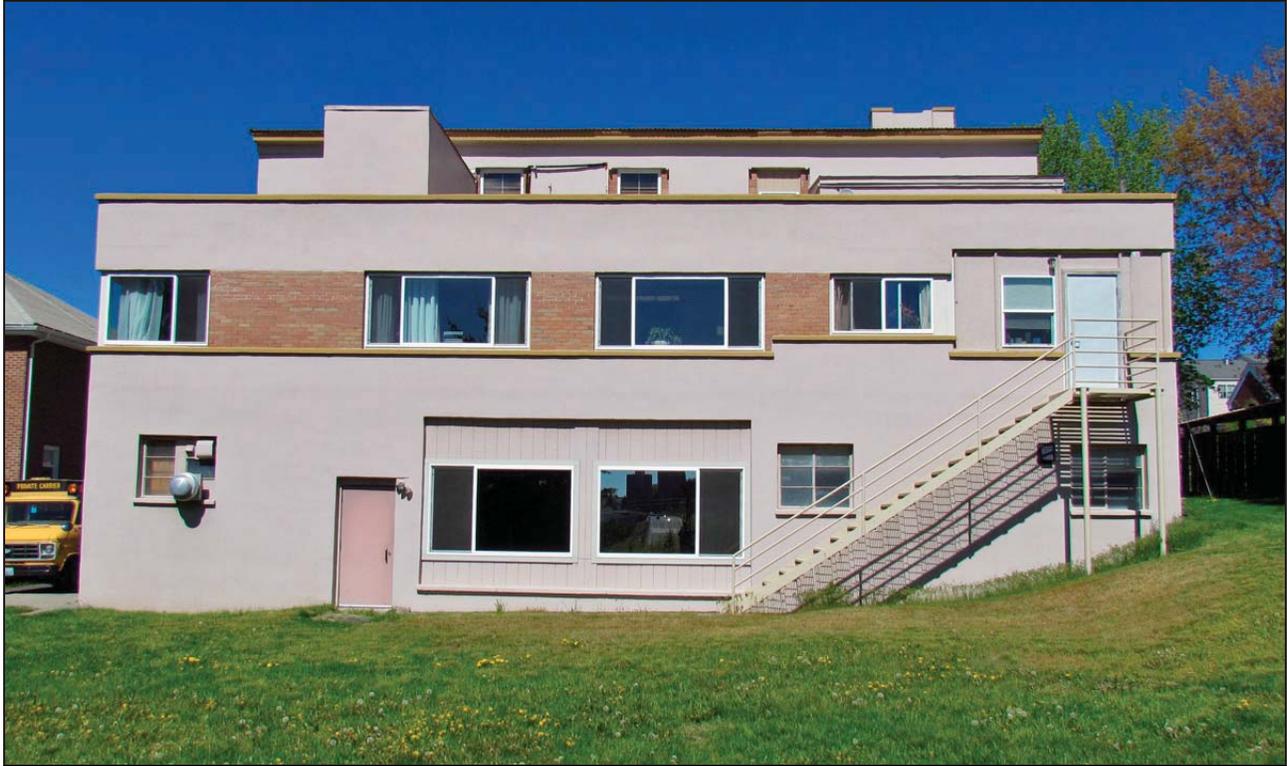
Figure 71. The southeast elevation of the Pullman Christian Church/Palouse River Counseling Center at 340 Maple Street, view to azimuth 300°.

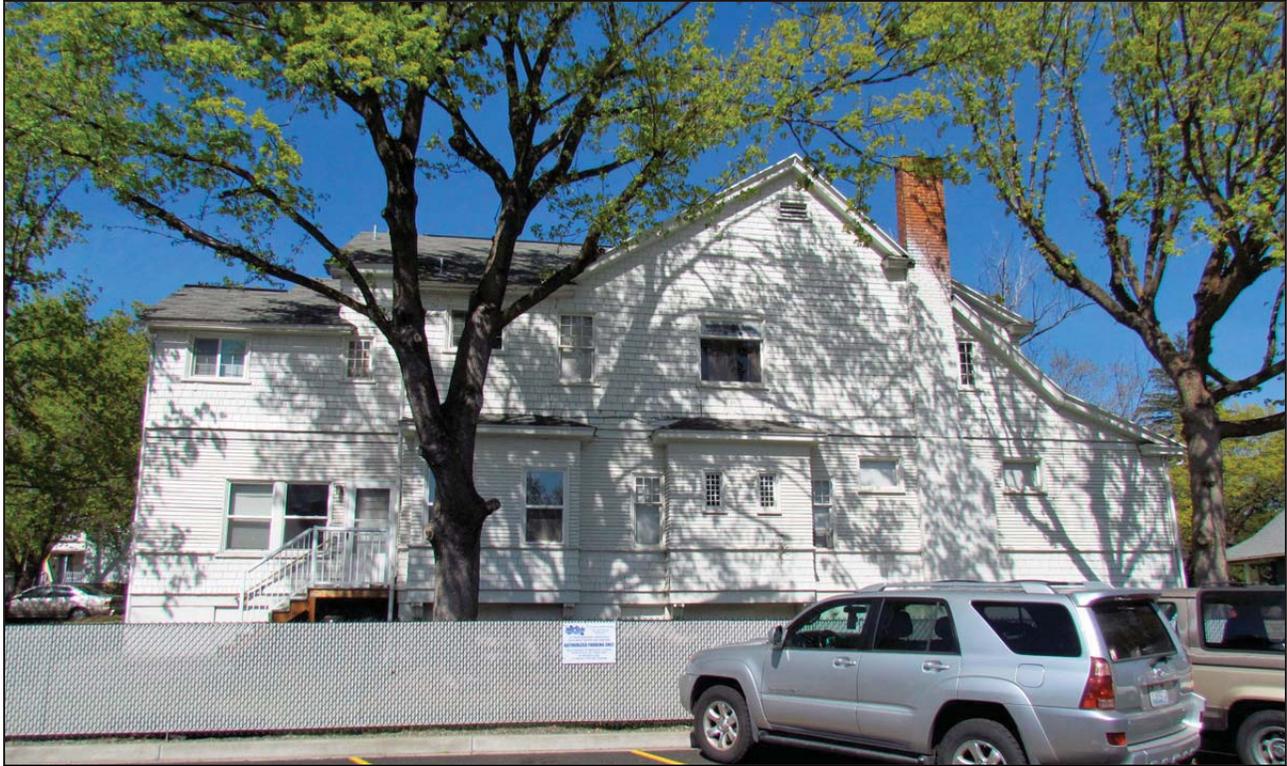
Figure 73. Southwest elevation of the house at 435 Maple Street, view to azimuth 30°;

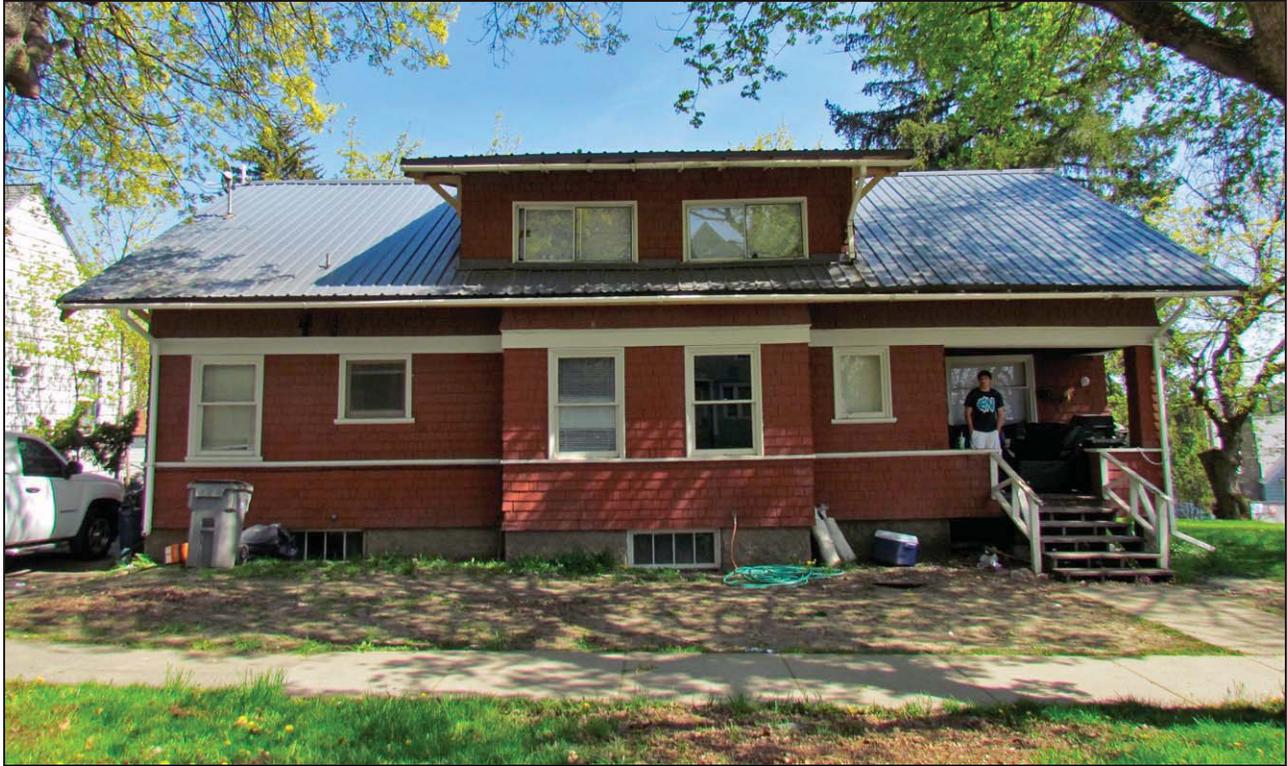
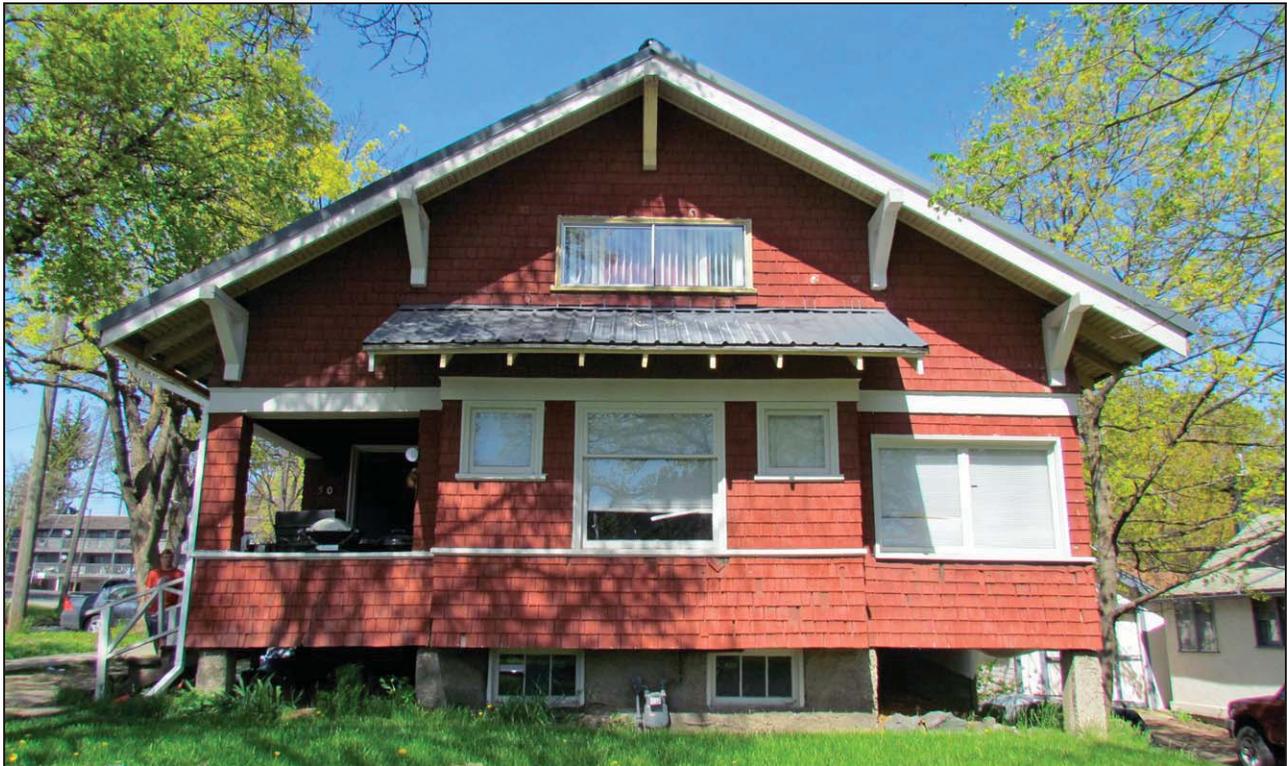
Figure 74. 500 Maple Street: (a) northwest elevation, view to azimuth 120°; (b) southwest elevation, view to azimuth 30°.

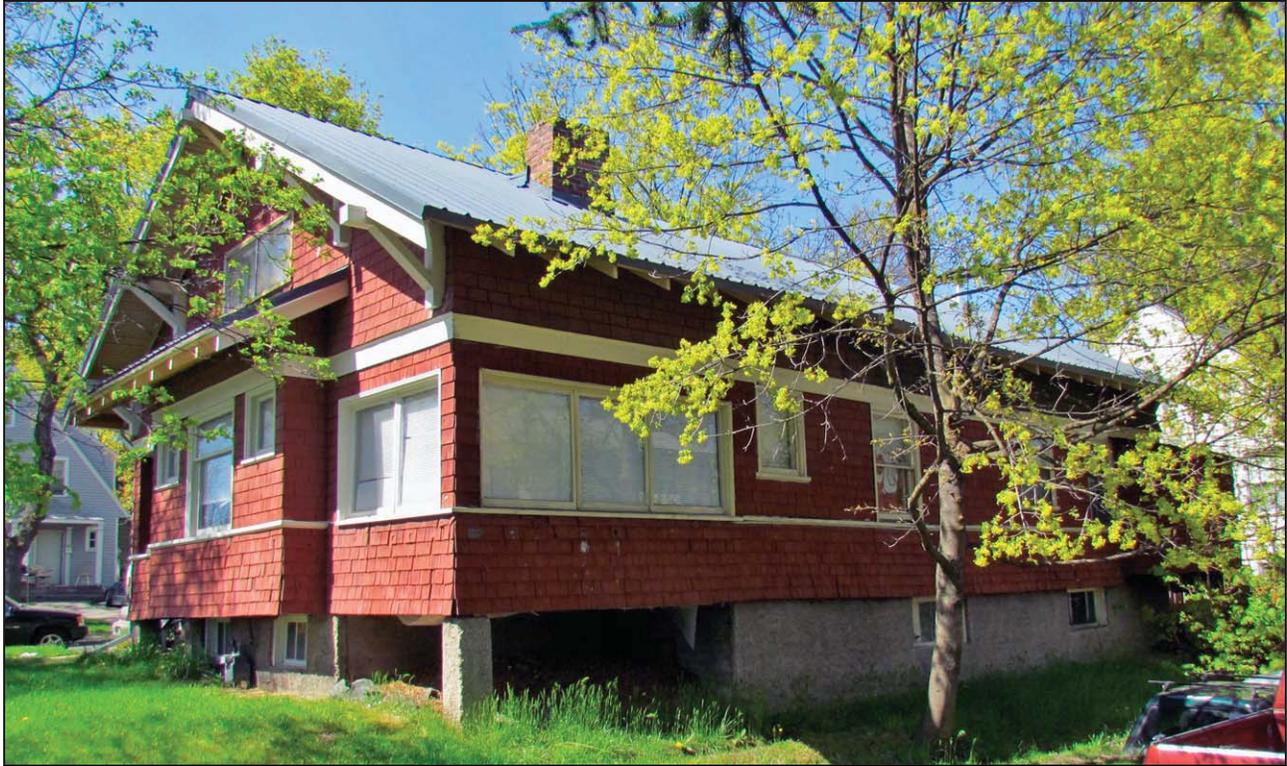
Figure 75. 500 Maple Street: three-quarter view of the southwest and southeast elevations, view to azimuth 345°.

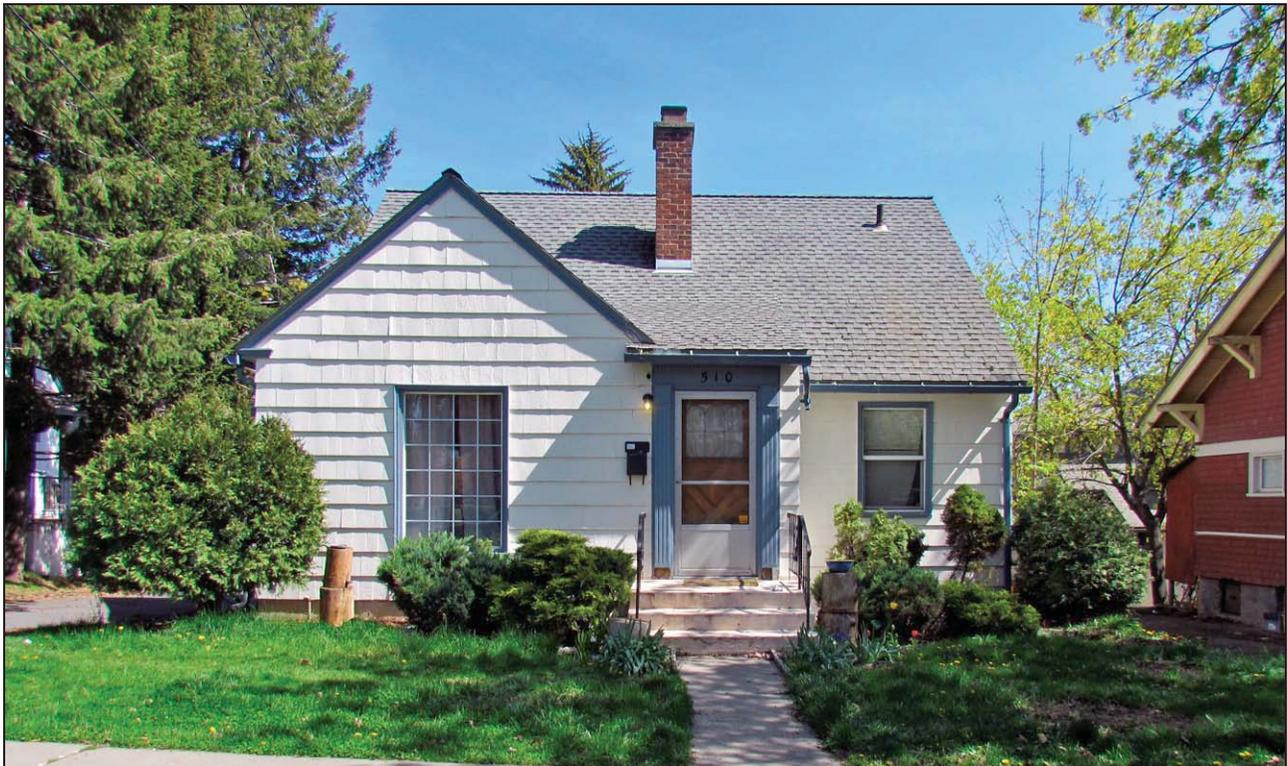
Figure 76. 510 Maple Street: the northwest, primary elevation, view to azimuth 1200°.
