440 Maiden Lane (Building 35)

This is a two-story multiple-family Colonial Revival built in 1938. It is on the east side of Maiden Lane, four lots north of its intersection with Maple Street (NW¼ NW¼ of Section 5, T. 14 N., R. 45 E., Pullman quadrangle, 1:24,000, 1964/1975). The building is on Lot 8 of Block 6 in Reaney’s Third Addition (Whitman County tax parcel 112400001080000). It is currently owned by Ralph Westermeyer of Bellevue, Washington. The address prior to 1972 was 1204 Maiden Lane.

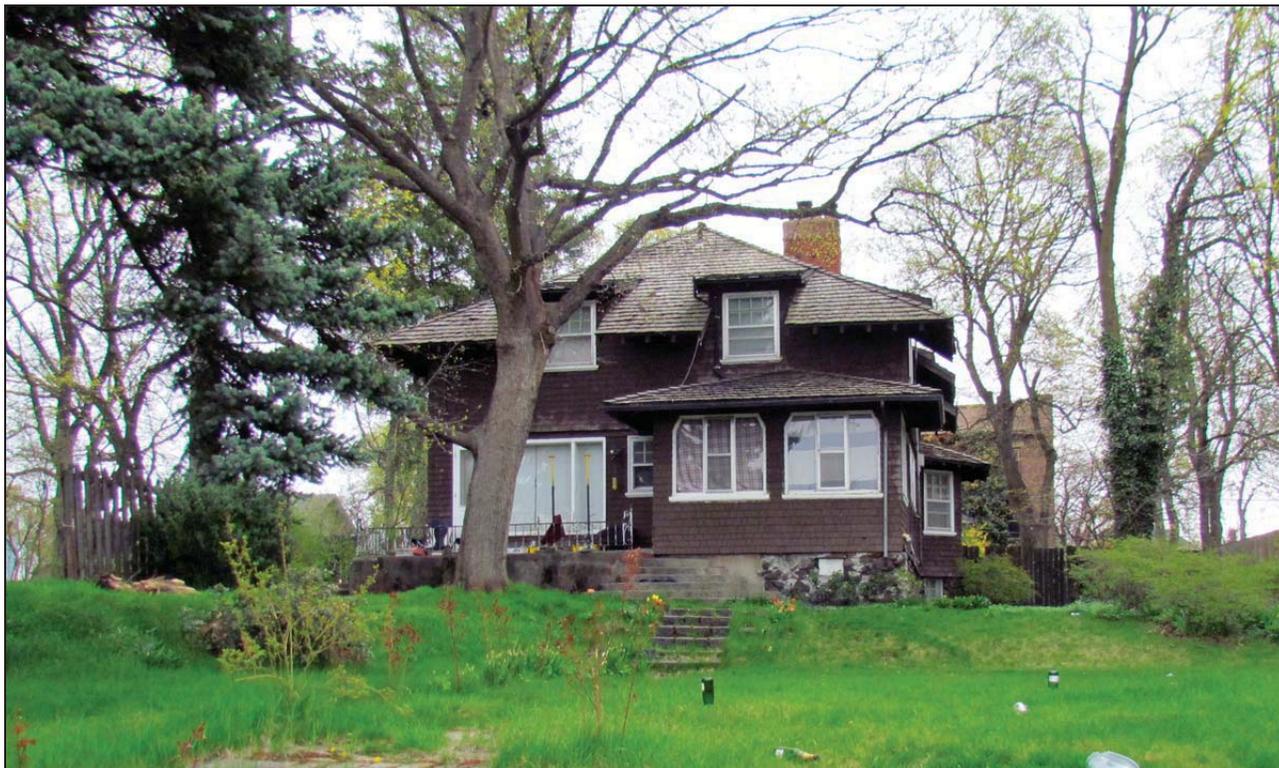
The northwest elevation has a poured concrete patio with decorative iron fencing, and dressed basalt stairs and walkway into the backyard (). At the north end ground level there is a door to the patio, and to the west of the house there is a two-sash window with mullion, with one sash being double the size of the other. Further to the west is a double-hung casement with the top sash having six panes and the bottom made of stained glass. The interior and screen door appear to be original and all windows on this elevation have plain trim and slip sill. At the west end there is a projection, in the northeast elevation of the projection there is a single-leaf door with four panel, an added pet door, and transom flush and blinds. The addition has two three-sash windows with wood mullion, and the top corners of outside sashes are bullnose, and the addition has a low-hip roof with new gutters.

Figure 84. 635 Maple Street: the northwest elevation and back yard, view to azimuth 115°.

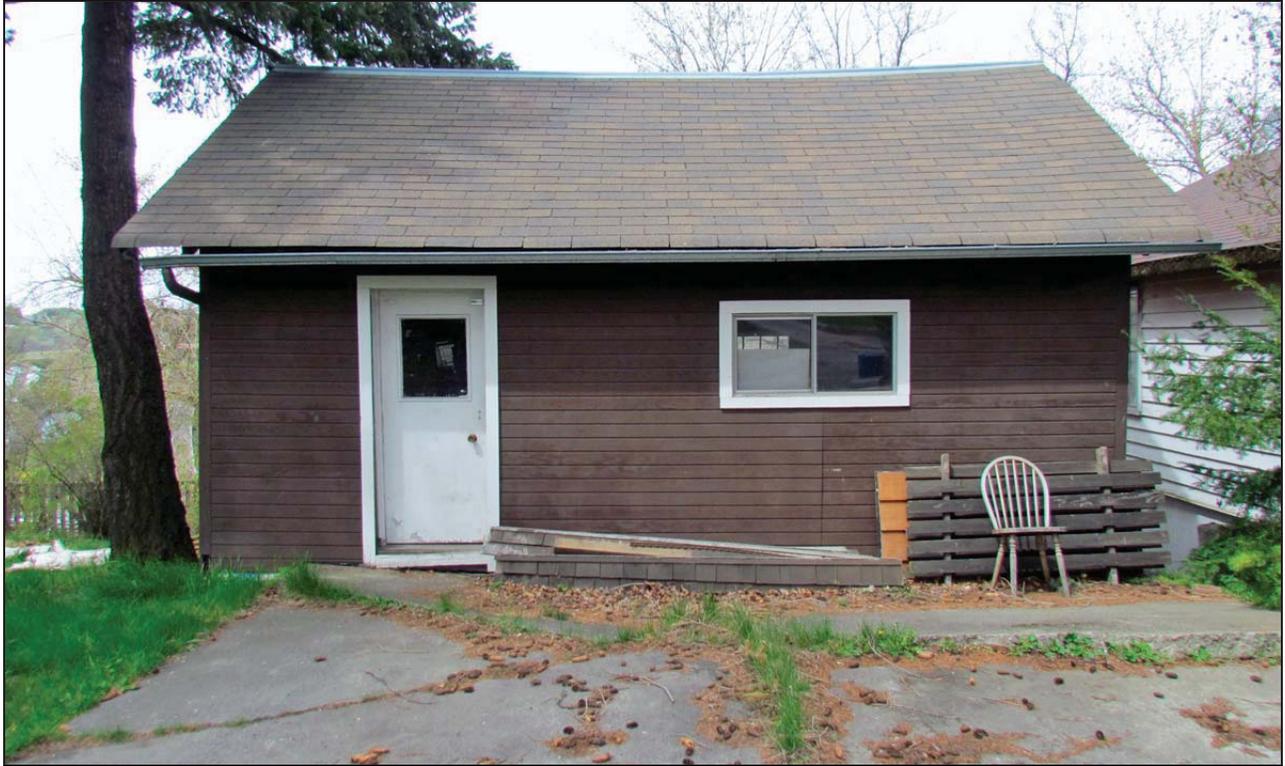
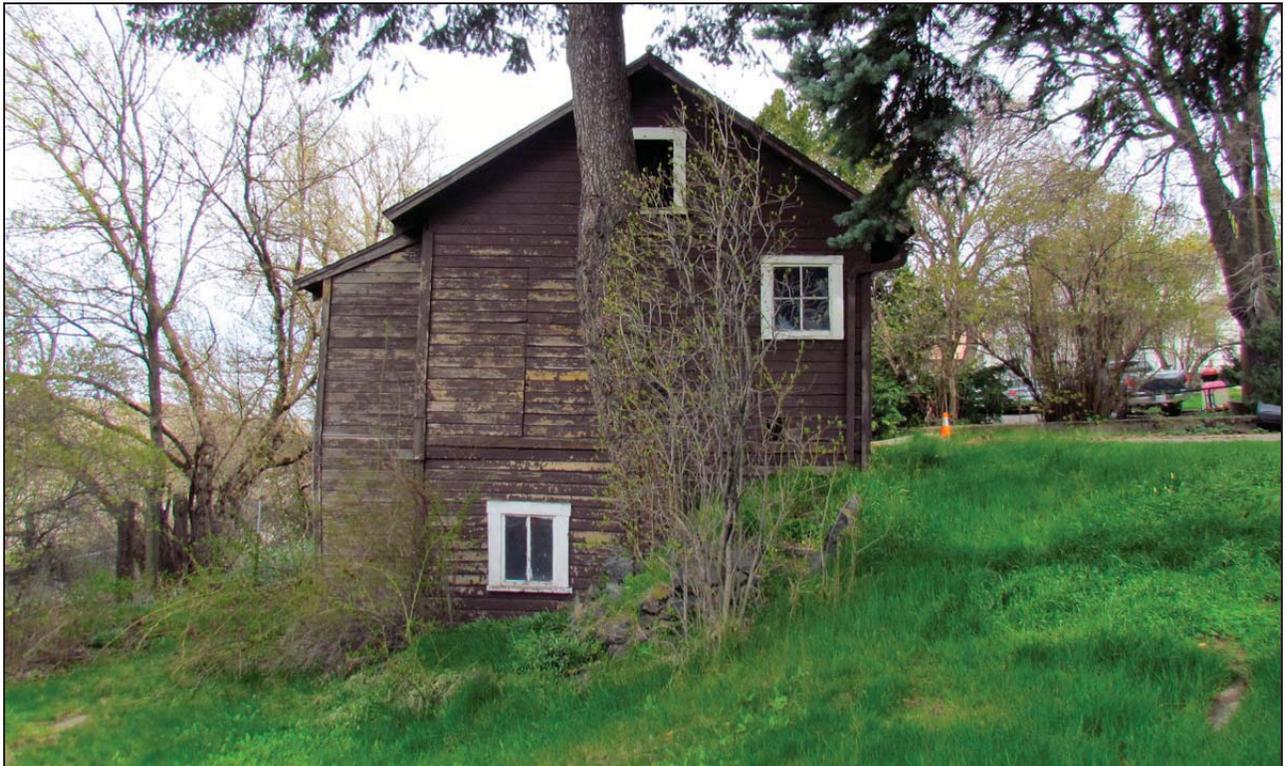
The southeast elevation has a poured concrete driveway leading to the walk-in door that is left of center (Figure 85a). The door is a single panel with a single light and plain trim. To the south is a horizontal sliding plain trim window. This elevation has been extensively modified, changing the building from a garage to its present configuration. The northeast elevation has a single-pane rectangular window. The dressed basalt walkway from the main house (Building 3) connects to the northwest elevation and joins with a poured concrete patio below a solid wooden door. This door has a hand-forged latch and plain trim and slip sill. The ground level of the northwest elevation has a single-sash window and the second story has two single-sash eight-pane windows with mullions. The southwest elevation at the ground level has a two-sash window with vertical mullion and plain trim and slip sill. At the second story is a single-sash four pane window, and a boarded opening next to the addition (Figure 85b).
