RECONNAISSANCE SURVEY FOR DOWNTOWN PULLMAN, WHITMAN COUNTY, WASHINGTON

By: Annie Doyon, MHP &
Kathryn Burk-Hise, MSHP

Prepared for:
Pullman Historic
Preservation Commission &
Pete Dickinson,
Planning Director –
Staff Liaison to the
Commission

July 11, 2014

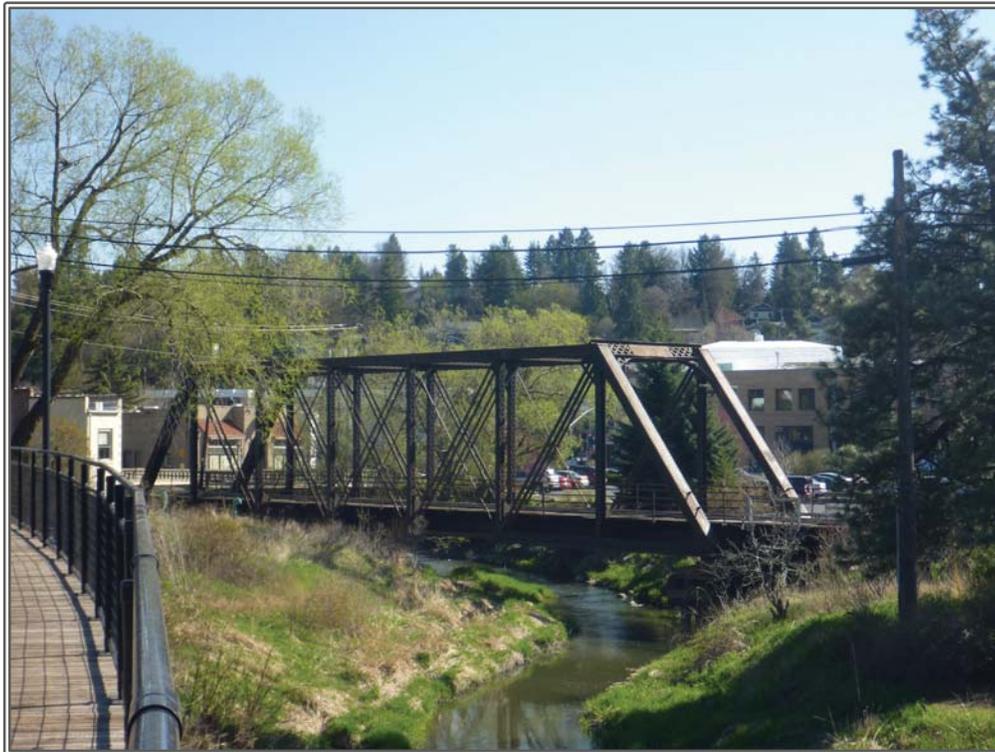
Figure 18: Train bridge over the South Fork of the Palouse River rear of Main Street

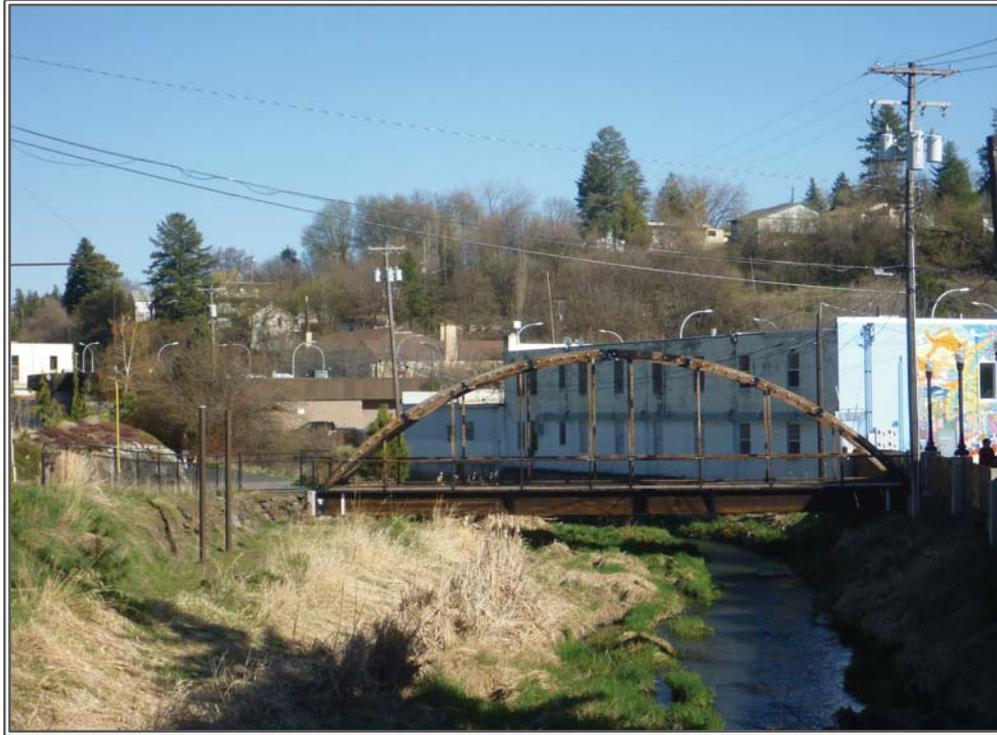
Figure 19: Pedestrian bridge extending from Pine Street over the South Fork of the Palouse River rear of Main Street

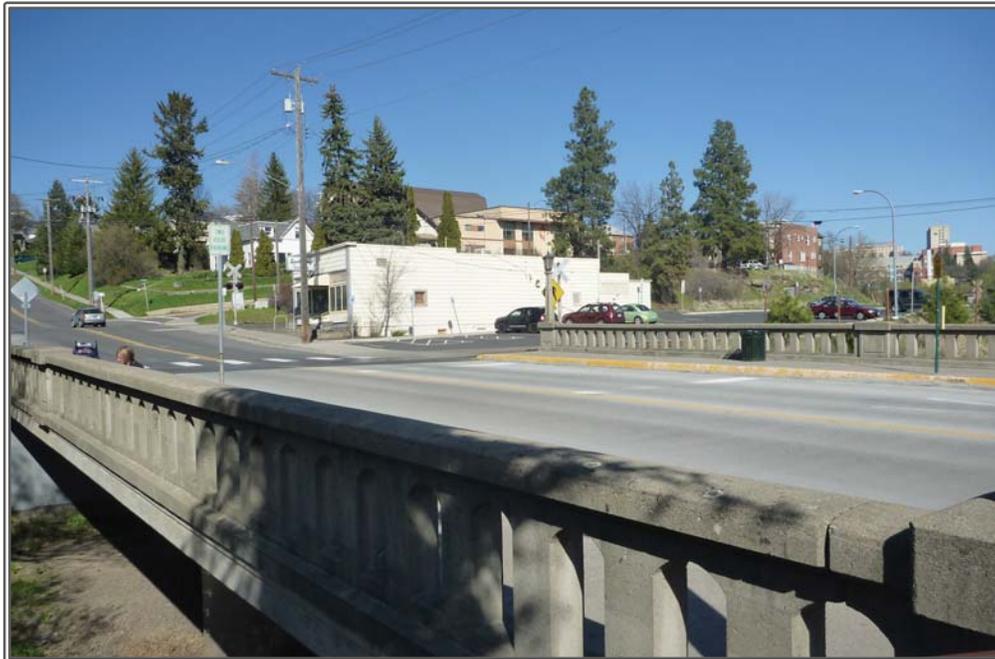
Figure 24: Vehicular bridge over the river along Kamiaken Street, looking north toward the train tracks and residential areas

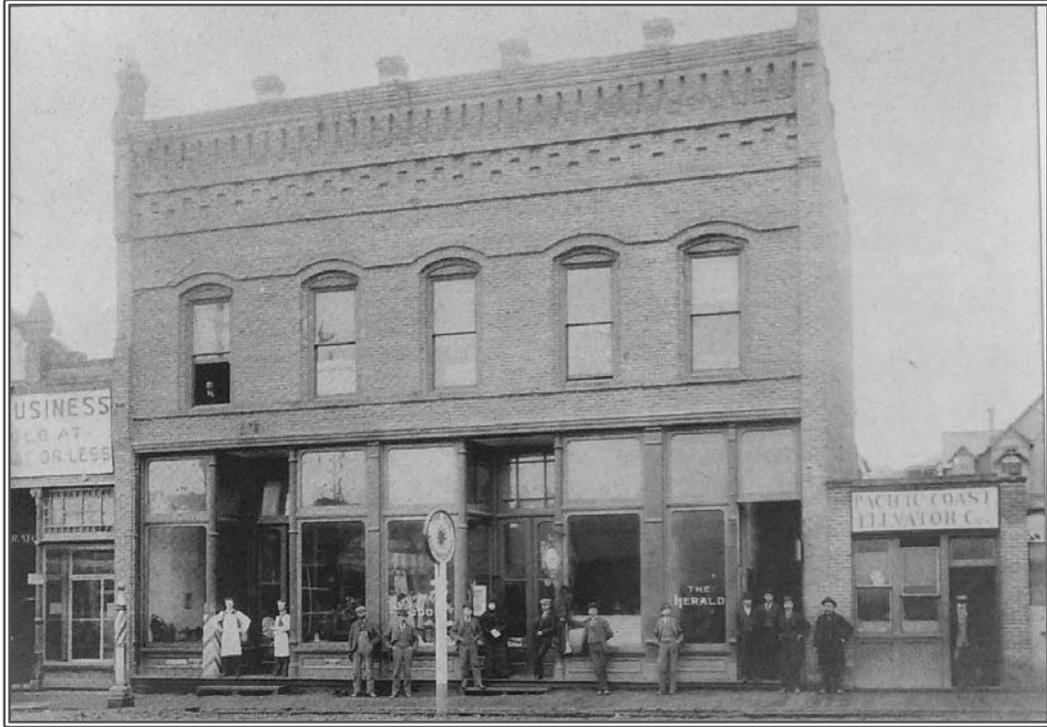
Figure 38: The Webb Block at 215 E. Main Street (Site 43) pictured ca. 1896 (Luedeking, 17)

West Bank (Site 12) (Figures 58–59); Design West Architects et al (Site 13) (Figure 60); the Webb Block/Combine Mall (Site 43) (Figure 38); and the Audian Theater and Basilio's (Site 52).

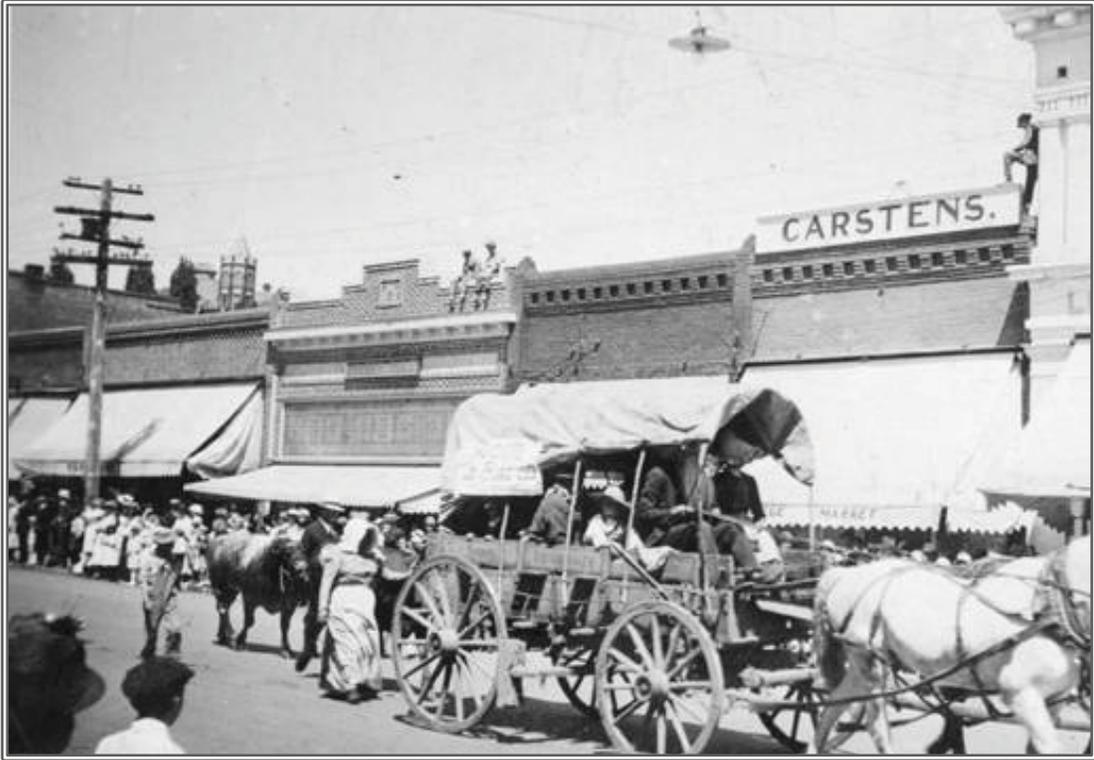
Figure 48: Main Street during the Pioneer Parade, 1920 (Two buildings on the right including Carstens and its neighbor, Site14; stepped parapet, Site 15) (City of Pullman Image Collection)

<p>Site #: 15 HPI #: N/A Listing Status: Not Listed Date: ca. 1890 238 E Main Street, Vision Source (Billiards, Saloon) DoE: Not Eligible Characteristics: Single-story, pre-1900 commercial building with large storefront windows and a flat awning. Simple, decorative brick elements found in the upper portion of the façade wall. Historic images (Figure 48) indicates this building originally had a stepped parapet.</p>

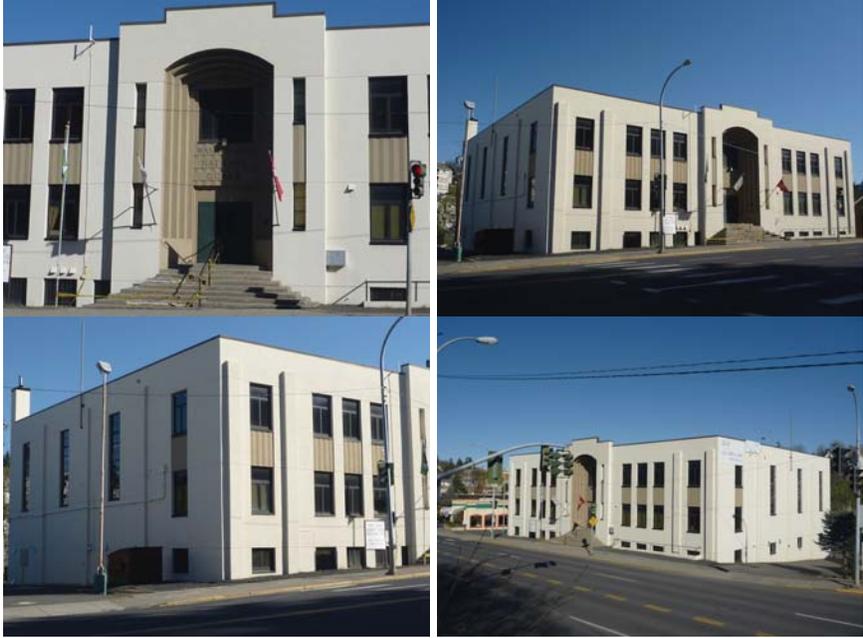
Survey Site Data	Site Photographs	
<p>Site #: 1 HPI #: 38-00348 Listing Status: Not Listed Date: ca. 1930 540 E Main Street, Condos & Yoga/Barre Studio (Washington National Guard Armory) DoE: Eligible, individually; contributing within a district Characteristics: Art Deco / Art Moderne building, built ca. 1930 as a PWA project. Central block with wings, with grand, arched entryway. Original windows remain on three elevations. Simple, smooth concrete exterior. See historical image, Figure 56.</p>

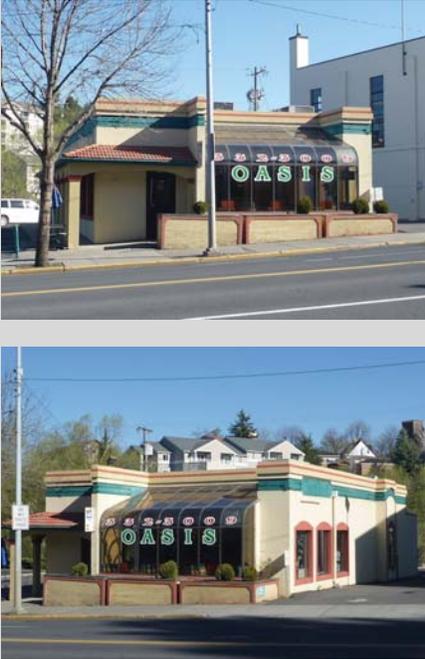
<p>Site #: 2 HPI #: N/A Listing Status: Not Listed Date: Contemporary 530 E Main Street, Oasis Teriyaki & Pho Restaurant DoE: Not Eligible Characteristics: Modern, single-story commercial, fast food type building marked by greenhouse style window and tile-roofed awning on the primary elevation.</p>

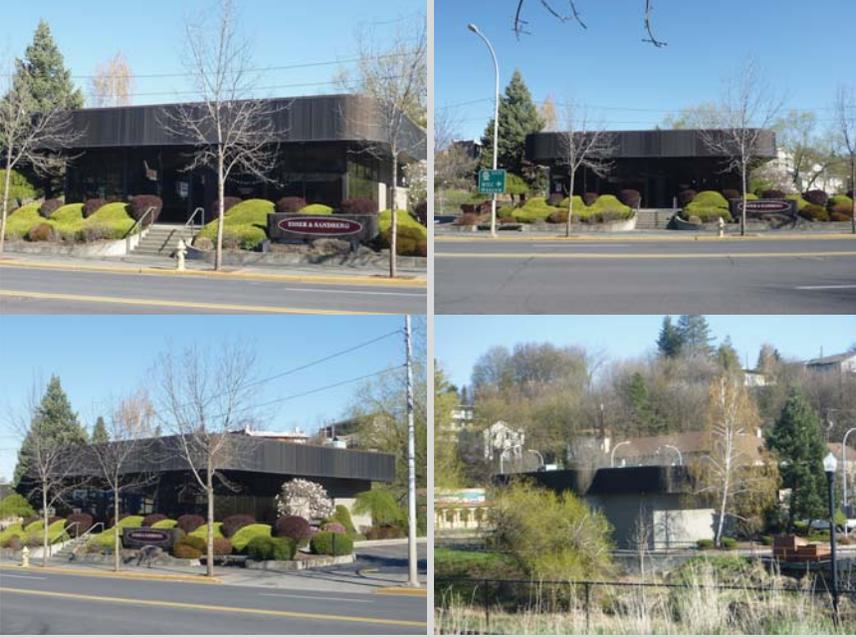
Survey Site Data	Site Photographs	
<p>Site #: 3 HPI #: N/A Listing Status: Not Listed Date: 1965-75 520 E Main Street, Esser & Sandberg Attorney-at-law DoE: Not Eligible Characteristics: Elements of Miesian influence in its form, with overall New Formalism design features including a flat, heavy, projecting roof. Floor-to-ceiling walls of windows. Potentially eligible within a district as an intact example of mid-century modern architecture relating to other buildings of this period in this area. Though this building is a significant representation of its type and period, it is outside of the period of significance for historical development in the commercial downtown core. This building may be eligible for the NRHP once it reaches the 50-year mark.</p>

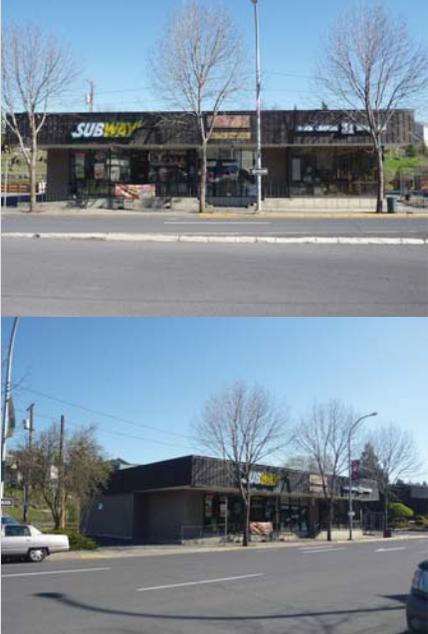
<p>Site #: 4 HPI #: N/A Listing Status: Not Listed Date: Contemporary 460-470-480 E Main Street, Subway, The Barber Shop, Fly Shop, Baskin & Robbins DoE: Not Eligible Characteristics: Modern, masonry-block building. Heavy, overhanging roof mimicking the historical version of this form found at neighboring Site 3.</p>

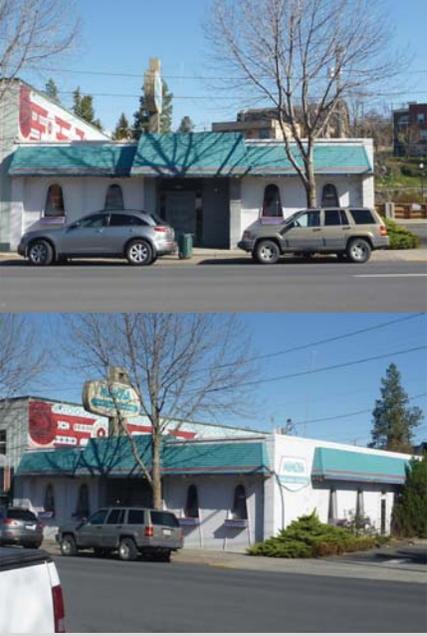
Survey Site Data	Site Photographs
<p>Site #: 5 HPI #: N/A Listing Status: Not Listed Date: Contemporary 420 E Main Street, Mimosa Grill-Bar-Catering – and parking lot DoE: Not Eligible Characteristics: Single-story, flat-roof, commercial, restaurant building with arched windows that flare at the bottom. Central, recessed entry. Awning roof spans façade and east side elevation.</p>

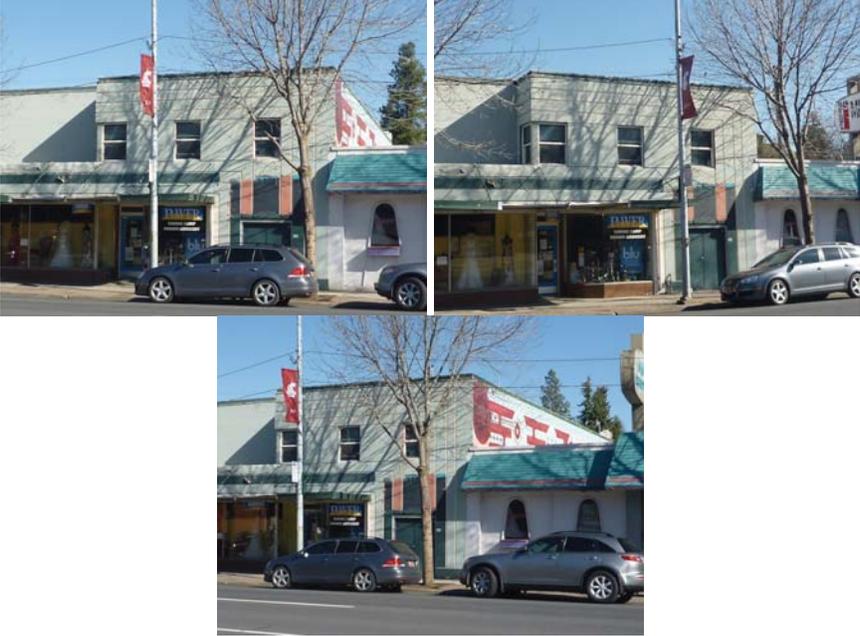
<p>Site #: 6 HPI #: N/A Listing Status: Not Listed Date: ca. 1930 408-414 E Main Street, Power Smoke Shop & Indian Grocery (Store) DoE: Eligible, contributing within a district Characteristics: Two-story, flat-roofed, streamlined Art Deco commercial building built ca. 1930. Windows and doors are replacements, though their scale and fenestration have been retained. A historic image (Figure 57) indicates this building has changed little since its early days.</p>

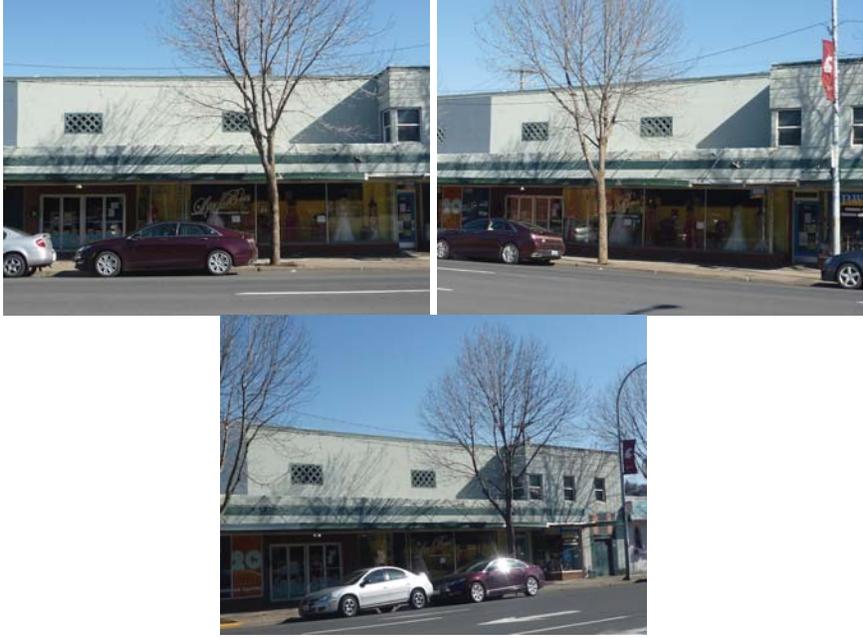
Survey Site Data	Site Photographs	
<p>Site #: 7 HPI #: N/A Listing Status: Not Listed Date: ca. 1930 410 E Main Street, Lily Bees Consignment Shop (Store) DoE: Eligible, contributing within a district Characteristics: Two-story, Art Deco-era commercial building with a storefront and flat awning attached along the original, wider awning spanning horizontally above the storefronts. Original decorative concrete vents are found on the second level. A historic image (Figure 57) indicates this building has changed little since its early days.</p>

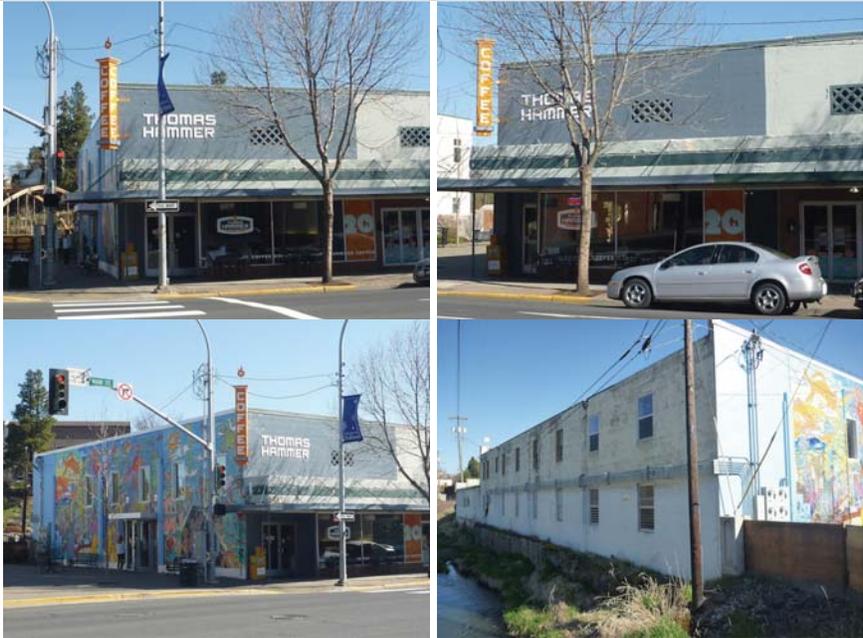
<p>Site #: 8 HPI #: N/A Listing Status: Not Listed Date: ca. 1930 400 E Main Street, Thomas Hammer Coffee Roasters (Store) DoE: Eligible, contributing within a district Characteristics: Two-story, flat-roof, Art Deco-era commercial building. Storefront windows span most of the façade while a recessed entry is located on the southwest corner. A flat awning spans the façade on an original, larger awning spanning the façade horizontally. A nonhistoric side entry and original, second-level windows are found on the west side. A historic image (Figure 57) indicates this building has changed little since its early days.</p>

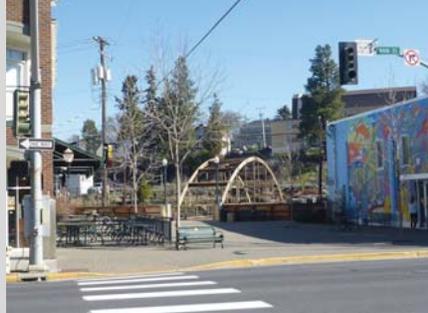
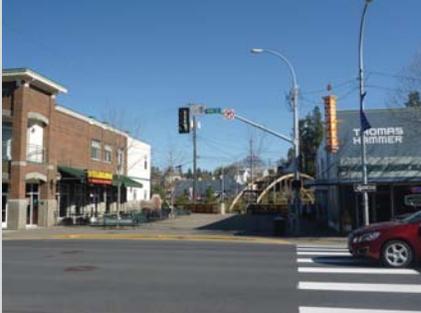
Survey Site Data	Site Photographs	
<p>Site #: 9 HPI #: N/A Listing Status: Not Listed Date: N/A N Pine & E Main Streets, Pine Street Plaza – and pedestrian bridge (N Pine Street) DoE: Not Eligible Characteristics: Former N Pine Street now closed off as a public plaza, with access to a nonhistoric pedestrian footbridge of the river and a footpath along the river west of Pine. The plaza features a modern paver surface while the footbridge is primarily constructed of wood.</p>

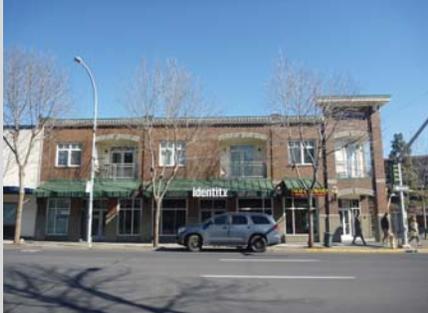
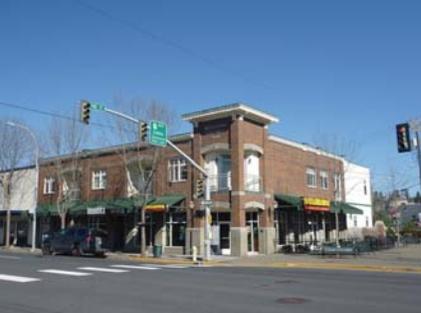
<p>Site #: 10 HPI #: N/A Listing Status: Not Listed Date: Contemporary (2004) 350 E Main Street, Bridgeway Center I DoE: Not Eligible Characteristics: Two-story, nonhistoric commercial building primarily covered in brick veneer. Residential portion spans the rear facing the river. Building is marked by a flat-roof tower-style entryway on the southeast corner. Storefront awnings span most of the façade. Faux dentil moldings and keystones over segmentally-arched windows decorate the building.</p>

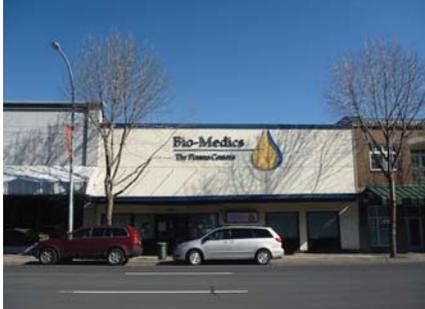
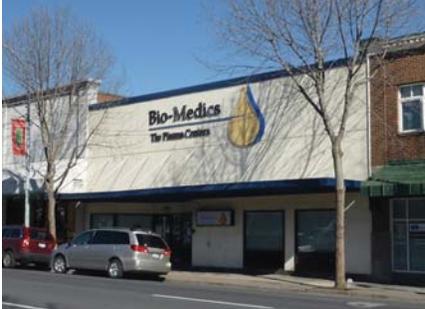
Survey Site Data	Site Photographs	
<p>Site #: 11 HPI #: N/A Listing Status: Not Listed Date: 1908–29 320 E Main Street, Bio-Medica, The Plasma Centers (Bakery, Furniture Store) DoE: Not Eligible Characteristics: Highly altered single-story commercial building dating to the early- twentieth century. Exterior exhibits a stucco finish on the lower level and panels applied above. A flat-roof awning spans the façade.</p>

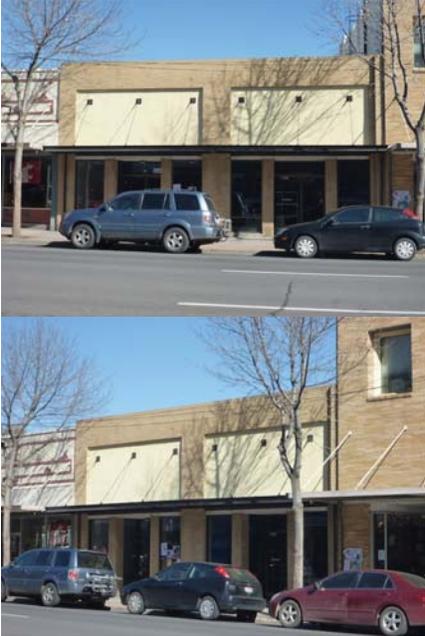
Survey Site Data	Site Photographs
<p>Site #: 14 HPI #: N/A Listing Status: Not Listed Date: ca. 1945 242-246 E Main Street, Vacant (Store, Restaurant) DoE: Eligible, contributing within a district Characteristics: Single-story, blonde-brick commercial building containing two commercial storefronts. Flat awning spans the façade.</p>

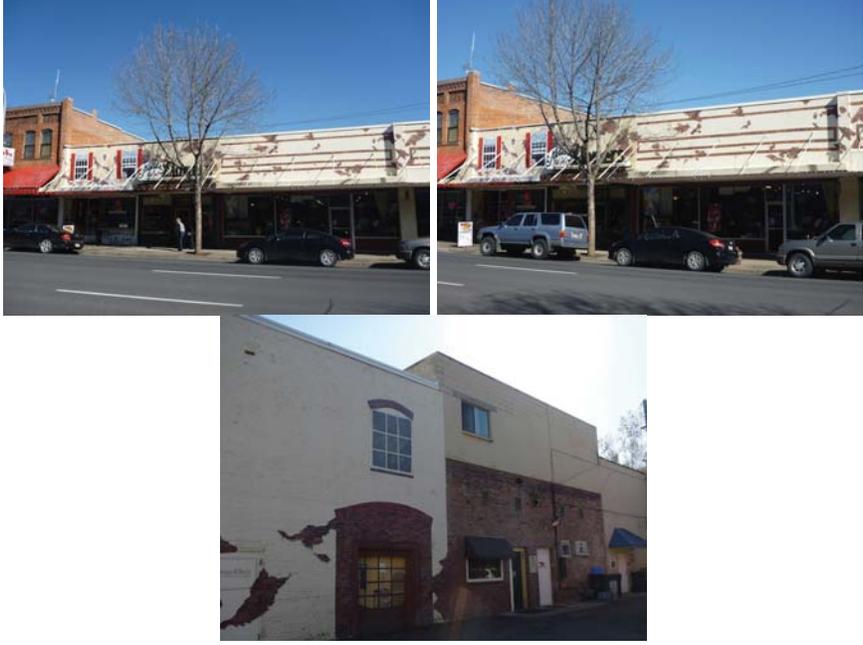
Survey Site Data	Site Photographs	
<p>Site #: 16 HPI #: N/A Listing Status: Not Listed Date: ca. 1893, 1929-49 230-234-236 E Main Street, Design Effects, Neil's Flowers & Gifts, Daily Grind Coffee House (Agricultural Implements) DoE: Eligible, contributing within a district Characteristics: Single-story commercial property with two-story rear elevations. Easterly portion appears to date back to ca. 1893 while the westerly portion appears to have been added in its current scale between 1929 and 1949. Large, commercial, storefront windows with a flat awning above. Faux paint effects are found on the upper portions of the walls.</p>

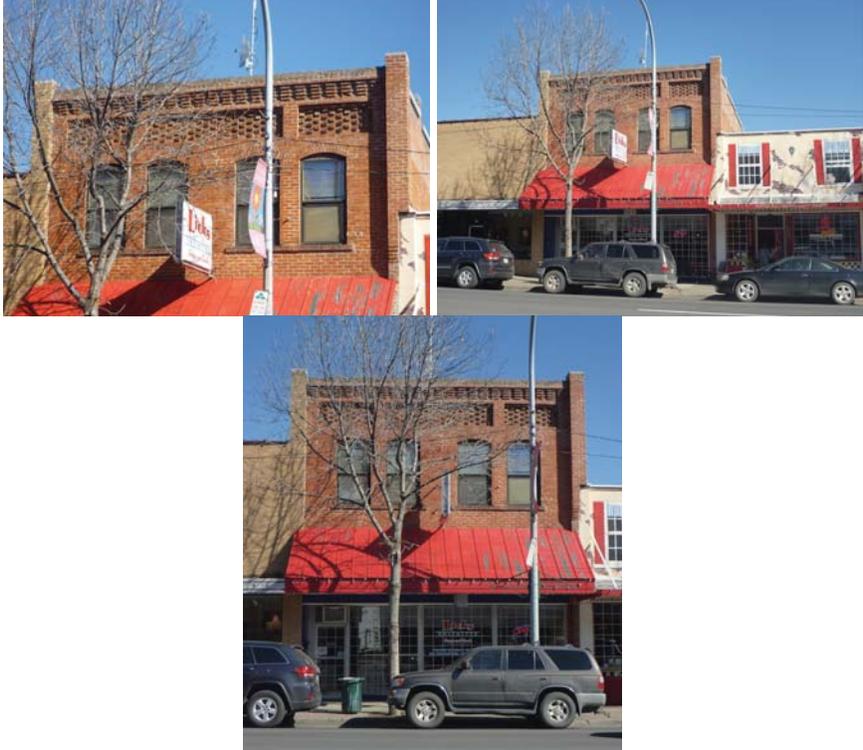
<p>Site #: 17 HPI #: N/A Listing Status: Not Listed Date: 1890 226 E Main Street, Licks Unlimited Soups & Sweets (Restaurant, Confectionary, Tobacco & Soft Drinks) DoE: Not Eligible Characteristics: Two-story, brick, 1890 building with decorative brickwork including corbelling and brick lintels and sills. Replacement sashes and a nonhistoric awning are found on this building with changes to the fenestration on the first level. An air-conditioning unit is found above the entry. This was built with one story in 1890 with the second story added by 1908.</p>

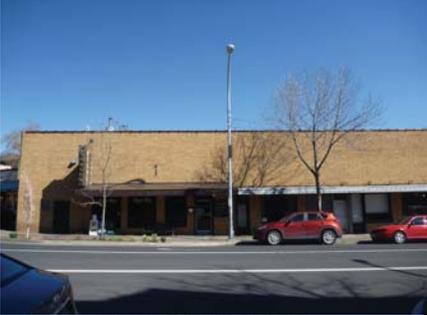
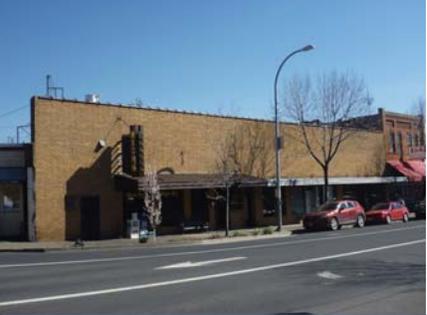
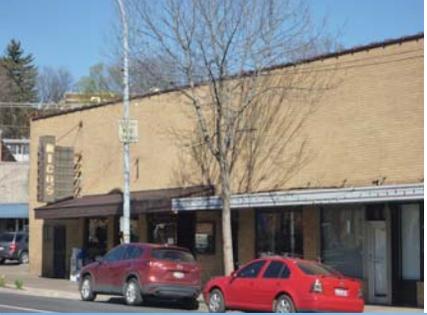
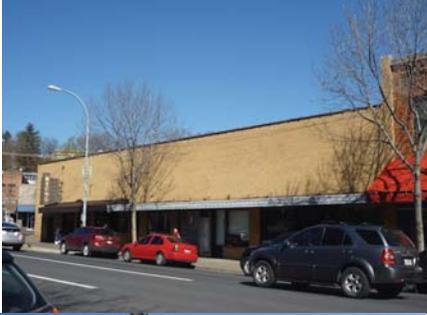
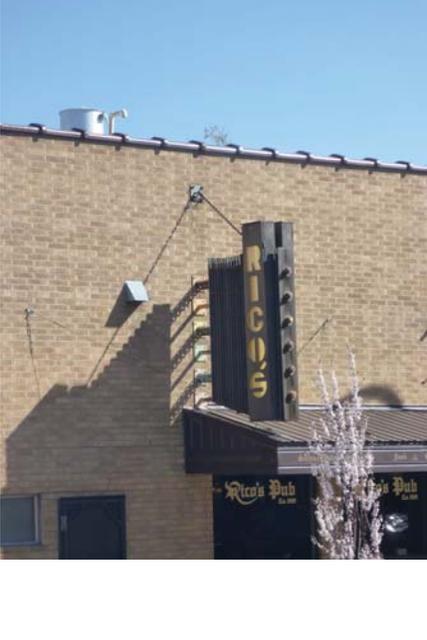
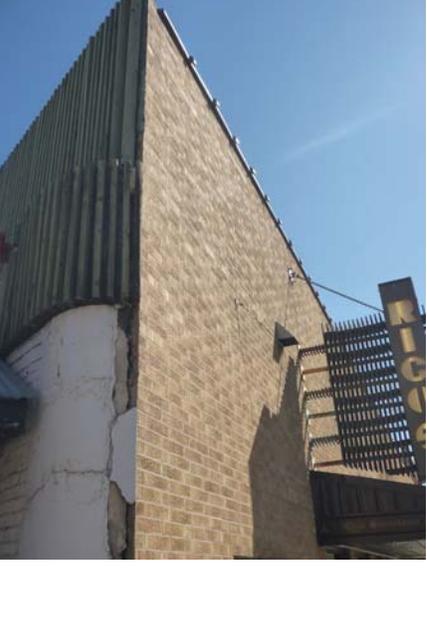
Survey Site Data	Site Photographs	
<p>Site #: 18 HPI #: N/A Listing Status: Not Listed Date: ca. 1960 200-214-222 E Main Street, Creative Images Portrait & Design, Rico's Pub DoE: Eligible, contributing within a district Characteristics: Single-story, mid-century modern commercial building with a low, horizontal profile, blonde-brick veneer, and a strong yet undecorated façade elevation. Flat awnings cover two storefronts on the east side while a pent-roof awning covers the storefront on the west side. Vertical wood slats decorate the west elevation and vintage commercial signage remains.</p>

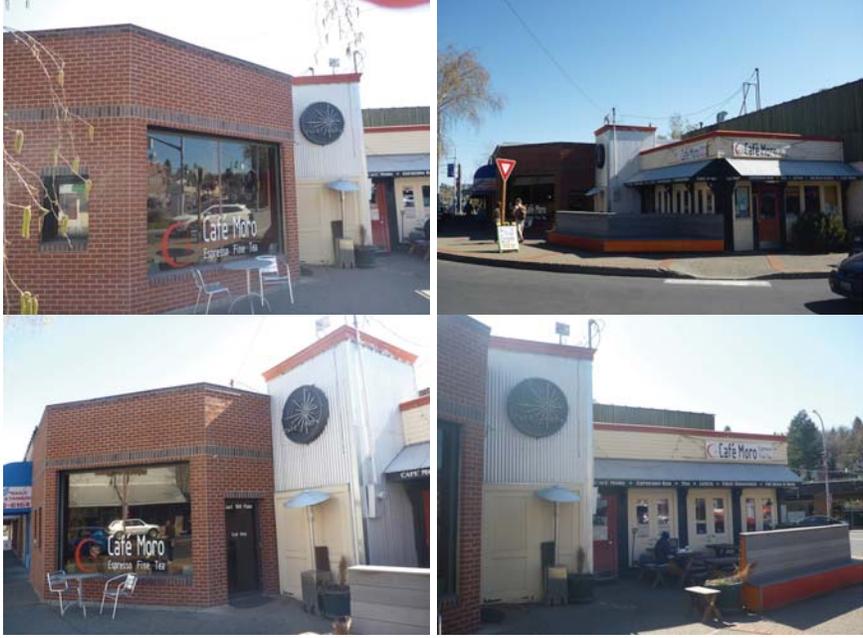
Survey Site Data	Site Photographs
<p>Site #: 19 HPI #: N/A Listing Status: Not Listed Date: ca. 1900, 1929–49 100-110 N Grand Avenue, Café Moro & Espresso, Fine Teas (Jeweler; Store, Gas & Oil) DoE: Not Eligible Characteristics: Single-story, L-shape commercial building. The southerly portion may date back prior to 1908, though the original small building of a similar scale in this location exhibited a chamfered southwest corner (see Figure 40). The northwest portion of the building was added between 1929 and 1949. A section in between these two sections is a modern addition. Doors and windows have been replaced, and additional openings have been added over time.</p>

<p>The photographs show the Café Moro building from four different perspectives. The top-left photo shows the corner of the building with a brick facade and a large window. The top-right photo shows the building from a street-level view, highlighting the modern addition. The bottom-left photo shows the building from a side angle, and the bottom-right photo shows the building from a street-level view, highlighting the modern addition.</p>

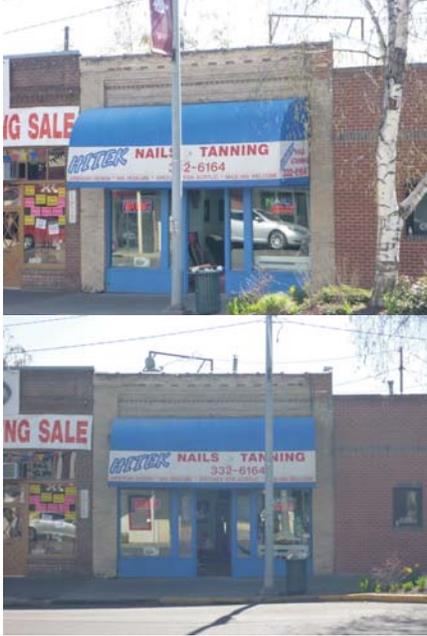
<p>Site #: 20 HPI #: N/A Listing Status: Not Listed Date: 1908–29 114 N Grand Avenue, Hi Tek Nail & Tanning (Cream & Milk Station) DoE: Eligible, contributing within a district Characteristics: Single-story commercial building with sandy-colored brick exterior. Multi-part commercial storefront with a central entry, sidelights and large storefront windows. A large nonhistoric awning is found just below original, decorative brickwork.</p>

<p>The photographs show the Hi Tek Nail & Tanning building from two different perspectives. The top photo shows the building from a street-level view, highlighting the brick facade and the awning. The bottom photo shows the building from a street-level view, highlighting the brick facade and the awning.</p>

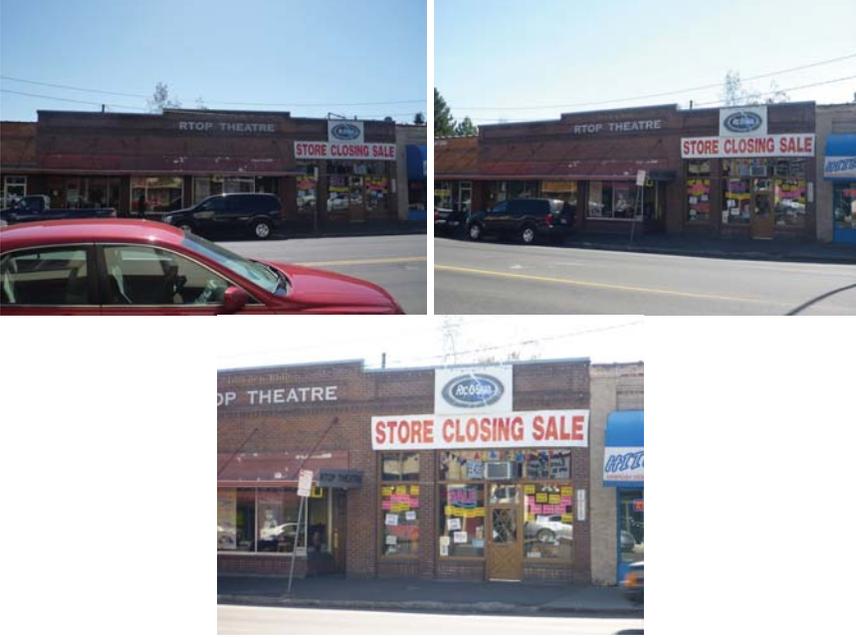
Survey Site Data	Site Photographs
<p>Site #: 21 HPI #: N/A Listing Status: Not Listed Date: 1908–29 118-122 N Grand Avenue, Ric-O-Shay & the RTOP Theatre (Downen Building; Hardware, Tin Shop, Restaurant) DoE: Eligible, contributing within a district Characteristics: Single-story, brick, commercial building with stepped roofline and higher parapet above the center of the building. Three commercial storefronts are found on the building, with one retaining original wood-sash windows. The other two contain recessed entries, metal windows, a metal awning, and covered transoms.</p>

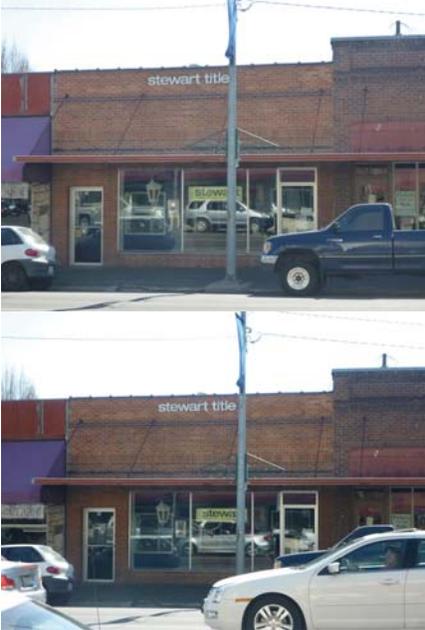
<p>Site #: 22 HPI #: N/A Listing Status: Not Listed Date: ca. 1920 130 N Grand Avenue, Stewart Title (Dance Parlor) DoE: Eligible, contributing within a district Characteristics: Simple, single-story, brick, commercial building. Windows and doors have been replaced and a flat-roof awning has been added. Brick exterior common to and indicative of the original period remains, along with terra cotta caps along the roofline.</p>

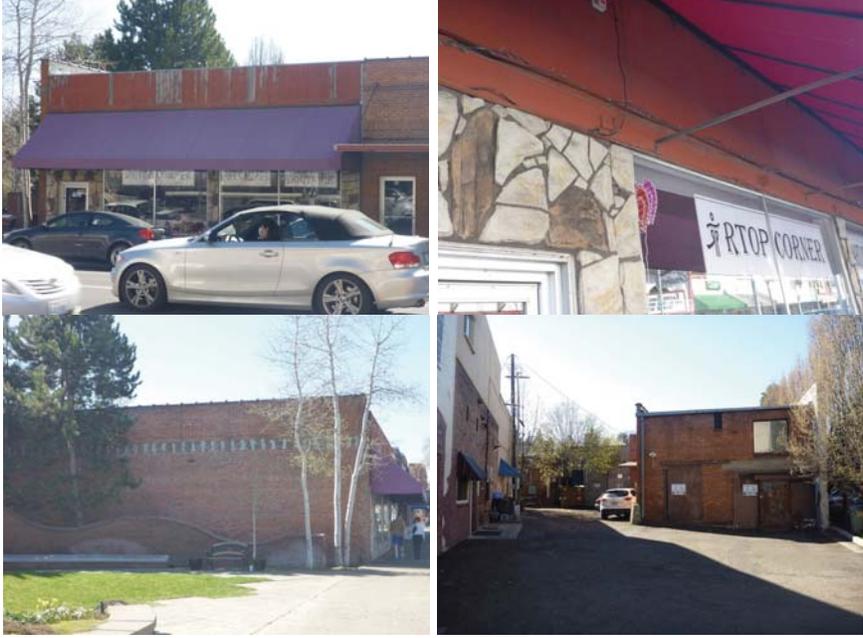
Survey Site Data	Site Photographs	
<p>Site #: 23 HPI #: N/A Listing Status: Not Listed Date: 1908–29 134 N Grand Avenue, RTOP Corner, Art Gallery, Thrift Boutique (Grocery) DoE: Not Eligible Characteristics: Single-story commercial with extensive alterations. A perma-stone veneer has been added the lower portions of the façade wall, while vertical boards are added above. A large awning covers a steel I-beam found between the large, replacement storefront windows and the transoms that have been covered with plywood. Original brick parapet walls are found on the north and south sides.</p>

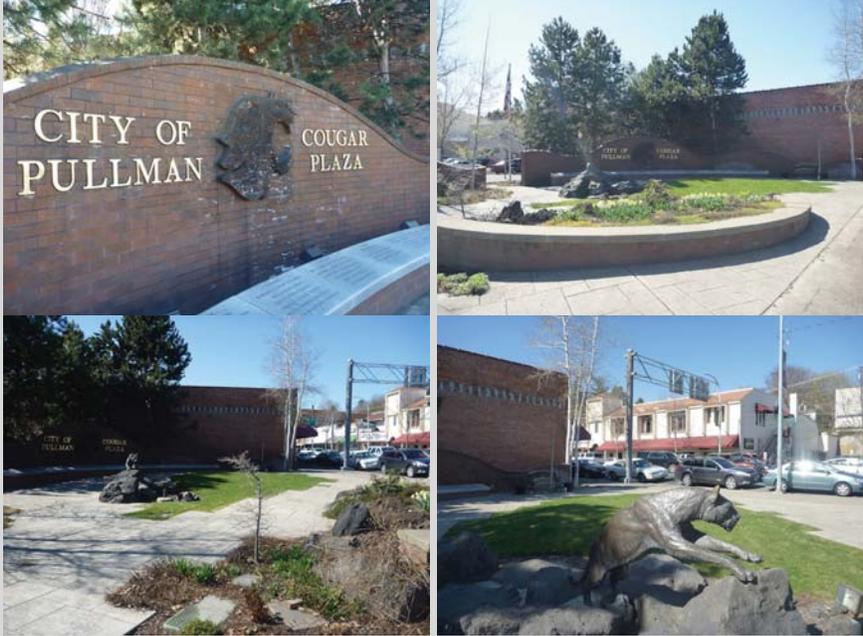
<p>Site #: 24 HPI #: N/A Listing Status: Not Listed Date: N/A E Olsen Street & N Grand Avenue, Cougar Plaza (Blacksmith & Wagon Shop, Hotel Pullman) DoE: Not Eligible Characteristics: Former site of a blacksmith and wagon shop (pre-dating the 1889 Sanborn map), and the Hotel Pullman, which was present on the site by 1929. Site currently contains Cougar Plaza, a modern, open, plaza or park space with brick walls, a cougar statue, grass and walkway areas, and plantings.</p>

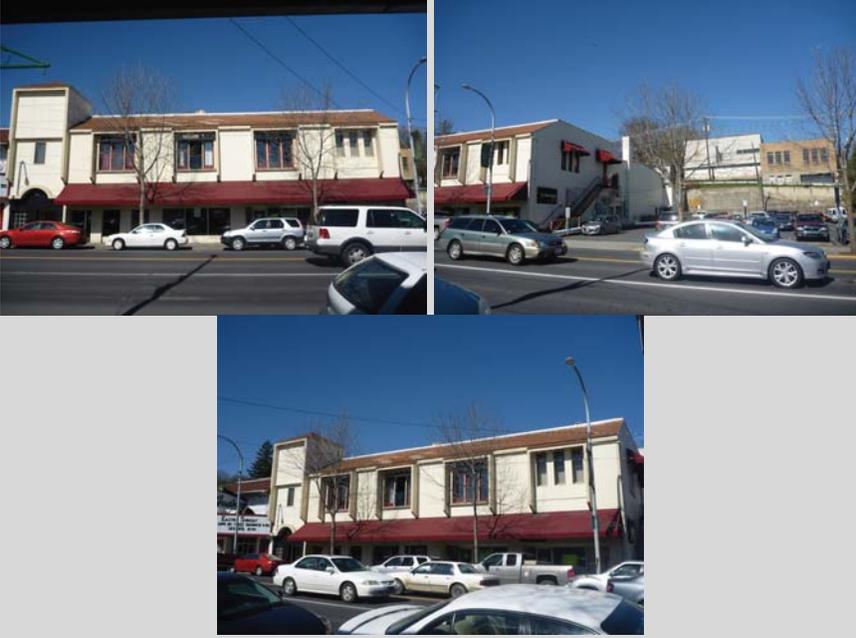
Survey Site Data	Site Photographs	
<p>Site #: 25 HPI #: N/A Listing Status: Not Listed Date: Contemporary 139-141-151 N Grand Avenue, H&R Block, Magic Game Shop DoE: Not Eligible Characteristics: A general store was on this site in 1891, by 1908 that building had been onto and then housed agricultural implements and a buggy depository. Between 1929 and 1949 the building had been demolished and replaced with a small service station. The site now contains a large parking lot and a two-story contemporary building ca. 1980 with commercial storefronts below, a large vinyl awning, and shouldered, wooden frames extending forward out around upper level windows.</p>

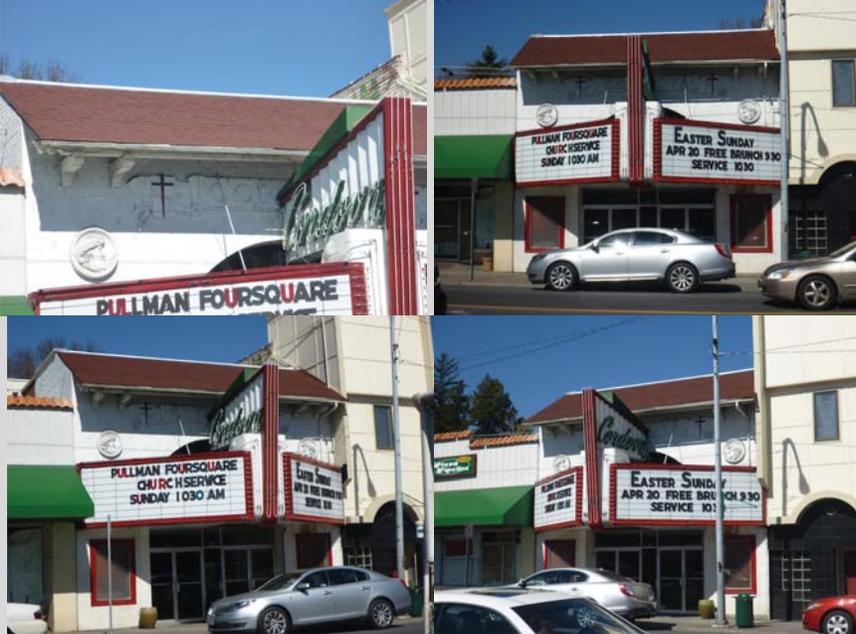
<p>Site #: 26 HPI #: WT00281 Listing Status: NRHP Listed, Individually: Cordova Theater Date: 1927 135 N Grand Avenue, Cordova Theater (Cordova Theater) DoE: Eligible, individually; contributing within a district Characteristics: Built in 1927 as a movie theater, being designed by significant Spokane architects Whitehouse and Price. Red Spanish tile no longer remains and doors have been replaced, but all of the architectural character and features remain including medallions, Cordova inscription on terra cotta, and prominent, historical theater sign and marquee. The current marquee dates to 1950 (WSU 2014). Listed to the NRHP in 2004 under Criteria A and C.</p>

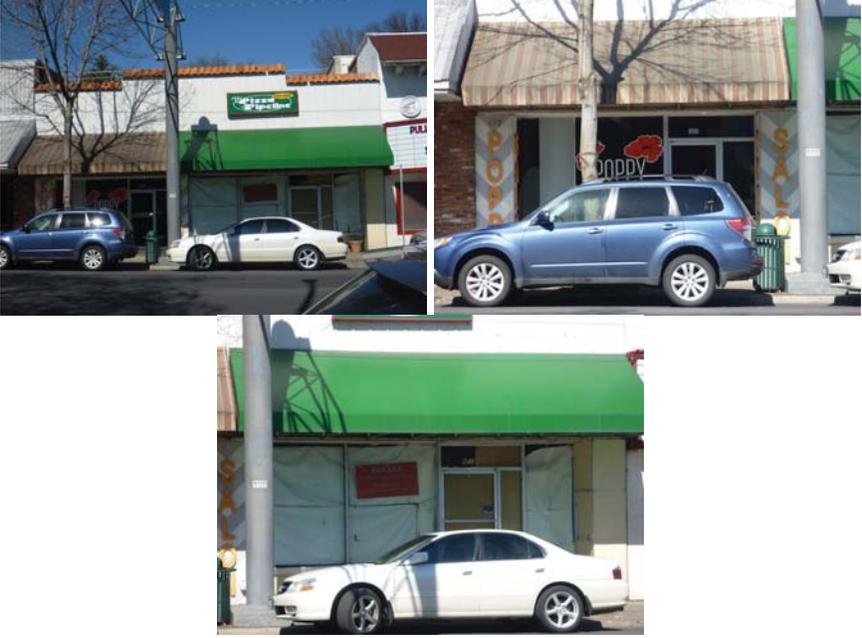
Survey Site Data	Site Photographs
<p>Site #: 27 HPI #: N/A Listing Status: Not Listed Date: 1908–29 127-131 N Grand Avenue, Pipeline Pizza, Poppy Salon (Grocery, Meat) DoE: Not Eligible Characteristics: Single-story commercial building with two storefronts. Doors and windows have been replaced, and shaded by modern awnings. The upper portion of the building is clad in metal panels and the cornice line is finished with Spanish tile. Stepped roofline with small, central parapet is the only obvious feature of the building's original character.</p>

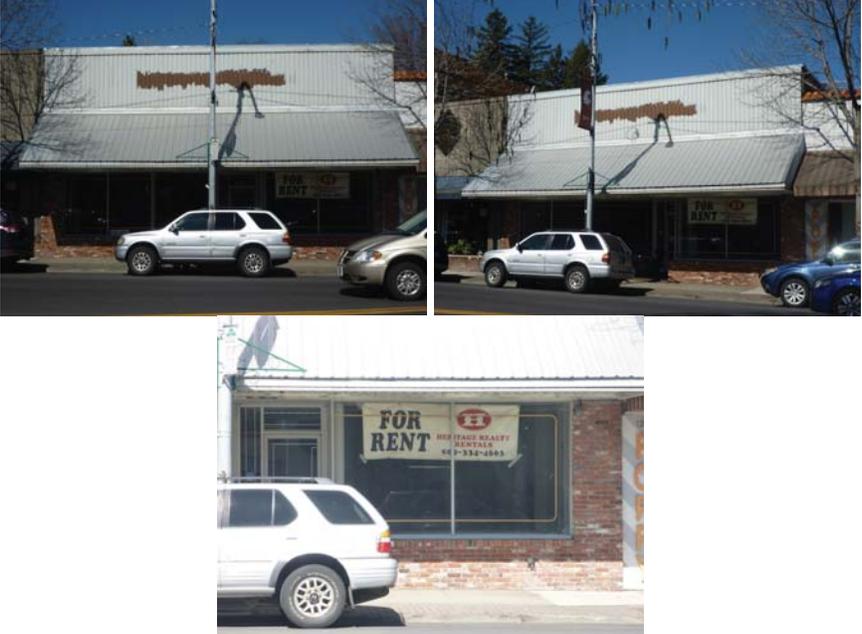
<p>Site #: 28 HPI #: N/A Listing Status: Not Listed Date: 1908–29 123 N Grand Avenue, Vacant (Garage, Store) DoE: Not Eligible Characteristics: Single-story commercial building, which has been highly altered. Storefront windows and a recessed entry are found on the lower portion of the façade, with a metal panel-covered, shed-roof awning above. The metal panel cladding carries through to the façade wall above the awning.</p>

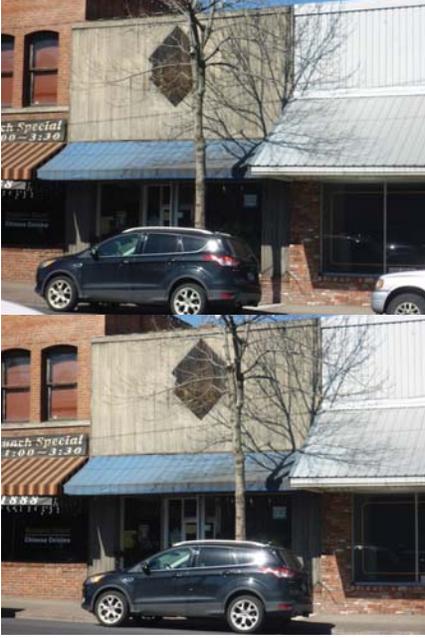
Survey Site Data	Site Photographs
<p>Site #: 29 HPI #: N/A Listing Status: Not Listed Date: 1896–1908 119 N Grand Avenue, Rain Shadow Research (Printing & Office, Telephone Exchange) DoE: Not Eligible Characteristics: Narrow, single-story commercial space. Storefront windows and a recessed entry are located on the façade, sheltered by a vinyl awning. Vertical board siding covers the upper portions of the wall and the far sides of the lower walls on either side of the large commercial windows.</p>

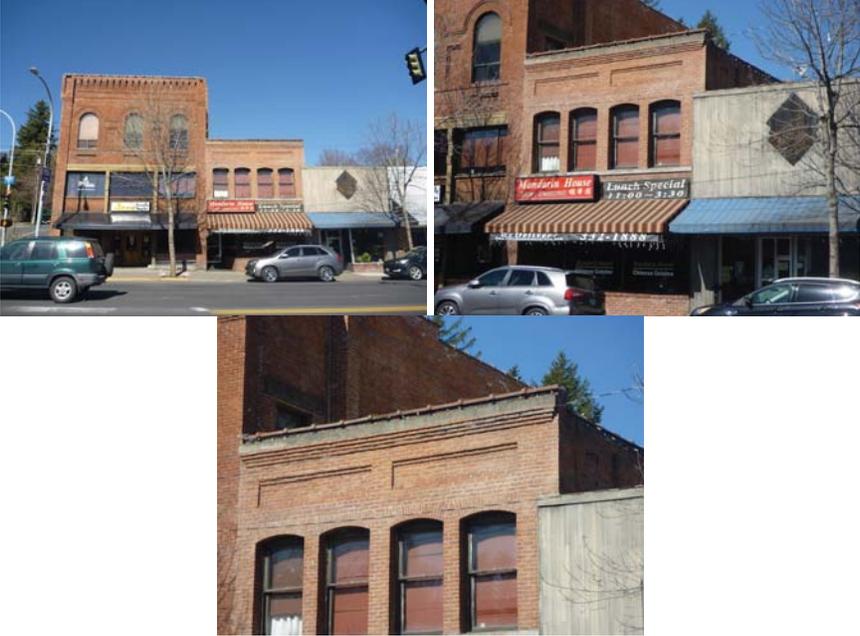
<p>Site #: 30 HPI #: N/A Listing Status: Not Listed Date: 1908–29 115 N Grand Avenue, Mandarin House Restaurant (Undertaker) DoE: Eligible, contributing within a district Characteristics: Two-story, early-twentieth century brick commercial building constructed for the undertaker. Nonhistoric storefront windows and a recessed entry topped by an awning are found on the lower level, while segmentally arched, one-over-one, wood- sash windows with brick, jack arches are found on the upper level. Decorative brickwork and terra cotta caps are found at the cornice.</p>

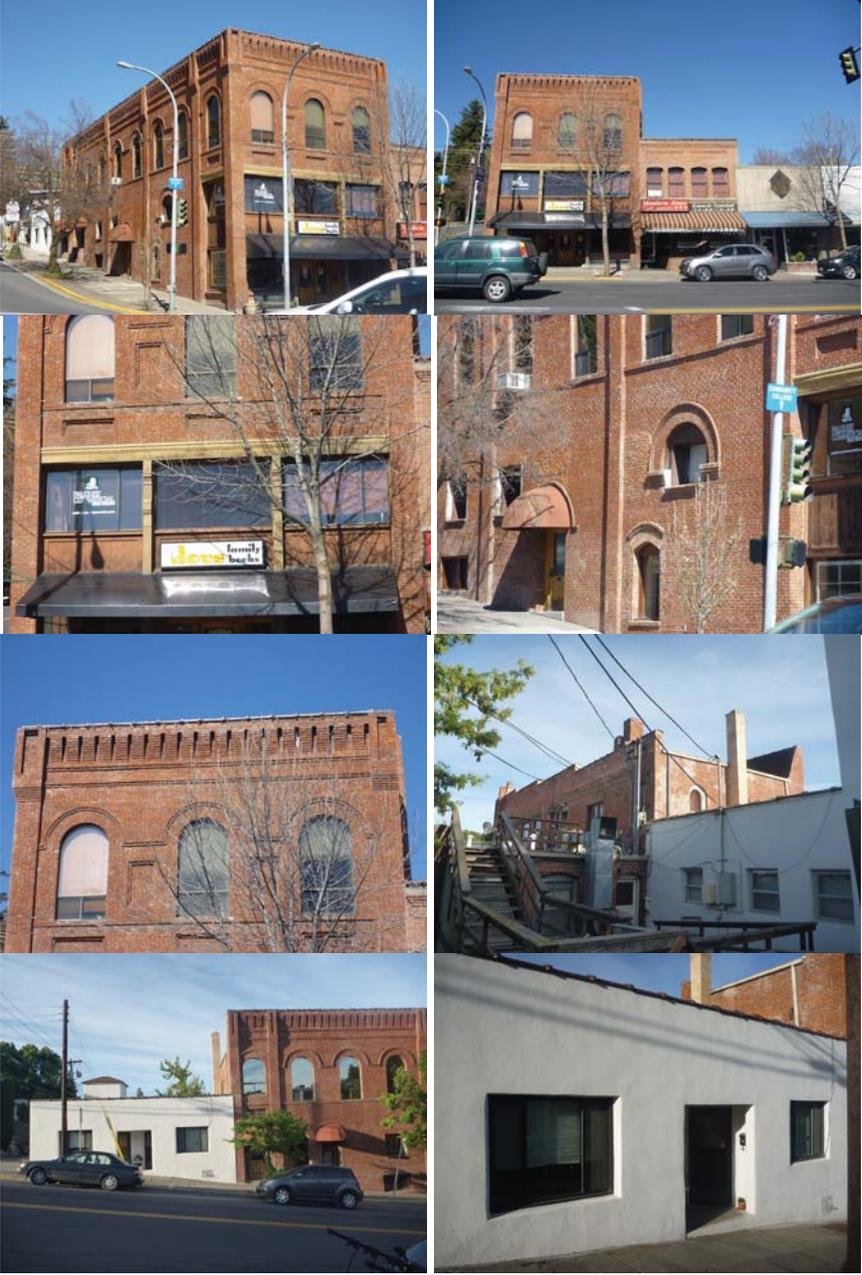
Survey Site Data	Site Photographs	
<p>Site #: 31 HPI #: 38-00273 Listing Status: Not Listed Date: ca. 1896 105 N Grand Avenue, Anawalt Building - Dove Family Books (Mason Building) DoE: Eligible, individually; contributing within a district Characteristics: Three-story, turn-of-the-century, brick, commercial building exhibiting Queen Anne elements. Sanborn maps indicate this was originally a two-story building, though historical images (Figures 61-62) indicate the building still retains its original exterior appearance and an additional level was only added on the interior. This space was finished as a furniture store and offices and evolved to offices with two dwellings in an addition on the rear. Windows and doors have been replaced, but the most character defining features have been retained, including brick arches, recessed brick panels, corbelling, and terra cotta panels. Though a portion of the original, larger storefront windows have been filled with brick to allow for an additional interior floor to be added, the detailed wood pilasters remain around the location of the original windows reflecting and retaining evidence of the building's two-story origins. A single-story, duplex unit is attached to the rear, having been added early in the building's history. Despite several remodels, the building was restored to its original appearance in 1978 (Pullman Main Street Program).</p>
