RECONNAISSANCE SURVEY FOR DOWNTOWN PULLMAN, WHITMAN COUNTY, WASHINGTON

By: Annie Doyon, MHP &
Kathryn Burk-Hise, MSHP

Prepared for:
Pullman Historic
Preservation Commission &
Pete Dickinson,
Planning Director –
Staff Liaison to the
Commission

July 11, 2014

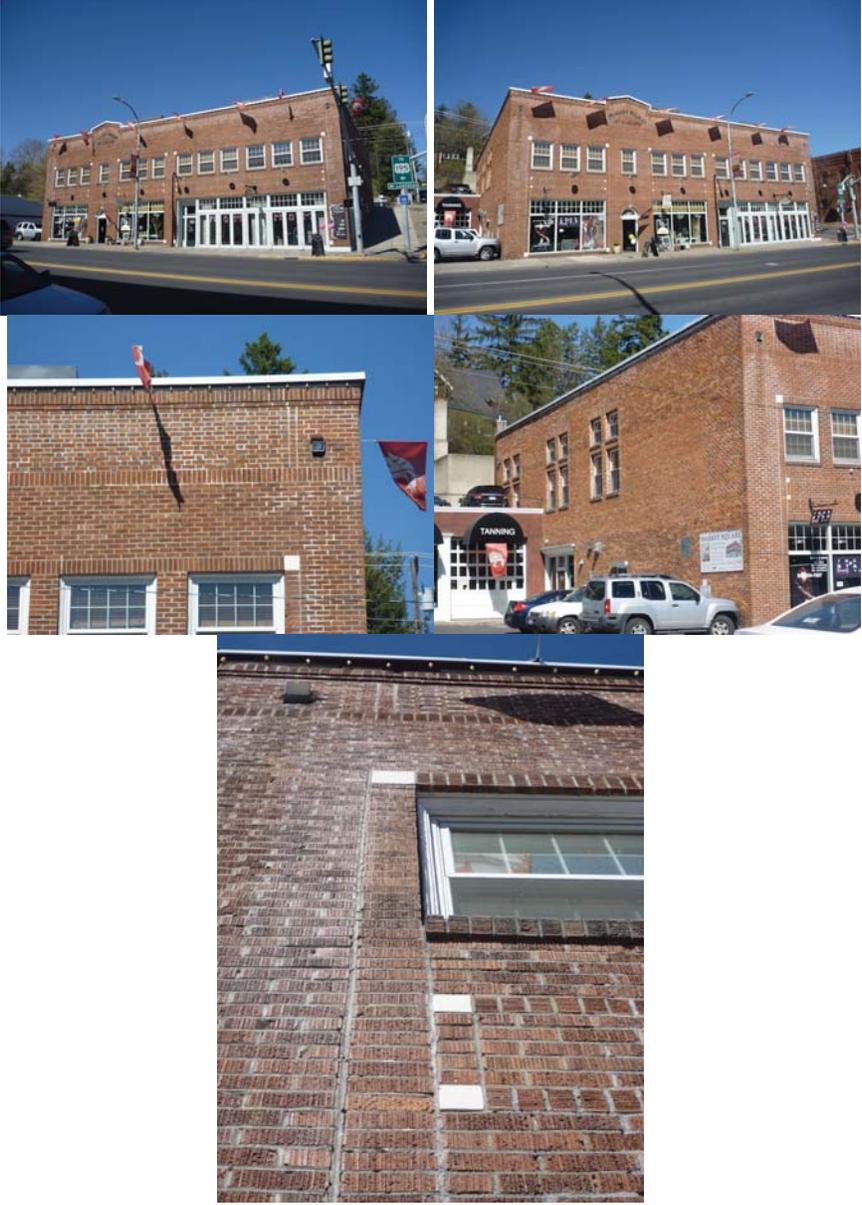
Survey Site Data	Site Photographs	
<p>Site #: 32 HPI #: N/A Listing Status: Not Listed Date: ca. 1925 107 S Grand Avenue, Market Square/Square One Building – Flirt, Prune Orchard, Rock Star Bar (Market Square; Garage) DoE: Eligible; contributing within a district Characteristics: Two-story, brick and tile, former garage and repair shop. Stretcher bond brick exterior with a Flemish bond parapet wall. Soldier course bricks create decorative patterns accented by glazed square tiles. Windows and doors have been replaced, though the building still exhibits strong elements of its period of construction.</p>

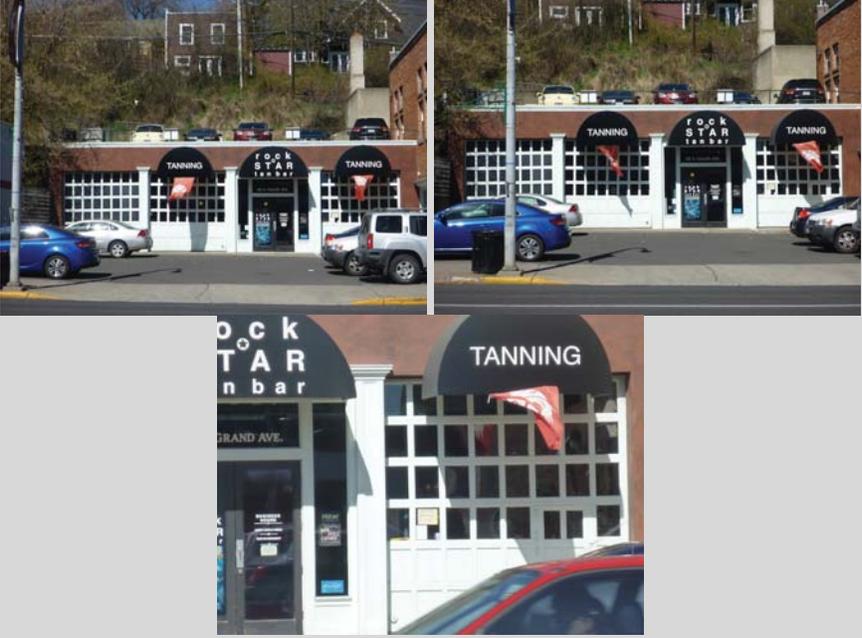
Survey Site Data	Site Photographs	
<p>Site #: 33 HPI #: N/A Listing Status: Not Listed Date: 1929-49 115 S Grand Avenue, Rock Star Tan Bar (Auto Service) DoE: Not Eligible Characteristics: Small, single-story building constructed as an auto garage, attached to the larger garage directly north at 107 S Grand Avenue (Site 32). Three vehicle bays and one entry with double doors, sidelights and transom. Square pilasters between each bay. Parking is on the roof, which is level with the street to the rear. Building has been altered, re-styled and modernized to hold non-automotive commercial businesses.</p>

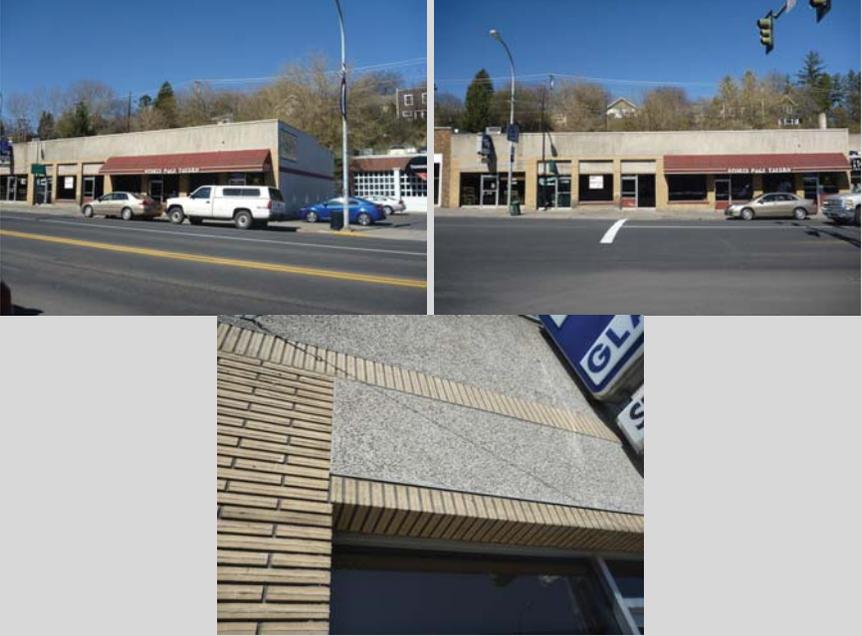
<p>Site #: 34 HPI #: N/A Listing Status: Not Listed Date: 1908-29 165-185-187-195 S Grand Avenue, Sports Page Tavern, Elaine's Hair Studio, (Battery Shop, Plumber, Harness, Paint Shop) DoE: Eligible, contributing within a district Characteristics: Single-story, early-twentieth century building with mid-century modern restyling. Original red brick is visible at a seam between this building and its neighbor. The façade features aggregate panels and textured, blonde-brick veneer. Numerous storefront windows with brick-veneered bulkheads below, and entries with replacement, commercial-style windows and doors. Slight recessed panels are above openings – likely filling original transoms. Vinyl awning is above one business.</p>

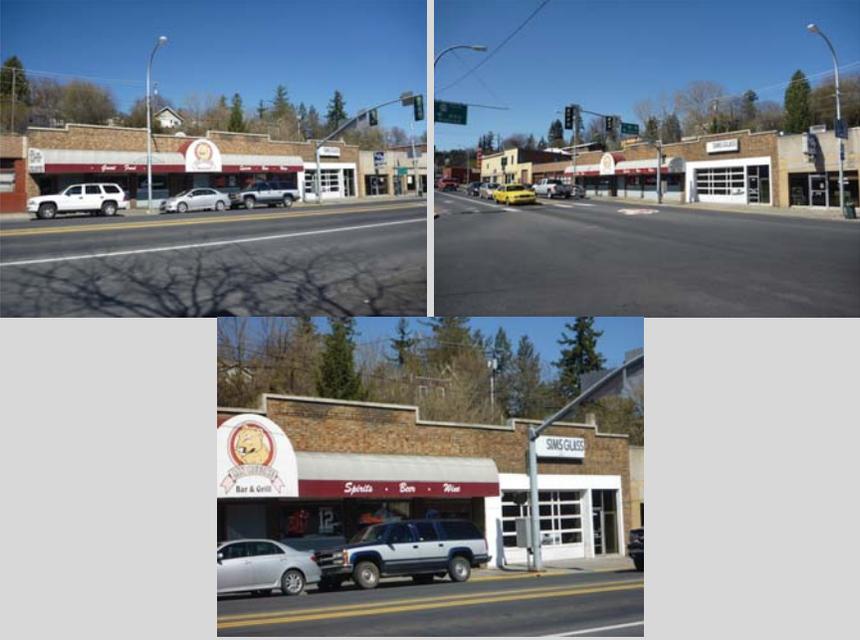
Survey Site Data	Site Photographs	
<p>Site #: 35 HPI #: N/A Listing Status: Not Listed Date: 1908–29 215 S Grand Avenue, My Office Bar & Grill, Sims Glass (Pop Factory, Tractor Storage, Paints & Wallpaper) DoE: Eligible, contributing within a district Characteristics: Single-story, brick, commercial building with three stepped-up parapet sections. Multi-colored rake bricks, with soldier course lintels. Large windows are set above panels clad in horizontal boards. One large vehicular bay found toward the north end of the building. Recessed panels beneath the parapets surrounded by decorative bricks. Concrete caps top the cornice.</p>

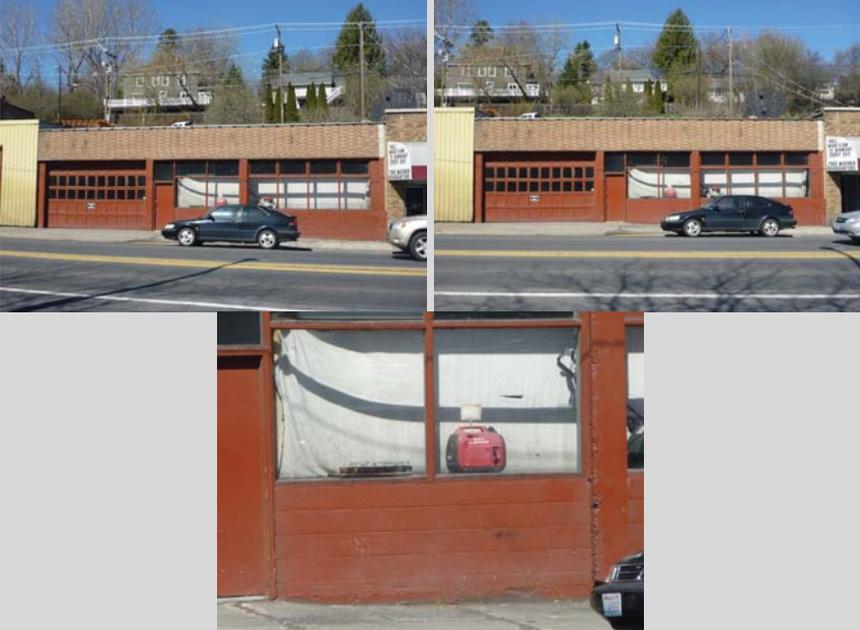
<p>Site #: 36 HPI #: N/A Listing Status: Not Listed Date: 1908–1929 245 S Grand Avenue, Machine Shop (Cabinet Shop) DoE: Eligible, contributing within a district Characteristics: Single-story, three-bay building with a large vehicular bay, a single door entry with two large windows with transoms beside the doorway, and three large windows with transoms. Wood-sash windows remain. Concrete blocks and concrete columns are found beside and below the windows. Multi-colored bricks are found at the top of the façade walls, laid in stretcher bond, with terra cotta caps lining the roofline.</p>

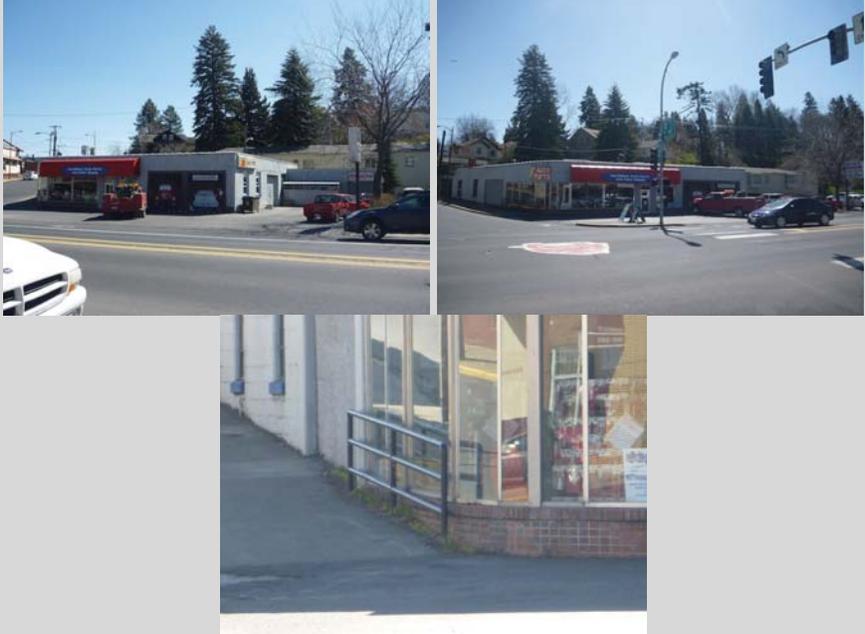
Survey Site Data	Site Photographs	
<p>Site #: 37 HPI #: N/A Listing Status: Not Listed Date: 1929-49 200 S Grand Avenue, Northwest Auto Parts (Auto Sales & Service, Gas & Oil) DoE: Not Eligible Characteristics: Single-story, concrete block and steel beam, service station. Replacement metal-sash windows curve around the northwest corner of the building set on a bulkhead of all header bricks. Smaller windows have been partially filled in with wood. Some openings retain original eight-light, metal-sashes. One vehicular bay on the south elevation; another on the north has been enclosed. A machine shop addition extends off the southeast corner. Faux vehicular bays have been painted on the west elevation.</p>

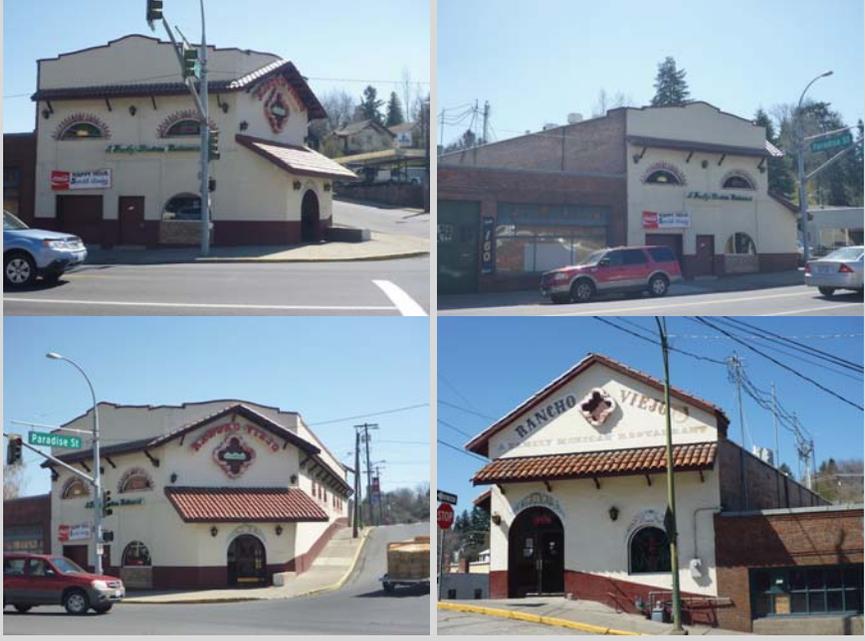
<p>Site #: 38 HPI #: N/A Listing Status: Not Listed Date: 1908-29 170 S Grand Avenue, Rancho Viejo Mexican Restaurant (Garage, Auto Body & Auto Sales, Office, Repair) DoE: Not Eligible Characteristics: Two-story brick building once an auto body and auto sales shop, with an office and repair area. Original brick is visible on north elevation, though the rest has been covered in stucco. Mission style parapet walls and Spanish tile roofs are found throughout as part of the building's remodel into a Mexican restaurant. Remnants of large vehicular bays are visible on the west elevation. Little else original remains readily visible.</p>

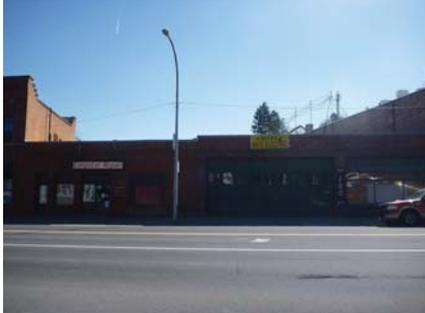
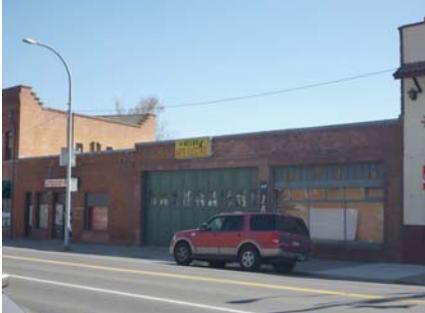
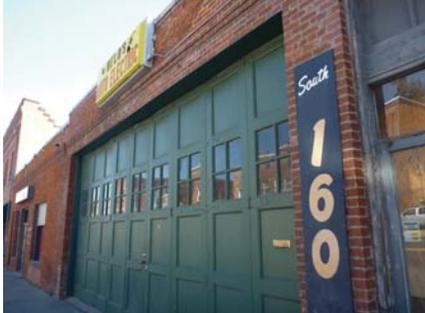
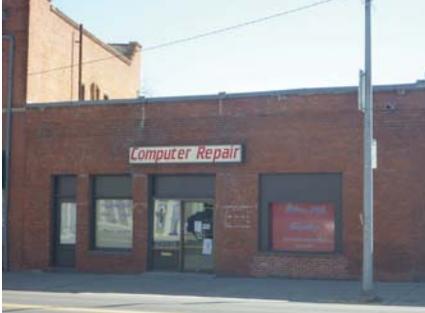
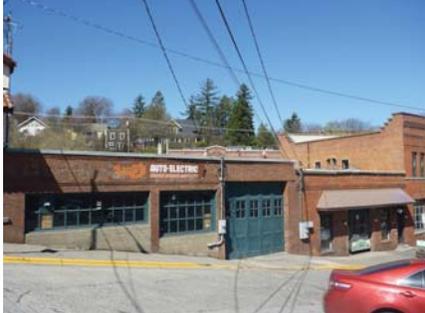
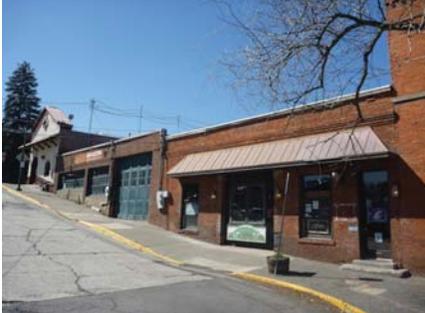
Survey Site Data	Site Photographs	
<p>Site #: 39 HPI #: N/A Listing Status: Not Listed Date: 1908-29 130-160 S Grand Avenue, Held's Auto Electric, Computer Repair (Agricultural Implements, Garage) DoE: Eligible, contributing within a district Characteristics: Single-story, brick building with horizontal brick band above the windows and doors. Original, multi- sectional, hinged, wooden doors with wood windows remain on both the front and back of the northerly portion of the building. Large, multi- light, wood-sash windows also remain. Windows and doors on the southerly end of the building have been modernized, but this has only moderately affected the building's appearance. Much of the original material and character remains, as does visual evidence of part of the building's original use as a garage.</p>

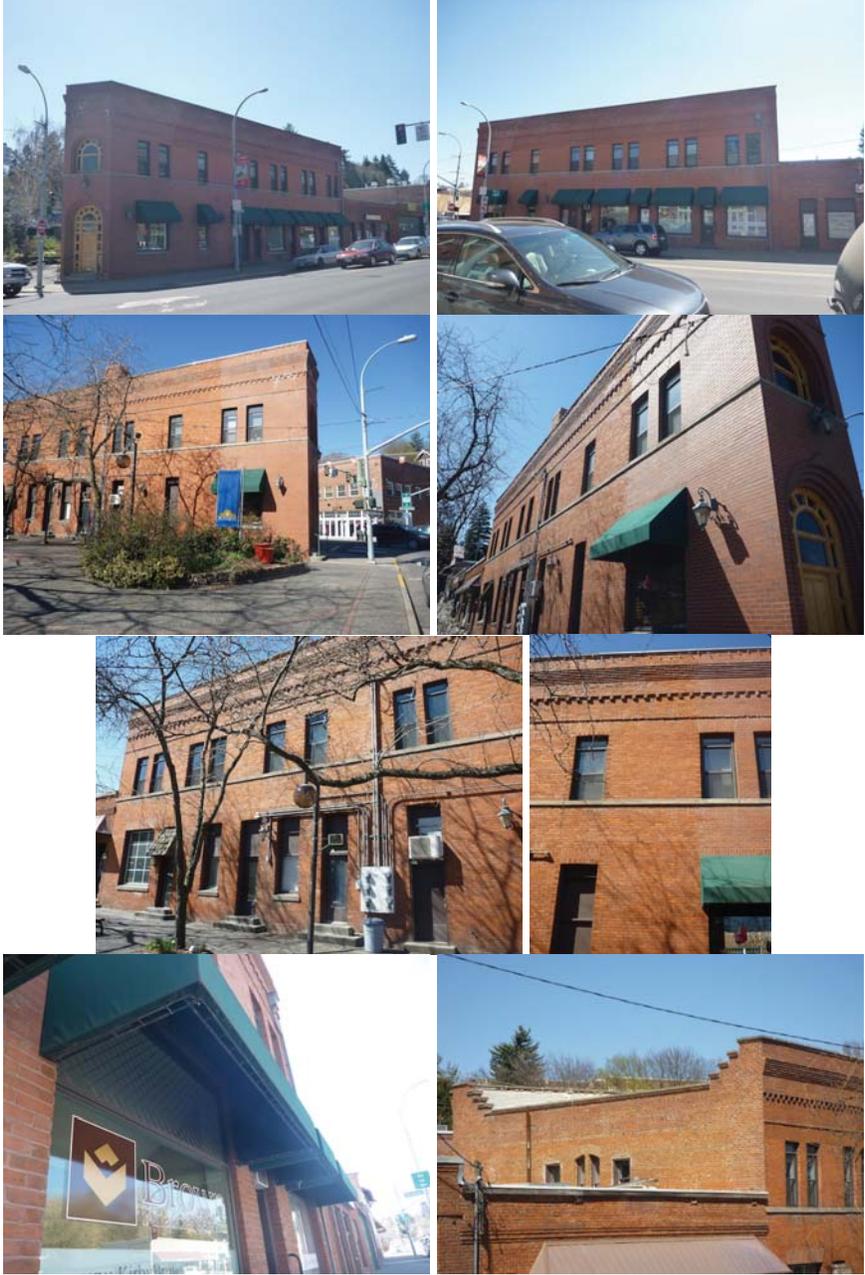
Survey Site Data	Site Photographs
<p>Site #: 40 HPI #: N/A Listing Status: Not Listed Date: 1904-05 105 E Main Street, Carmel Minogue, Whitman County Humane Society, Brown Financial Services (Flatiron Building; Offices) DoE: Eligible, contributing within a district Characteristics: Two-story, brick Flatiron building with numerous office spaces, all of which the original entries into remain. Doors and windows have been replaced or altered and some have been covered with modern awnings. Some windows exhibit diamond- shaped, leaded-glass transoms. A small portion at the north tip of the building has been reconstructed following an accident involving a runaway truck that caused major damage to the front corner of the building, but it was done to match the original building. Brick corbelling is found at the cornice line. The building was constructed between 1904 and 1905, as planned by architect William Swain (Pullman Main Street Program; Triposo).</p>

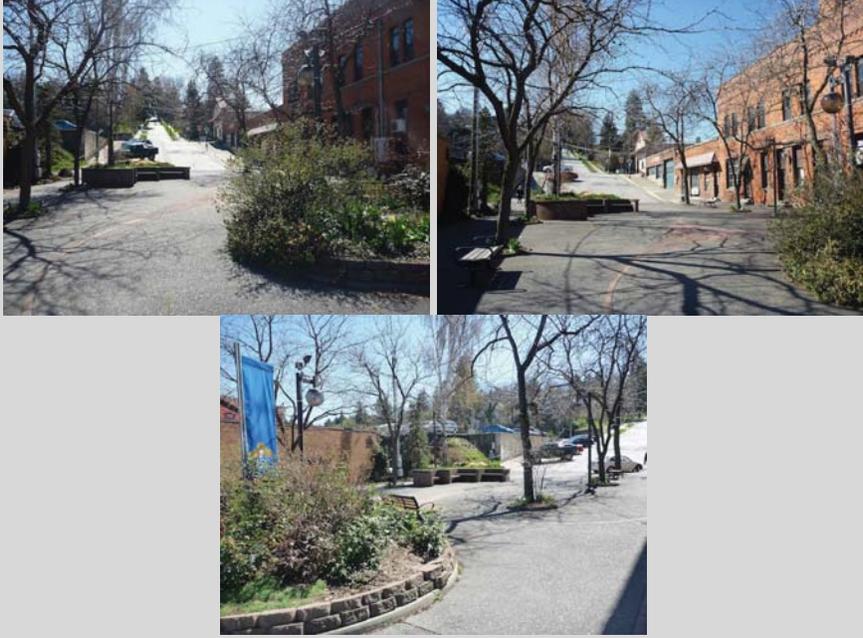
Survey Site Data	Site Photographs	
<p>Site #: 41 HPI #: N/A Listing Status: Not Listed Date: N/A Former High Street at E Main Street, High Street Mall (High Street) DoE: Not Eligible Characteristics: Former N High Street now closed off as a public plaza. The plaza features modern paving and bricks, as well as a curved brick bench seating area.</p>

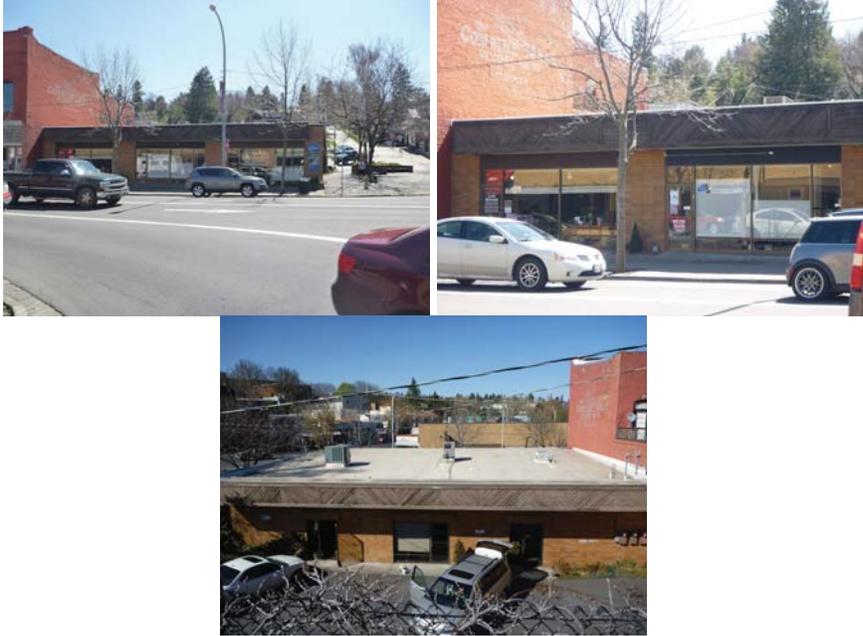
<p>Site #: 42 HPI #: N/A Listing Status: Not Listed Date: 1960-70 205-209 E Main Street, Waddell & Reed, Martonick Law Offices DoE: Not Eligible Characteristics: Single-story, flat-roof commercial building with wide brick veneer and a wide cornice covered in diagonal and horizontal boards. Three bays on the façade each contain an entry door and two large windows.</p>

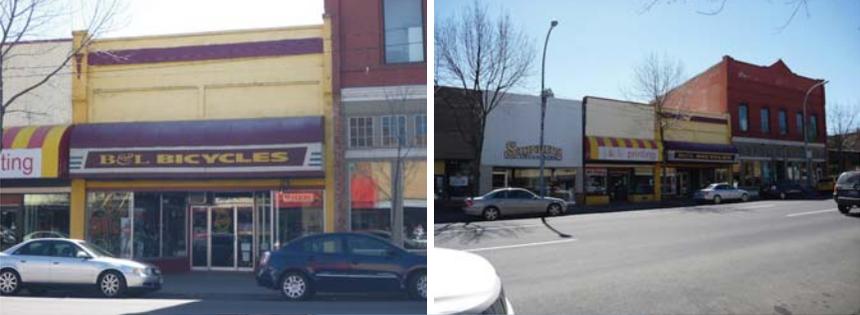
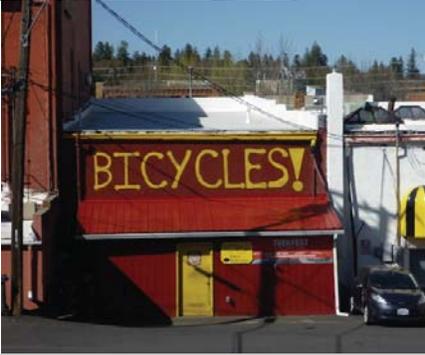
Survey Site Data	Site Photographs	
<p>Site #: 44 HPI #: N/A Listing Status: Not Listed Date: ca. 1891 219 East Main Street, B&L Bicycles (Leitch Block) DoE: Eligible, contributing within a district Characteristics: Single-story, one-part commercial block with recessed entry, parapet, flat roof, and modernized storefront with awning.</p>

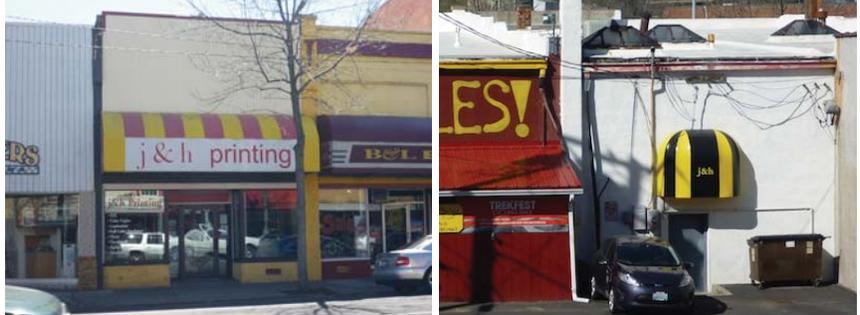
<p>Site #: 45 HPI #: N/A Listing Status: Not Listed Date: ca. 1891 223 East Main Street, j & h Printing (R. Block) DoE: Not Eligible Characteristics: Single-story, one-part commercial block with recessed entry, parapet, flat roof, and modernized storefront with a fabric awning.</p>

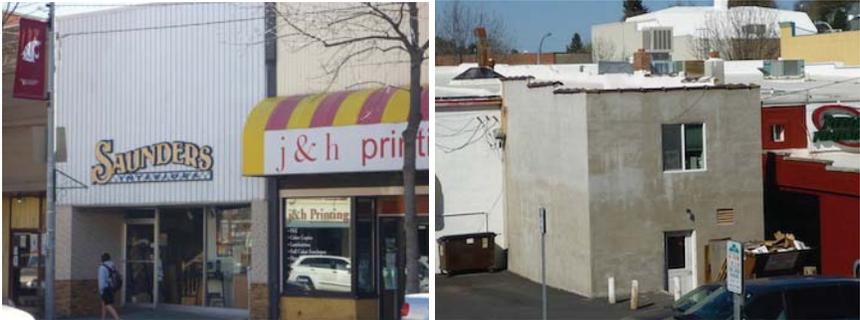
<p>Site #: 46 HPI #: N/A Listing Status: Not Listed Date: ca. 1891 227 East Main Street, Saunders Interiors (R. Block) DoE: Not Eligible Characteristics: Single-story, one-part commercial block with off center, recessed entry, parapet, flat roof, and modernized storefront.</p>

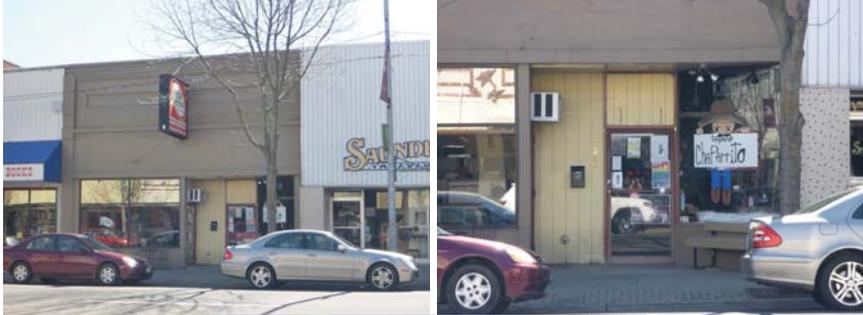
Survey Site Data	Site Photographs	
<p>Site #: 47 HPI #: N/A Listing Status: Not Listed Date: ca. 1889 231 East Main Street, Pizza Perfection (Fariss Bros. Hardware) DoE: Eligible, contributing within a district Characteristics: Single-story, one-part commercial block with off-center, recessed entry, parapet, flat roof, and modernized storefront entry and display windows.</p>

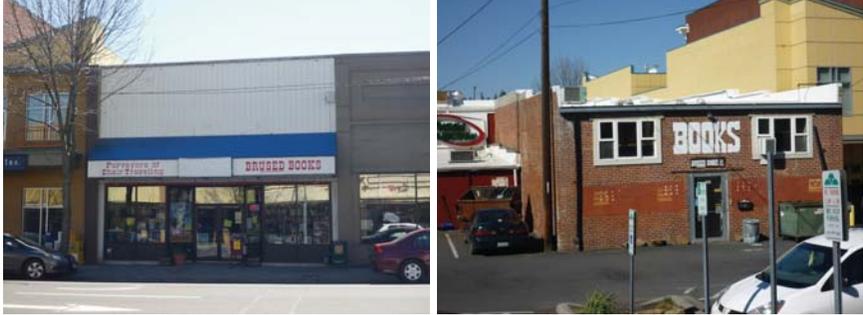
<p>Site #: 48 HPI #: N/A Listing Status: Not Listed Date: ca. 1889 265 East Main Street, Bruised Books (Fariss Brothers Hardware) DoE: Not Eligible Characteristics: Single-story, one-part commercial block with modernized, centered, slightly recessed storefront entry and display windows, a parapet and flat roof.</p>

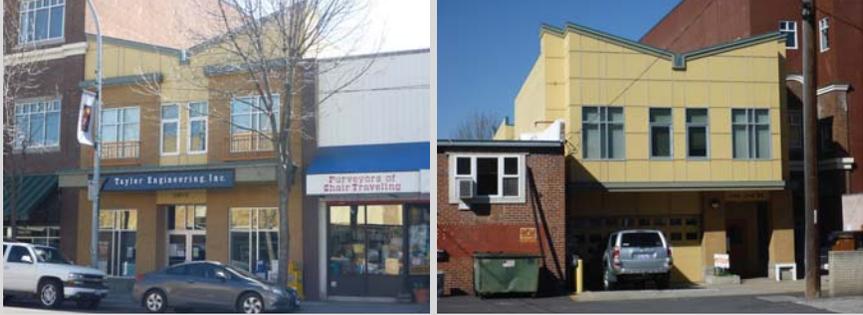
<p>Site #: 49 HPI #: N/A Listing Status: Not Listed Date: Contemporary 245 East Main Street, Taylor Engineering Inc. DoE: Not Eligible Characteristics: Contemporary, two-story, with a symmetrical façade, Y-shaped roof, and railings at second story windows. Rear elevation features inset two-car garage door, inset entry door and windows at second story.</p>

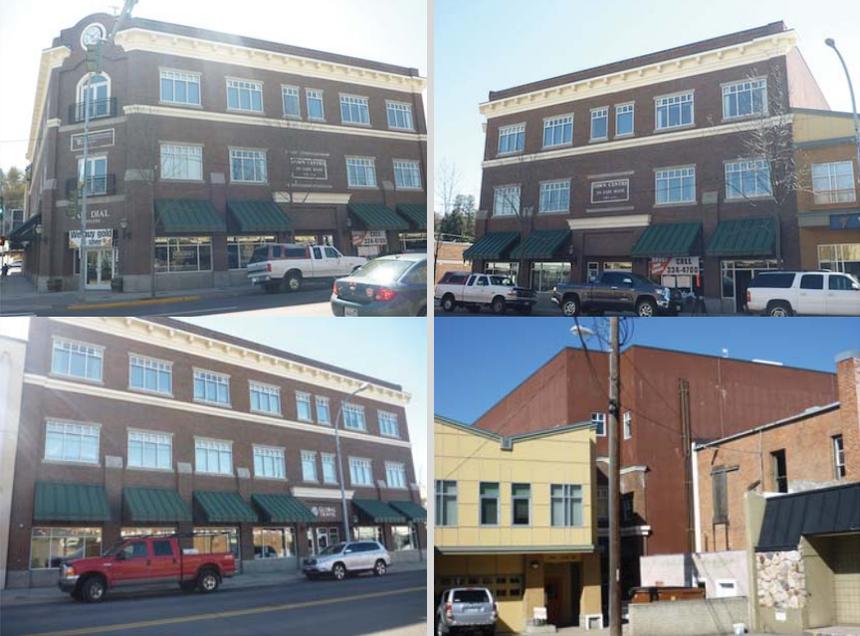
Survey Site Data	Site Photographs	
<p>Site #: 50 HPI #: 38-00349 Listing Status: Not Listed Date: 2002 255 East Main Street, Town Centre DoE: Not Eligible Characteristics: Three-story commercial building with corner entry with large clock above and balconettes, brick veneer exterior walls, cultured stone window lintels and sills, angled, metal awnings, wall buttresses, modillions under cornice, string course and parapet. Corner Drug store formerly located on this site as referenced on previous HPI survey form is no longer extant.</p>

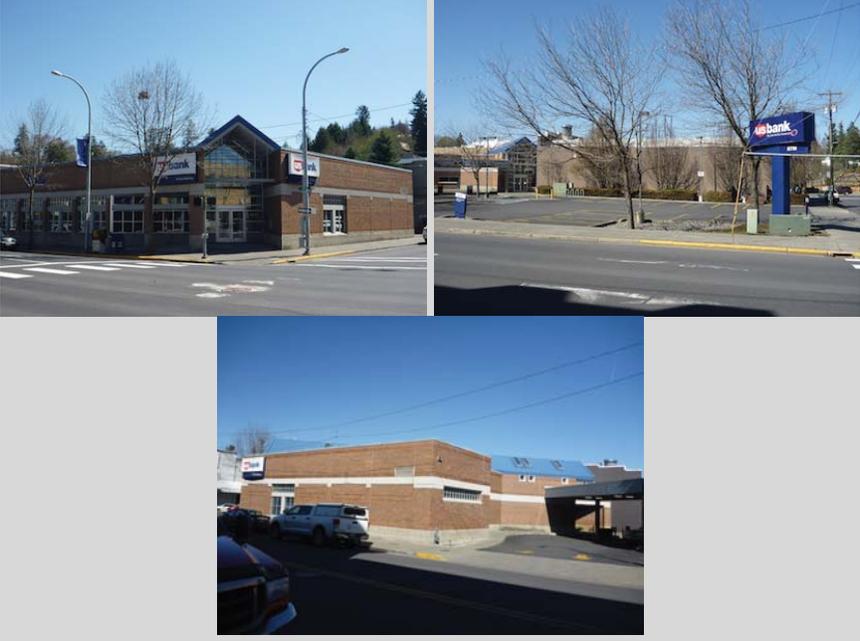
<p>Site #: 51 HPI #: N/A Listing Status: Not Listed Date: Contemporary 301 East Main Street, US Bank DoE: Not Eligible Characteristics: One-story, brick veneer bank building with a two-story, front-gabled, corner entry. Multi-pane ribbon windows at north elevation, parapet, flat roof, contrasting string course, and concrete foundation.</p>

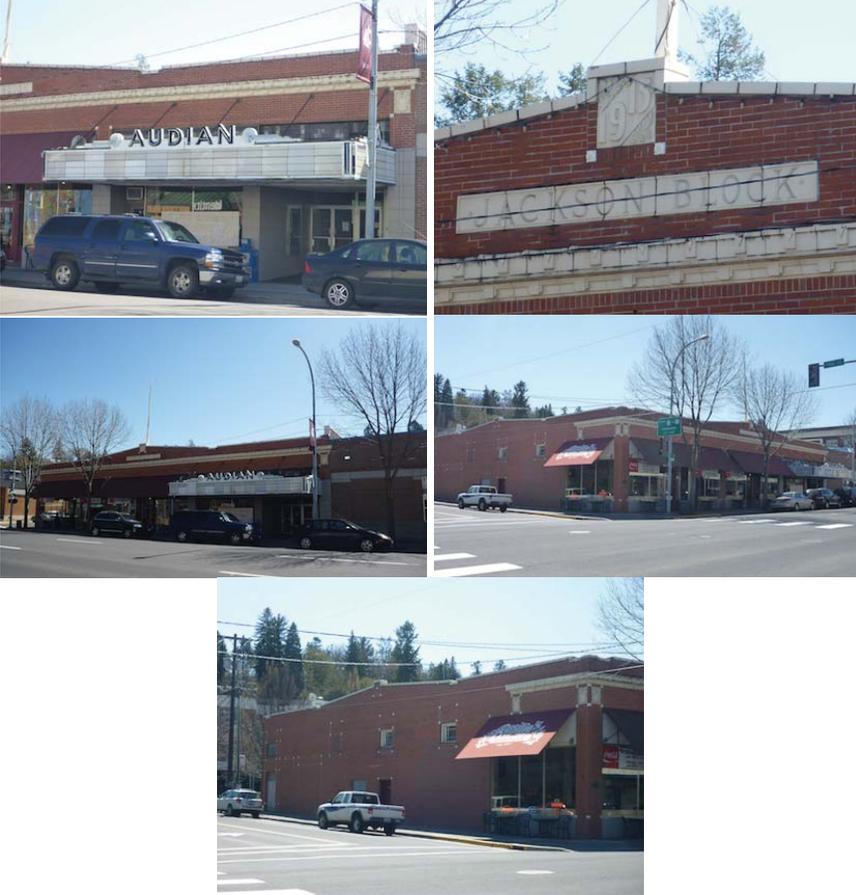
Survey Site Data	Site Photographs
<p>Site #: 52 HPI #: Surveyed, No # Assigned Listing Status: Not Listed Date: 1915 315-317-337 East Main Street, Audian Theater, Palouse Specialty Foods and Basilio's Italian Cafe, (Jackson Block/Grand Theater) DoE: Eligible, individually; contributing within a district Characteristics: One-story brick with terracotta details and ornamentation including two-part string course, plaques, rosettes, coping, and a seven-part name plaque. One-part commercial block theater building with display windows, transoms and theater marquee. Some original windows remain extant. Building originally constructed 1915 as the Grand Theater, renovated to the Audian Theater in 1930 and expanded in 1936 when a neighboring building was demolished (WSU, 2014).</p>

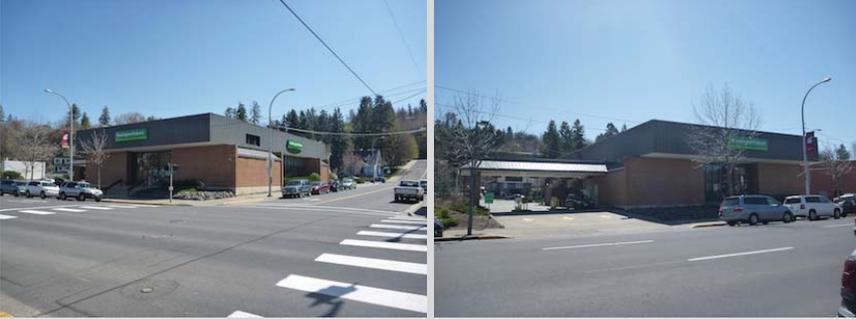
<p>Site #: 53 HPI #: N/A Listing Status: Not Listed Date: Contemporary 425 East Main Street, Washington Federal DoE: Not Eligible Characteristics: One-story with loft, brick façade, wide overhanging metal-clad cornice, flat roof, and enframed window walls at each entry. Metal, hip-roofed covered drive-through banking lanes and drive-up window are present. A parking lot is present at this site.</p>

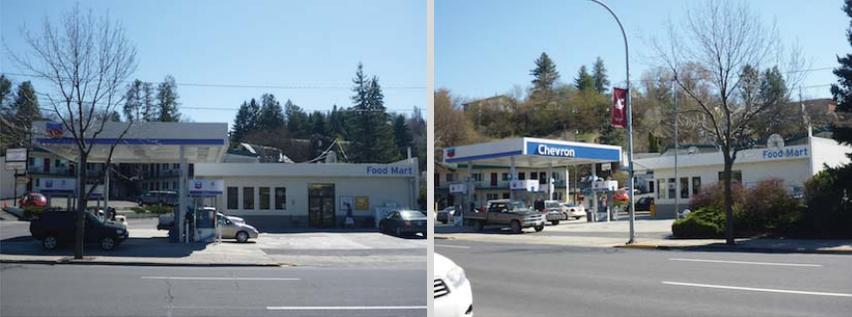
Survey Site Data	Site Photographs	
<p>Site #: 54 HPI #: N/A Listing Status: Not Listed Date: Contemporary 485 East Main Street, Chevron Gas Station DoE: Not Eligible Characteristics: One-story food mart with flat roof, metal frame doors and windows, and textured concrete-block construction. Flat metal canopy over four gas pumps and corner signage with Chevron logo and gas prices.</p>

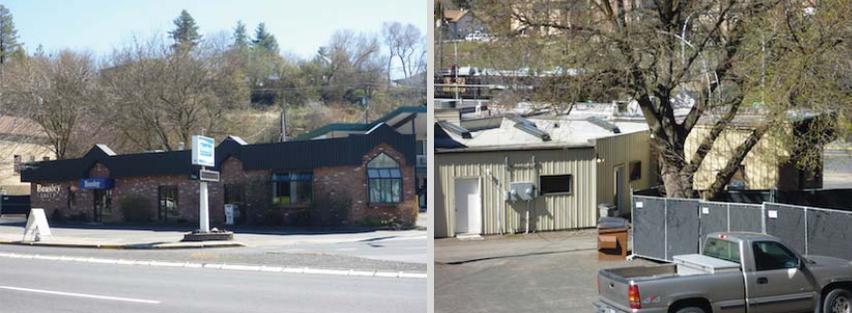
<p>Site #: 55 HPI #: N/A Listing Status: Not Listed Date: Contemporary 515 East Main Street, Beasley Realty DoE: Not Eligible Characteristics: One-story, brick-veneered, commercial building with projecting, metal-faced, decorative cornice featuring gable peaks over entry doors and corner greenhouse window. Nearly triangular plan. Flat roof with skylights. Small parking lot and roadside lighted signage.</p>

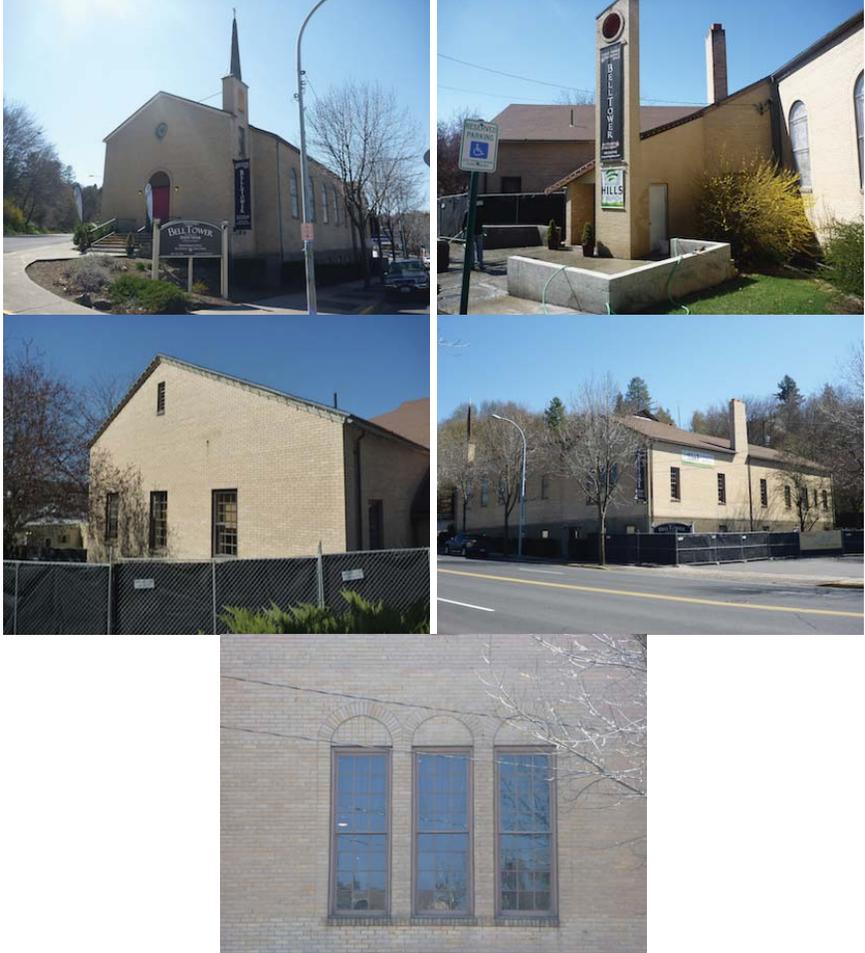
Survey Site Data	Site Photographs	
<p>Site #: 56 HPI #: N/A Listing Status: Not Listed Date: ca. 1929 125 SE Spring Street, Belltower Event Venue and Hills Church, (Baptist Church) DoE: Eligible, contributing within a district Characteristics: Tall, one-story, blonde brick church with L- shaped plan. Features round- arched, stained-glass windows, a stained-glass, oculus window, cross-gabled roof, narrow eaves, and original wood-sash windows. Prominent on the building is a bell tower, which breaks the eave, and is capped by a tall, narrow, tapering spire and cross finial.</p>

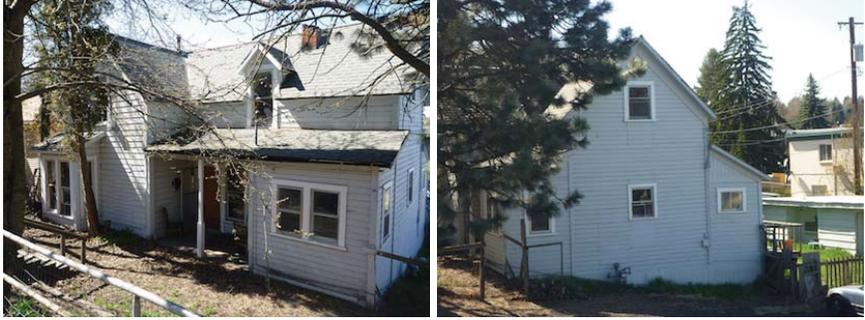
<p>Site #: 57 HPI #: N/A Listing Status: Not Listed Date: ca. 1900 215 SE Spring Street, Dwelling DoE: Not Eligible Characteristics: Altered, one- and-one-half story, frame dwelling with gable and wing plan. Wood siding, filled-in shed-roofed porches, shed- roofed square bay, hip-roofed addition at south elevation, and few historic windows.</p>

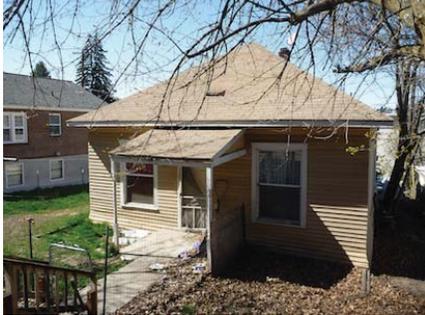
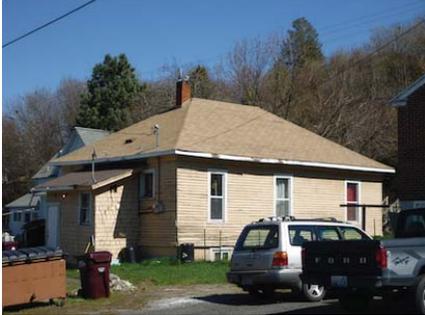
Survey Site Data	Site Photographs	
<p>Site #: 58 HPI #: N/A Listing Status: Not Listed Date: ca. 1910 225 SE Spring Street, Dwelling DoE: Not Eligible Characteristics: Altered, one-story, hip-roofed cottage with a rectangular plan, shed-roof entry porch, and filled-in, shed roof rear the entry porch. Narrow clapboard siding and composition shingle roof. Replacement windows throughout.</p>

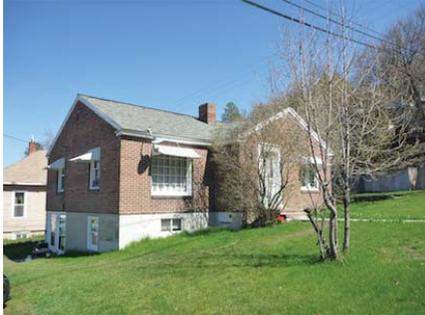
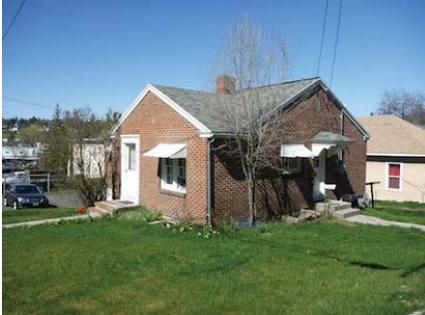
<p>Site #: 59 HPI #: N/A Listing Status: Not Listed Date: ca. 1949 230 Daniel Street, Dwelling DoE: Not Eligible Characteristics: One-story, multi-unit, Minimal Traditional with walk-out basement and brick veneer. The property retains its original form and use and reflects social and economic associations with Pullman's downtown as well as its unique characteristic for possessing and retaining residential dwellings so near the downtown.</p>

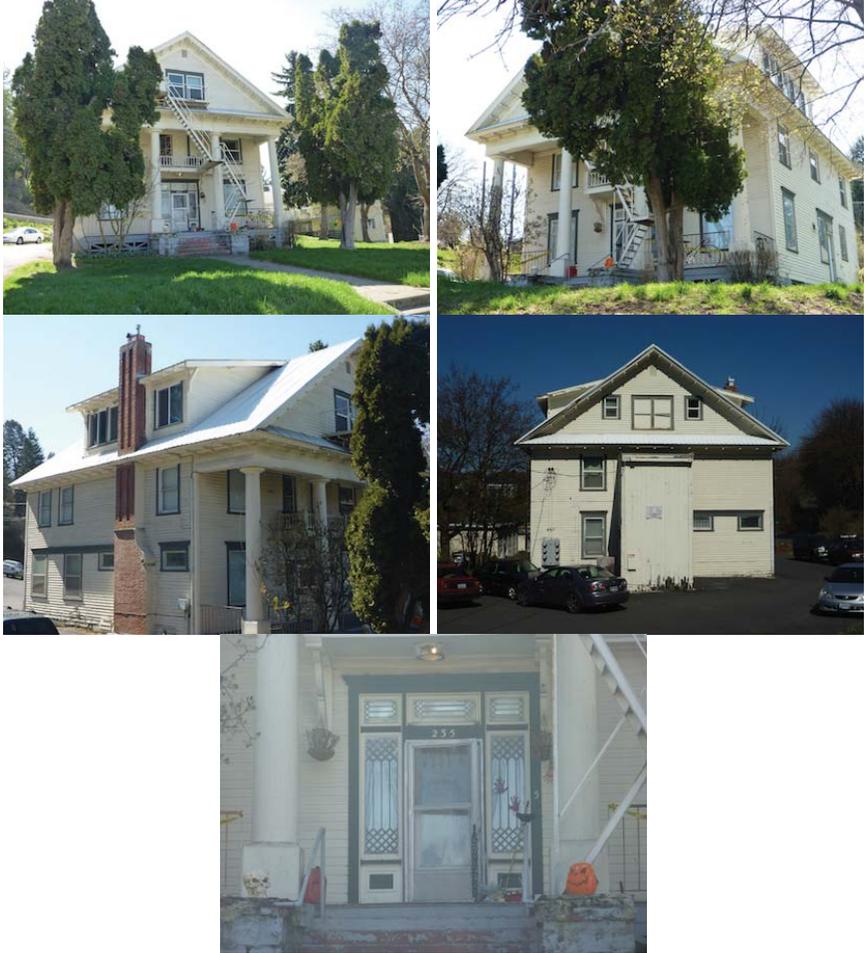
Survey Site Data	Site Photographs	
<p>Site #: 62 HPI #: N/A Listing Status: Not Listed Date: 1906 235 Daniel Street, Dwelling (Squires House) DoE: Not Eligible Characteristics: Two-and-one-half story, Greek Revival style, multi-unit dwelling. Pedimented entry portico atop Tuscan columns. Leaded-glass sidelights and transoms surround front entry door. Second level balcony above front door supported on brackets. Stone foundation, tall brick chimney. Shed-roofed dormers. Many vinyl or metal replacement windows, and nonhistoric doors. Fire escape attached to façade.</p>

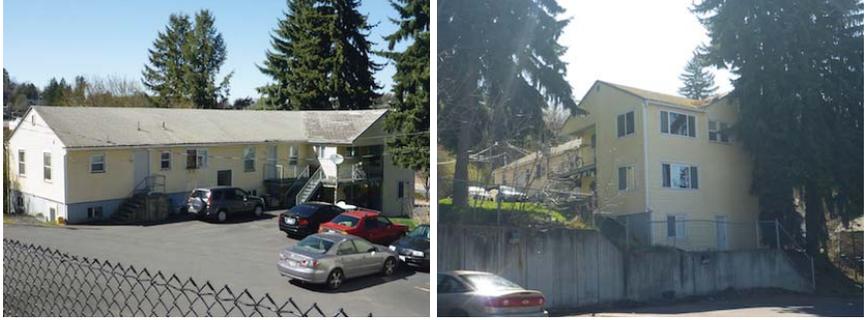
<p>Site #: 63 HPI #: N/A Listing Status: Not Listed Date: ca. 1950 410 East McKenzie Street, Apartments DoE: Not Eligible Characteristics: One story with full daylight basement, L-shaped plan, vinyl siding, vinyl windows, fiberglass doors, composition shingle roof.</p>

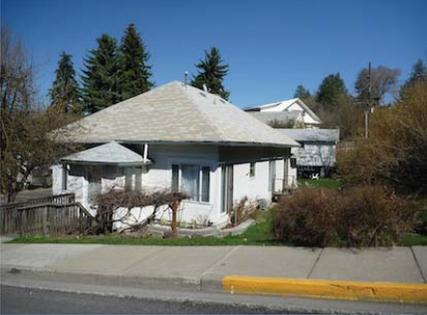
Survey Site Data	Site Photographs	
<p>Site #: 64 HPI #: N/A Listing Status: Not Listed Date: ca. 1915 230 North Pine Street, Dwelling DoE: Not Eligible Characteristics: One-story, hip roof dwelling with partial basement and rectangular plan. Rough-face block foundation. Entry vestibule added to front of filled-in original porch, changes to rear entry porch, changes in fenestration and replacement vinyl windows. Historic gable-front, single-car garage also on site.</p>

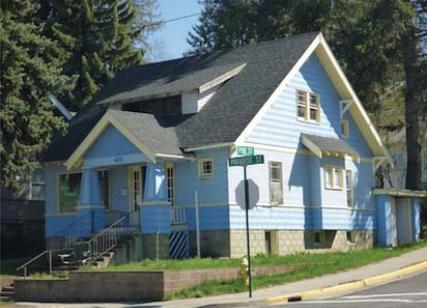
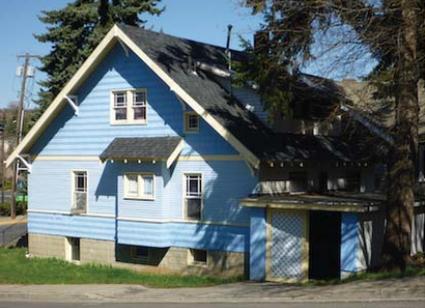
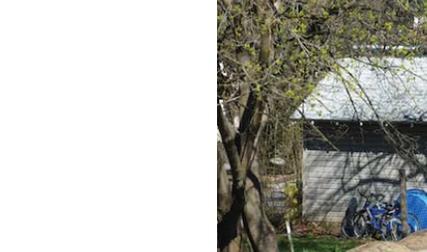
Survey Site Data	Site Photographs	
<p>Site #: 66 HPI #: N/A Listing Status: Not listed Date: ca. 1915 415 SE Paradise Street, DoE: Not Eligible Characteristics: One-and-one-half story, cross-gabled Craftsman style with inset entry at corner, shed roof dormer, tall brick shouldered outside chimney, addition at east elevation, replacement windows, concrete foundation, and historic single car garage.</p>

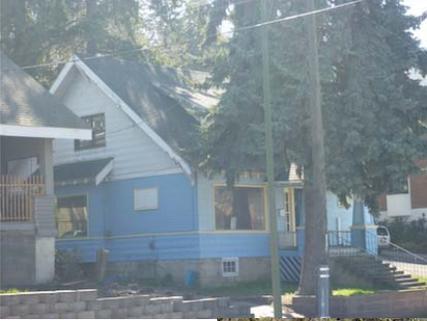
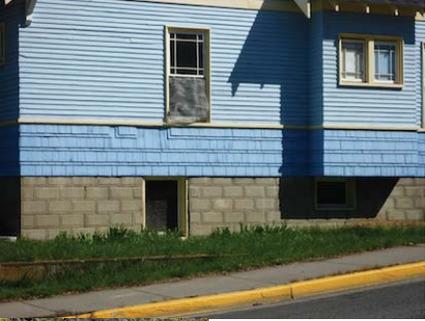
<p>Site #: 65 HPI #: N/A Listing Status: Not listed Date: ca. 1929 405 SE Paradise Street, Dwelling DoE: Not Eligible Characteristics: One-and-one-half story, side-gabled Craftsman with gable front porch roof, tapered columns, exposed rafter tails, bargeboards, brackets, and rusticated-block foundation. Nonhistoric attached garage.</p>

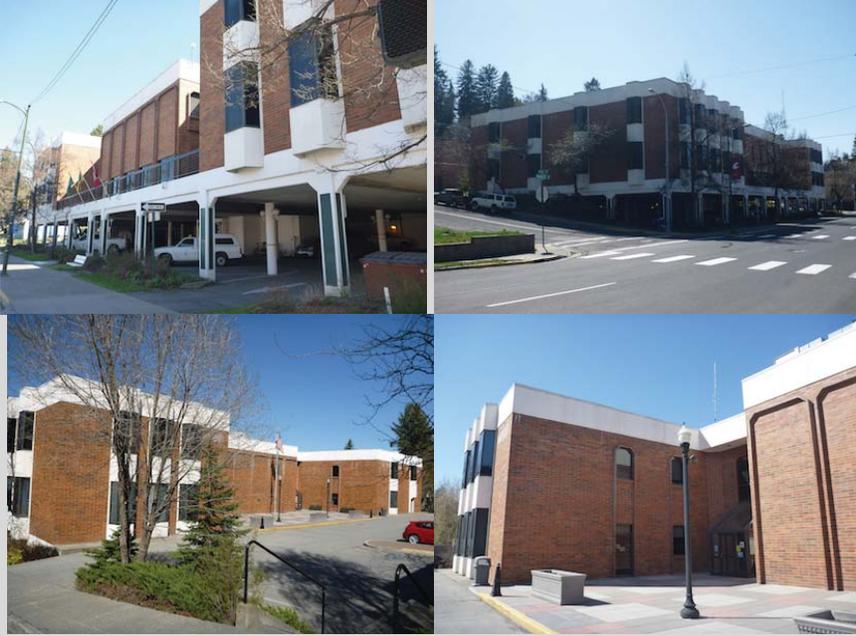
<p>Site #: 67 HPI #: N/A Listing Status: Not listed Date: 1970 325 SE Paradise Street, City Hall DoE: Not Eligible Characteristics: Two-story, central block with wings, modern, civic building atop an open parking garage. Original, round globe sconces light the garage. Wings feature brick veneer walls broken up by two-story window bays with dark glazing and white stucco bands. A wide, white, cornice band surrounds the building. The central block is set back with brick banding detail and low, dark windows. It is fronted by a balcony with a metal balustrade. This building may be eligible for the NRHP once it reaches the 50-year mark, as a locally significant example of late, mid-century modern, civic architecture (Figure 63).</p>

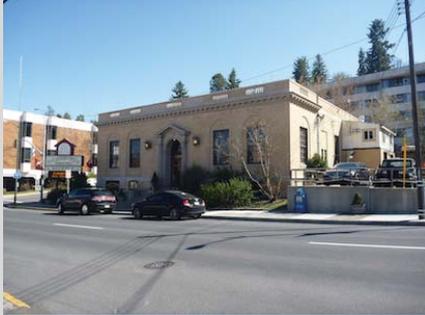
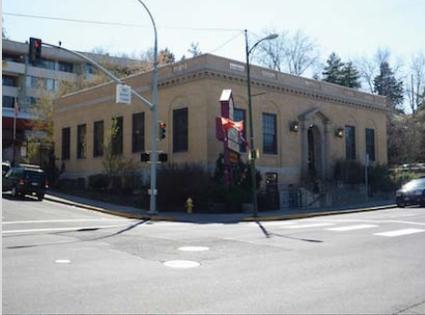
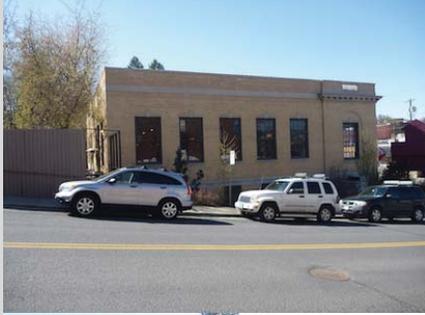
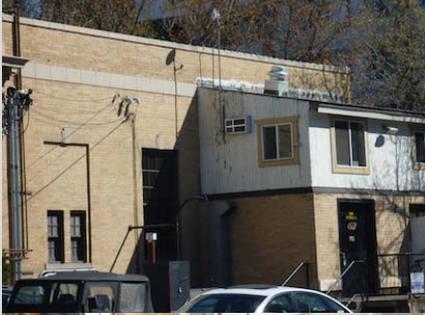
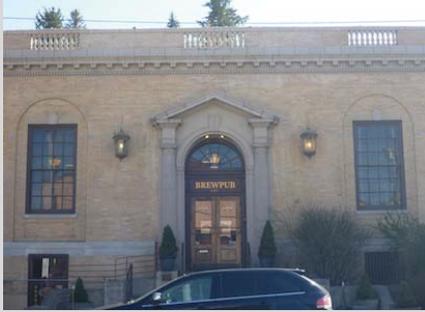
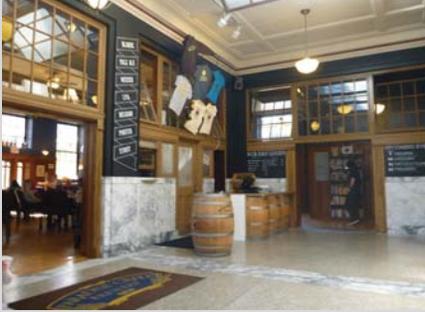
Survey Site Data	Site Photographs		
<p>Site #: 69 HPI #: N/A Listing Status: NRHP Listed, Historic US Post Offices in Washington: 1893-1941 MPD and Individually Listed (2003) Date: 1930 245 SE Paradise Street, Paradise Creek Brewery & Brew Pub (U.S. Post Office - Pullman) DoE: Eligible, individually; contributing within a district Characteristics: Neo-classical style with a formal, classical entry with Doric pilasters, pedimented hood and fanlight. Exterior walls are blond brick with terra cotta and sandstone detailing. The symmetrical façade features insert arch detail, twelve-over-twelve, double-hung, wood-sash windows with simple, flat, brick hoods and stone sills. The building is elevated several feet above the street due to the sloped site. Inside the main lobby the building retains marble wainscoting, terrazzo and marble floors, original light fixtures, skylights, and stained wood trims and doors. Restrooms retain historic layouts, fixtures and materials. Brewery entrance is at the façade, below grade.</p>

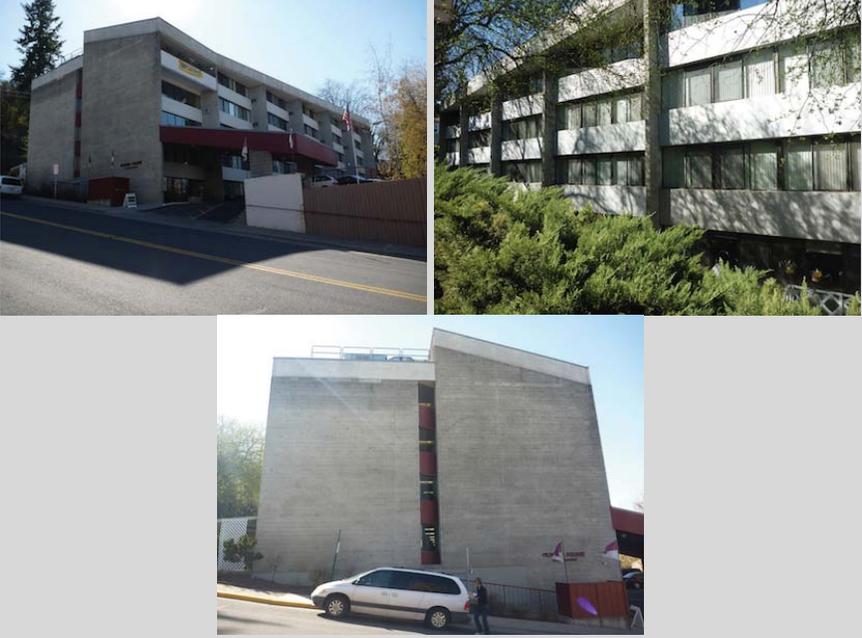
Survey Site Data	Site Photographs	
<p>Site #: 70 HPI #: N/A Listing Status: Not Listed Date: Contemporary 220 SE Kamiaken Street, Pioneer Square Apartments DoE: Not Eligible Characteristics: Five-story, parallelogram-shaped, two-part building connected by hallway with angled windows, grooved finish concrete block construction, parapet, flat roof on southern half of building and shed roof on northern half. Broad white stuccoed bands between floors under windows at both north and south elevations, balanced by the broad white cornice. Wide, deep, shed roof covered drive-through entry.</p>

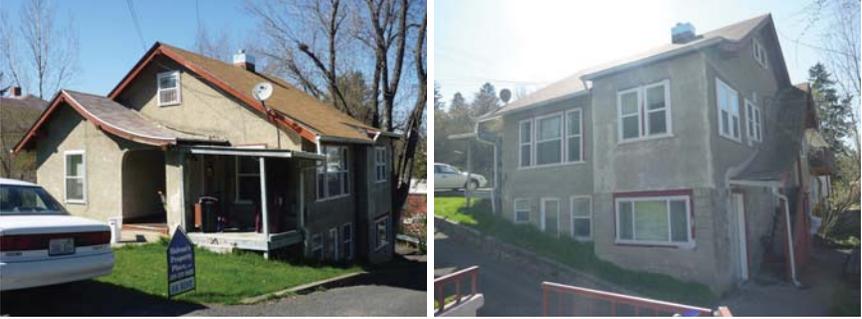
<p>Site #: 71 HPI #: N/A Listing Status: Not Listed Date: ca. 1940 220 East McKenzie Street, Dwelling DoE: Not Eligible Characteristics: One-and-one-half story, front-gable dwelling on steeply sloping lot with walk-out basement. Some Craftsman style details, some English cottage details. Changes to fenestration. Vinyl windows.</p>
