RECONNAISSANCE SURVEY FOR DOWNTOWN PULLMAN, WHITMAN COUNTY, WASHINGTON

By: Annie Doyon, MHP &
Kathryn Burk-Hise, MSHP

Prepared for:
Pullman Historic
Preservation Commission &
Pete Dickinson,
Planning Director –
Staff Liaison to the
Commission

July 11, 2014

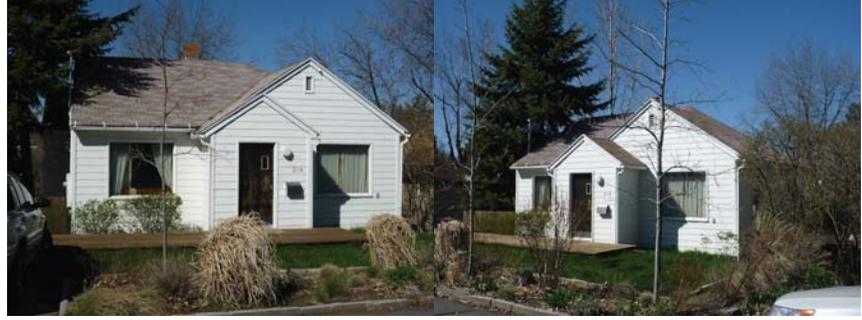
<p>Site #: 72 HPI #: N/A Listing Status: Not listed Date: ca. 1940 210 East McKenzie Street Dwelling DoE: Not Eligible Characteristics: One-and-one-half story Minimal Traditional with walkout basement and T-shaped plan. Entry gable, wood-sash picture windows.</p>

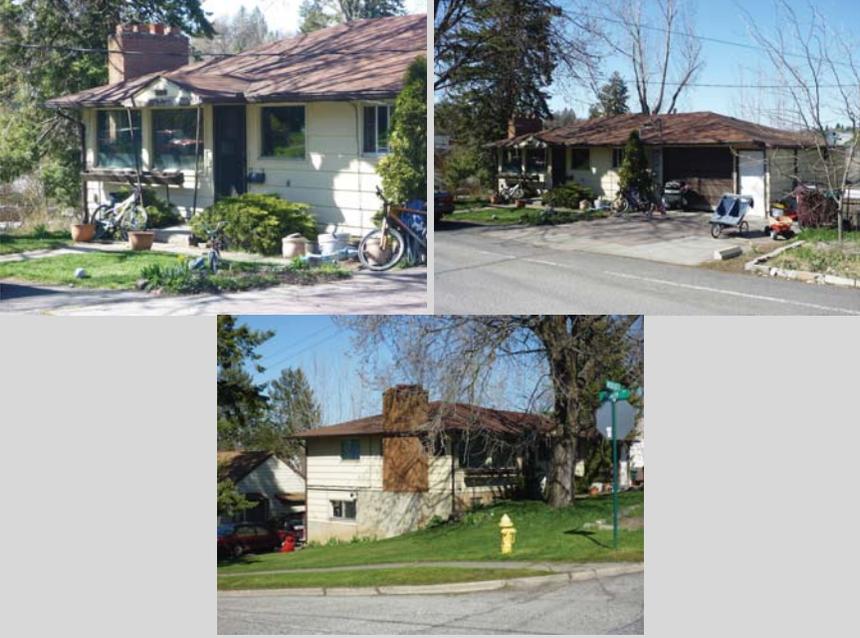
Survey Site Data	Site Photographs	
<p>Site #: 73 HPI #: N/A Listing Status: Not listed Date: ca. 1955 200 East McKenzie Street, Dwelling DoE: Not Eligible Characteristics: One-story low hipped roof, small gable porch roof on angled iron poles, picture windows, integral single-car garage, aluminum siding, quadruple-flue brick outside chimney, parged concrete foundation, walk-out basement on steeply sloping lot.</p>

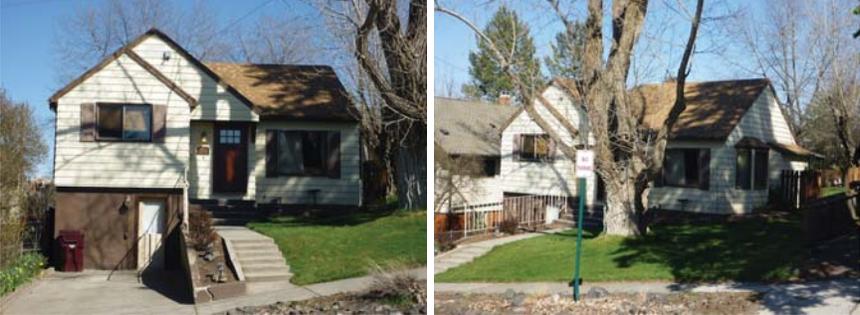
<p>Site #: 74 HPI #: N/A Listing Status: Not listed Date: ca. 1940 220 High Street, Dwelling DoE: Not Eligible Characteristics: One-story cross-gabled, Minimal Traditional dwelling with inset entry, three-window bay, filled in integral single-car garage, and aluminum siding.</p>

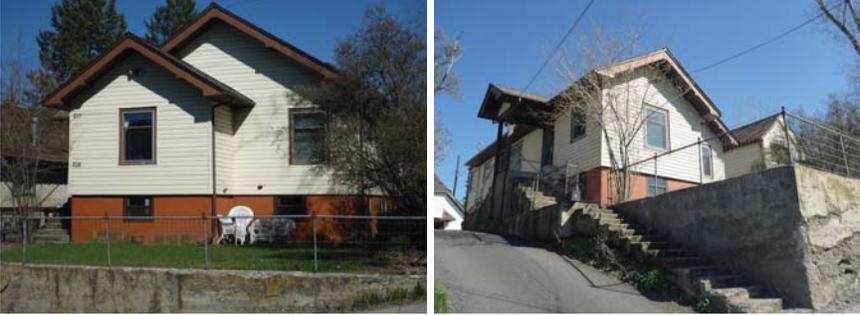
<p>Site #: 75 HPI #: N/A Listing Status: Not Listed Date: ca. 1920 208-210 High Street, Dwelling DoE: Not Eligible Characteristics: One-story, gable front, duplex dwelling with full basement. Altered entrance with original porch filled in and new entrance opened at north elevation. Vinyl siding. Historic fence.</p>

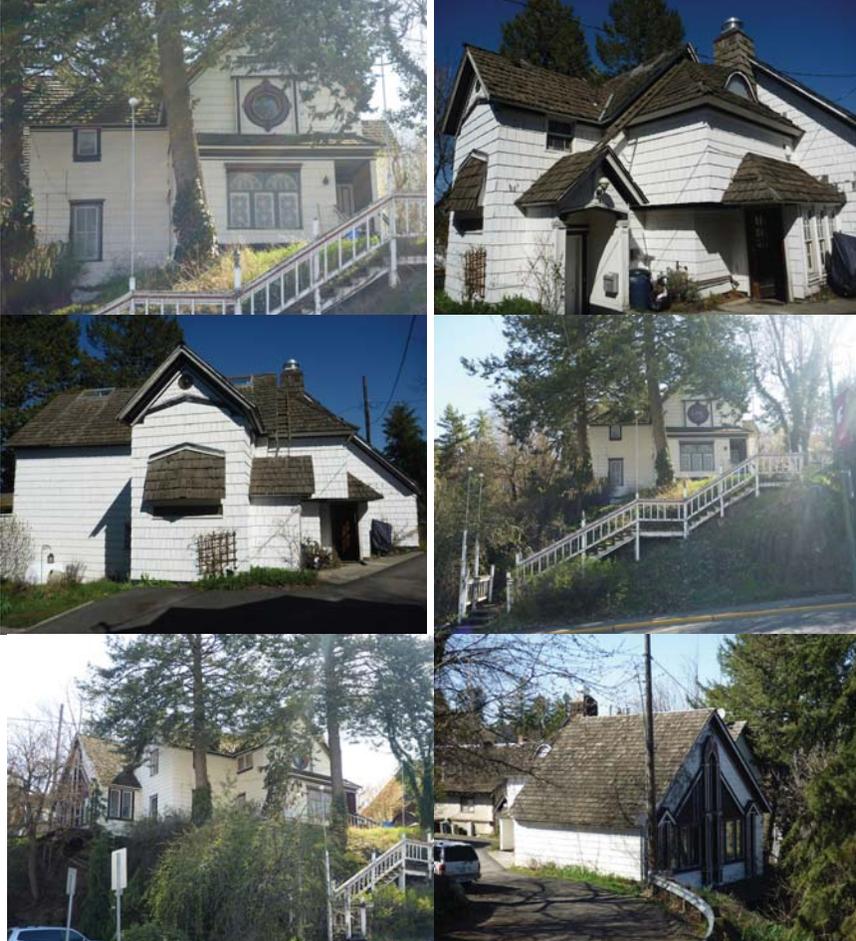
Survey Site Data	Site Photographs	
<p>Site #: 76 HPI #: N/A Listing Status: Not listed Date: ca. 1892 215 SE Paradise Street, Dwelling DoE: Not Eligible Characteristics: Highly altered, one-and-one-half story, multi-unit dwelling, with shingled walls and roof, eyebrow window, oculus windows, double-hung, wood-sash windows, and numerous entry doors.</p>

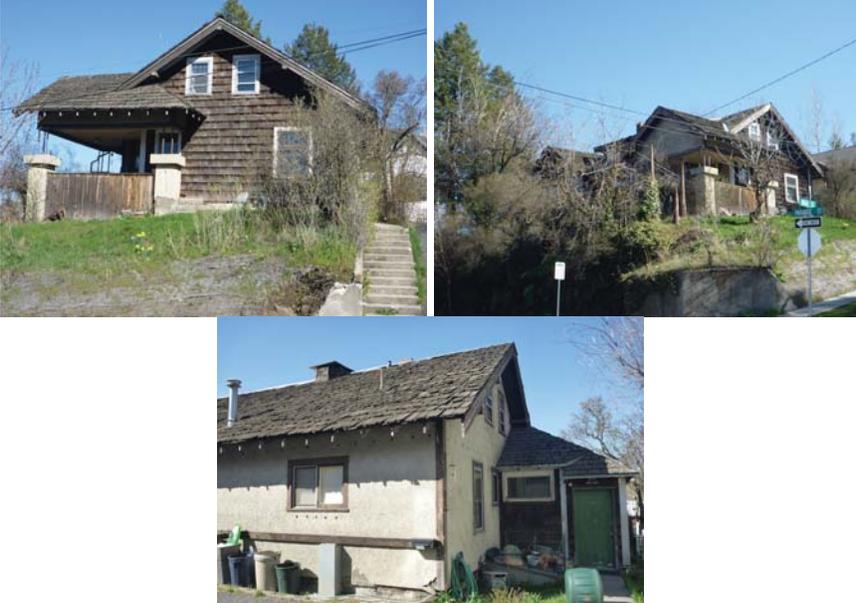
<p>Site #: 77 HPI #: N/A Listing Status: Not Listed Date: ca. 1920 205 SE Paradise Street, Dwelling DoE: Not Eligible Characteristics: One-and-one-half story, gable-oriented dwelling with an unusual twin-gabled roof over a full width porch. Exterior walls are a combination of stucco and shingles. Roof is wood shingled. Altered porch and rear entry.</p>

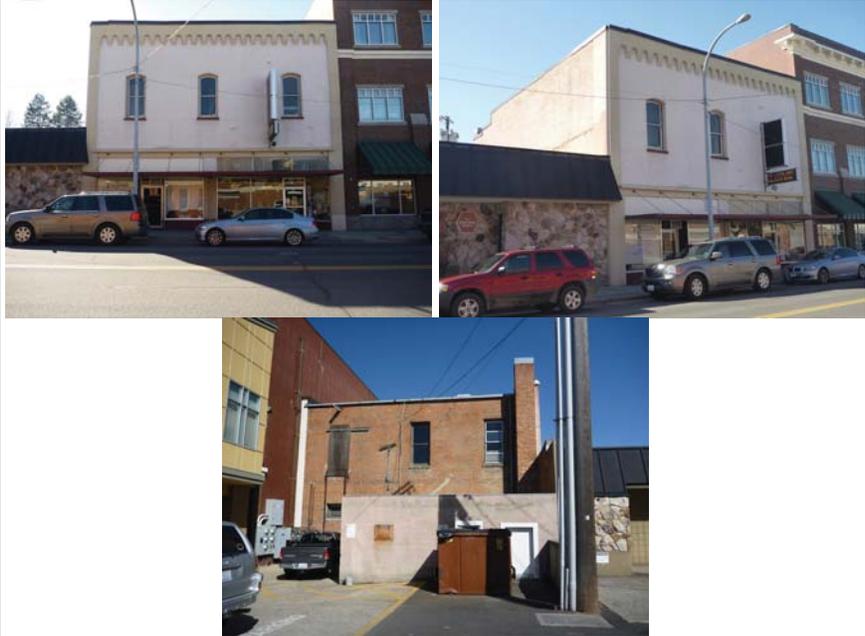
<p>Site #: 79 HPI #: N/A Listing Status: Not Listed Date: ca. 1893 145 SE Kamiaken Street, Glassphemy, Shear Heaven (Pullman Mercantile Co., Pullman Post Office, I.O.O.F.) DoE: Eligible, contributing within a district Characteristics: Two-story, two-part commercial block, brick building with metal awning, altered transoms and storefront, original, segmental, arch-top windows at second level, and arcaded corbel detail and pilasters at façade.</p>

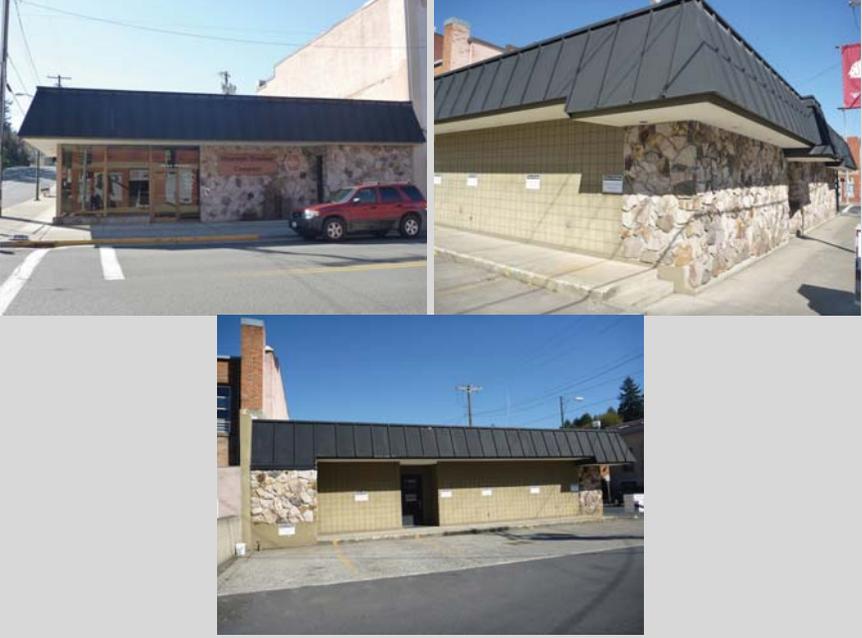
Survey Site Data	Site Photographs	
<p>Site #: 80 HPI #: N/A Listing Status: Not Listed Date: ca. 1965 155 SE Kamiaken Street, Hinrich's Trading Company DoE: Not Eligible Characteristics: One-story commercial building with low, Mansard-style roof, applied Permastone on both east and south elevations, tiled wall at west elevation, corner display windows at façade, and various entry doors on all elevations.</p>

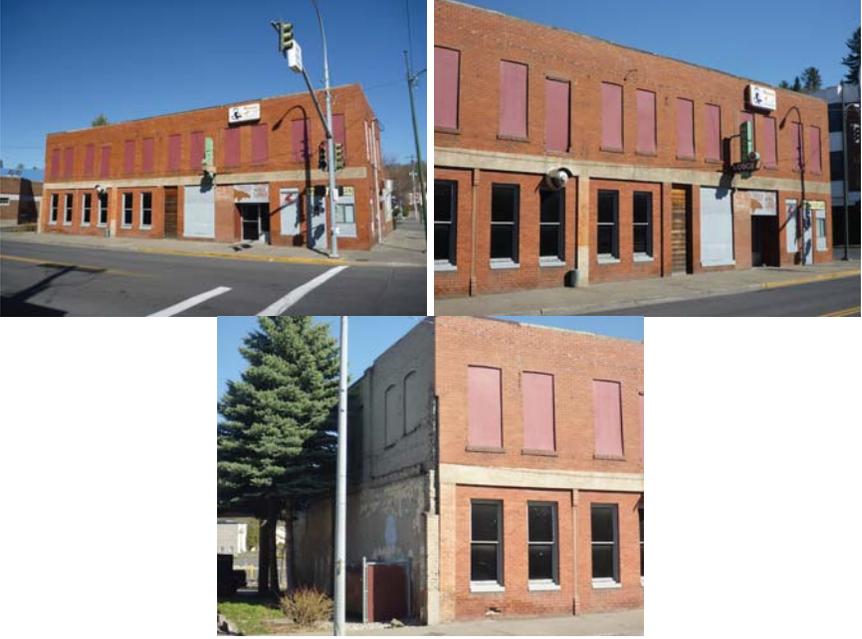
<p>Site #: 81 HPI #: N/A Listing Status: Not Listed Date: ca. 1909-1929 150 SE Kamiaken Street, Pullman Moose Lodge (Russell Hotel) DoE: Not Eligible Characteristics: Two story, two-part commercial block. This is a brick building, the former Russell Hotel. Street level entrance inset with aluminum sash door and sidelight, six, double-hung, wood-sash, windows extant at street level with glass painted black, other openings and all windows at second level filled in with various materials. Historic neon Moose Lodge sign and modern Moose sign.</p>

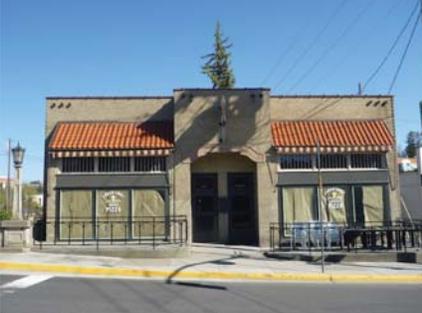
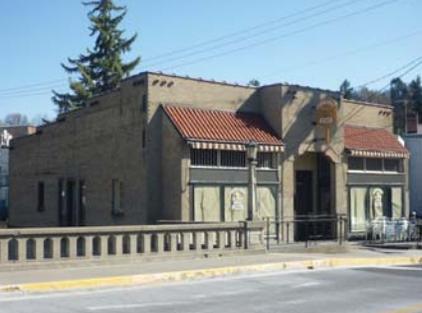
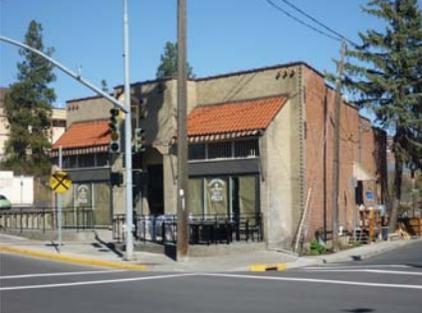
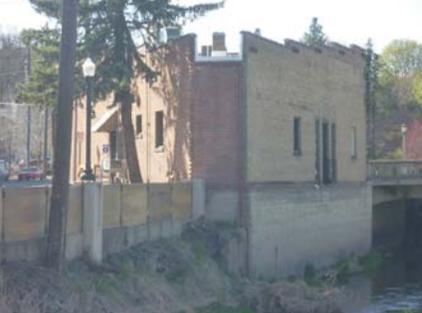
Survey Site Data	Site Photographs	
<p>Site #: 82 HPI #: 38-00327 Listing Status: Not Listed Date: 1926 200 NE Kamiaken Street, Porch Light Artisan Pizza (Hutchinson Studio / Carson Building / Swillys) DoE: Eligible, contributing within a district Characteristics: Wedge- shaped, one-story, brick commercial building with blonde-colored brick veneer at façade, and red and blonde solid brick masonry walls at north and south elevations. Spanish tiled, shed-roof extensions with contemporary windows and transoms flank projecting entry bay that shields a pair of doors. Cast- stone, Mission-style lintel spans opening. Multiple canales in pairs and threes are present at tile-capped parapet. Bricks are braided at southwest corner. Historically this building served as the photography studio for Raymond Hutchison, a portrait photographer (WSU, 2014).</p>

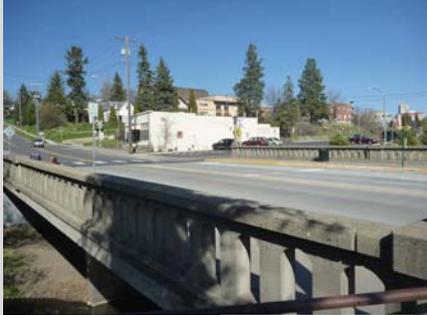
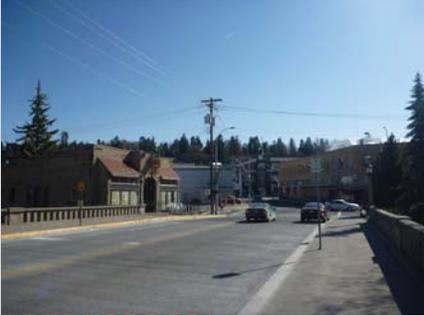
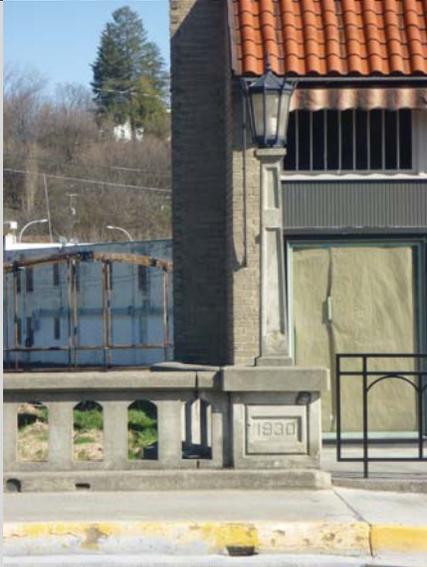
Survey Site Data	Site Photographs	
<p>Site #: 83 HPI #: N/A Listing Status: Not Listed Date: 1930 Kamiaken Street, between Olsen and Palouse Streets, SE Kamiaken Street Bridge DoE: Eligible, contributing within a district Characteristics: Reinforced concrete bridge supporting two lanes of roadway and sidewalks along both sides. The balustrade is pierced with segmental arched openings and each end pier features a tapered, incised concrete stem for an ornate iron and glass light fixture, which is similar to light fixtures present at the old Post Office (Site 69). The bridge spans the South Fork of the Palouse River. This bridge replaced a steel bridge with a wood approach that had replaced a ca. 1900 wooden wagon bridge. Nearby are a replica artesian well monument and fountain (April 11, 1988) and a monument for the old Pullman City Hall (built 1892, rebuilt 1934). This bridge is strongly tied in style, form, character, and use to its period of construction and remains a representation of Pullman's growth during the period.</p>

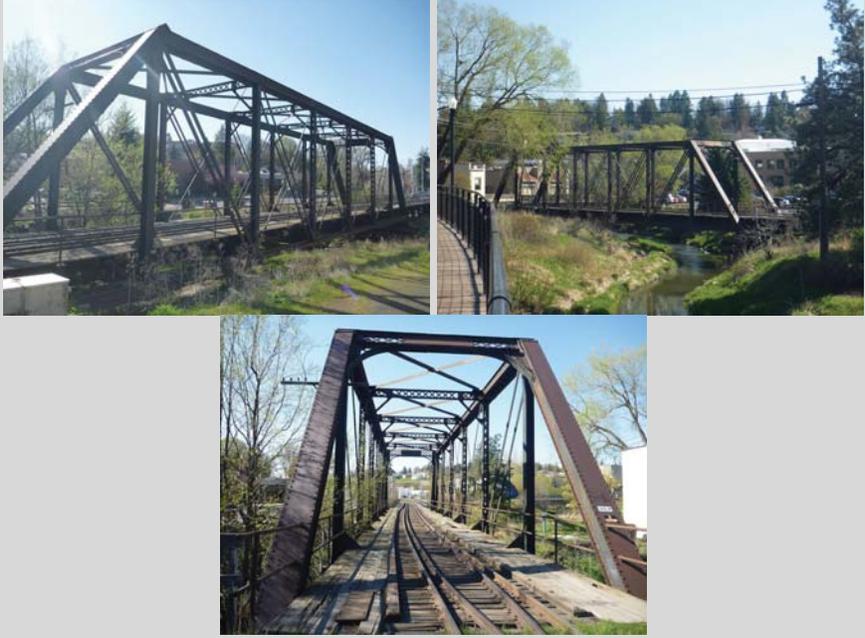
Survey Site Data	Site Photographs
<p>Site #: 84 HPI #: N/A Listing Status: Not Listed Date: ca. 1900 West of Kamiaken between Olsen & Palouse Streets, Oregon Railway and Navigation Company Railroad Bridge DoE: Eligible, contributing within a district Characteristics: Pratt-type, iron, through truss bridge set on heavy timber cribbing and round pilings. Riveted inclined end posts, riveted top chords, lattice bracing with pin connections, diagonal and counter bracing ties, top lateral bracing, and triangular bracing at floor beam (NPS, 1976). This bridge is strongly tied in style, form, character, and use to its period of construction and remains a representation of Pullman's growth during the period. It is still in use today.</p>

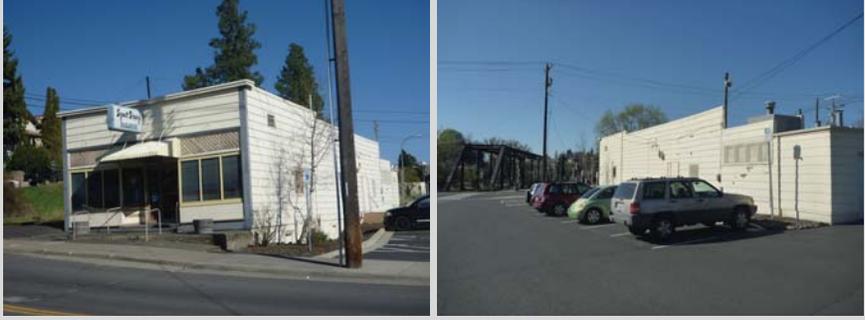
<p>Site #: 85 HPI #: 38-00329 Listing Status: Not Listed Date: ca. 1920 240 NE Kamiaken Street, Spot Shop Cleaners (Restaurant) DoE: Not Eligible Characteristics: Wedge-shaped, one-story, one-part commercial building that was built ca. 1920 and was originally used as a restaurant. Flat roof and parapet. Central recessed entry with metal awning, display windows on canted bulkheads, and filled in transoms. Aluminum siding, lattice, and Spot Shop Cleaners sign above entry.</p>

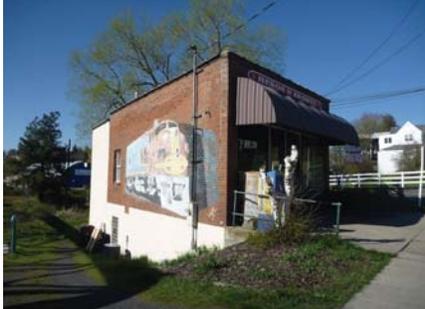
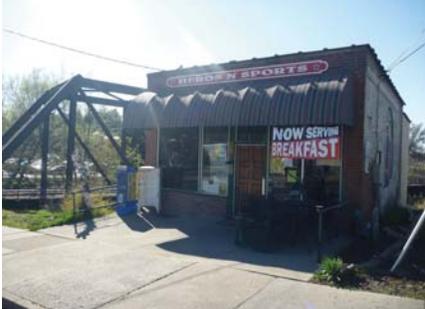
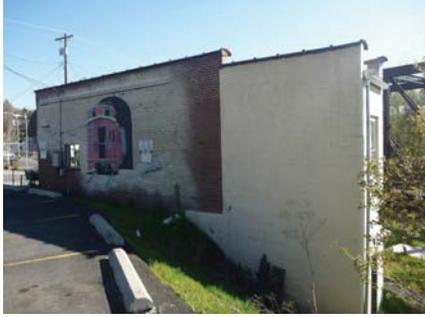
Survey Site Data	Site Photographs	
<p>Site #: 86 HPI #: N/A Listing Status: Not Listed Date: ca. 1930 245 NE Kamiaken Street, Heros N Sports (shop with dry cleaning in basement) DoE: Eligible, contributing within a district Characteristics: Wedge- shaped, one-story, brick vener, flat-roof building with parapet. Round-arch canvas awning. Display windows above brick bulkheads, replacement entry door. Painted murals. Concrete block addition to rear.</p>

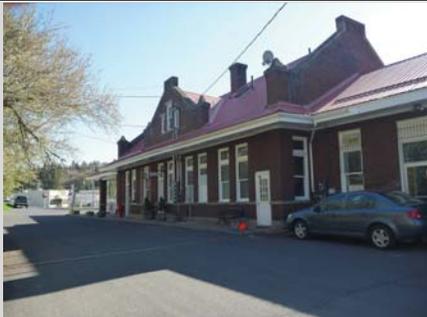
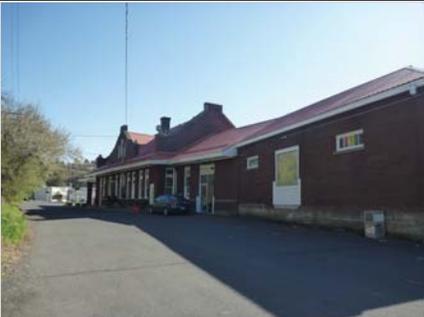
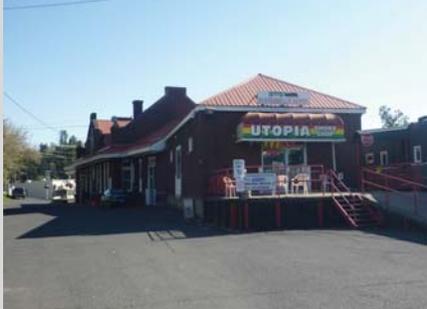
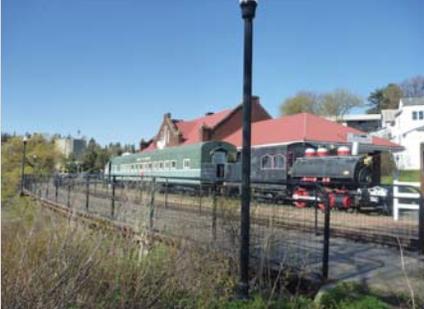
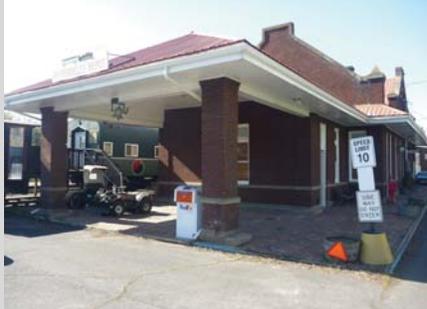
Survey Site Data	Site Photographs	
<p>Site #: 87 HPI #: N/A Listing Status: Not Listed Date: 1916 330 N Grand Avenue, Pufferbelly Depot (Northern Pacific Railroad Freight and Passenger Depot) DoE: Eligible, contributing within a district Characteristics: One-and-one- half story, brick veneer train depot with linear plan and gable-on-hip roofs. Two large, cast-stone-capped parapets that frame the former freight and baggage room and waiting room portion of the building. Smaller parapets are found fronting the gables. Three windows in a stair-step pattern pierce the gable end. Cast stone lintels, sills and water table. Metal roofs. Some historic windows extant, some changes have been made to fenestration. Multiple train cars are situated on site on the passenger loading or track- side of the building, are now used as office space. This property continues to strongly represent its original form, type, style, and character and is a clear visible representation of its original period and use. This is related to numerous elements of Pullman's developmental context.</p>

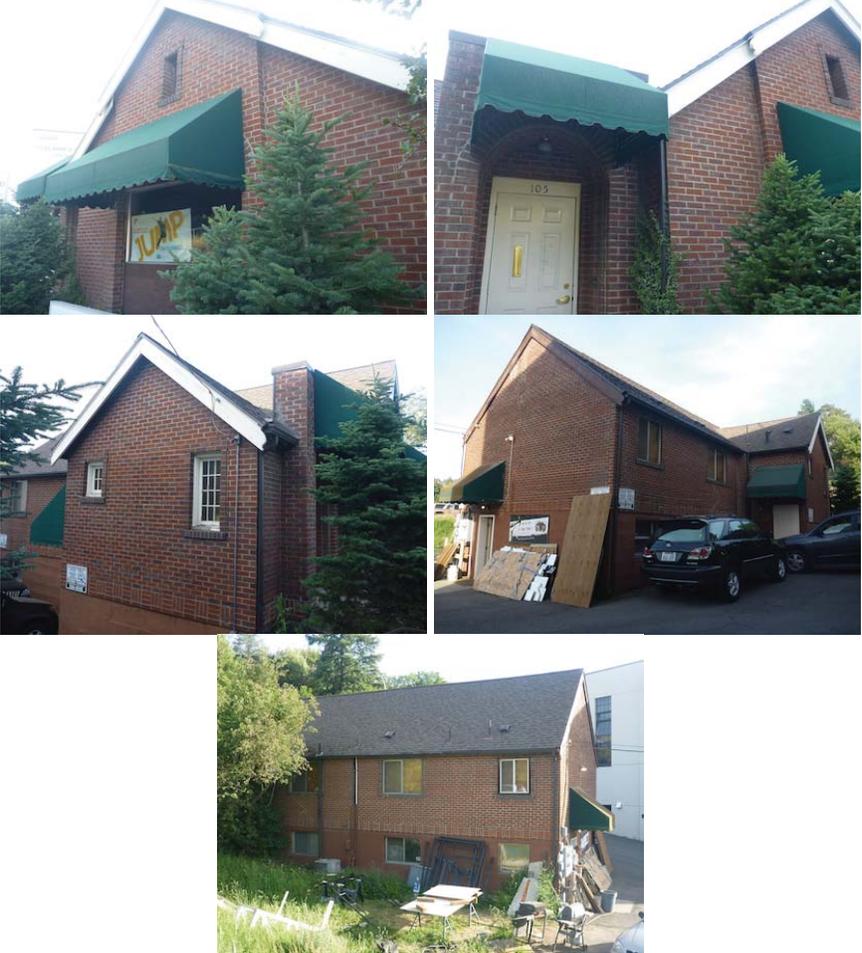
Survey Site Data	Site Photographs
<p>Site #: 88 HPI #: N/A Listing Status: Not Listed Date: ca. 1940 105 NE Spring Street, YMCA (Seventh Day Adventist Chapel) DoE: Eligible, contributing within a district Characteristics: One-and-one- half story, raked brick veneer building with an L-shaped plan. Crossing gable roof, arched openings, brick surrounds, elaborated bargeboard, basket-weave pattern brick water table, parged concrete foundation, and fabric awnings. Though it may appear to be a residential building, this property was originally a chapel, a use made evident by its unexpectedly large picture window on the façade and lack of any windows on the rear.</p>

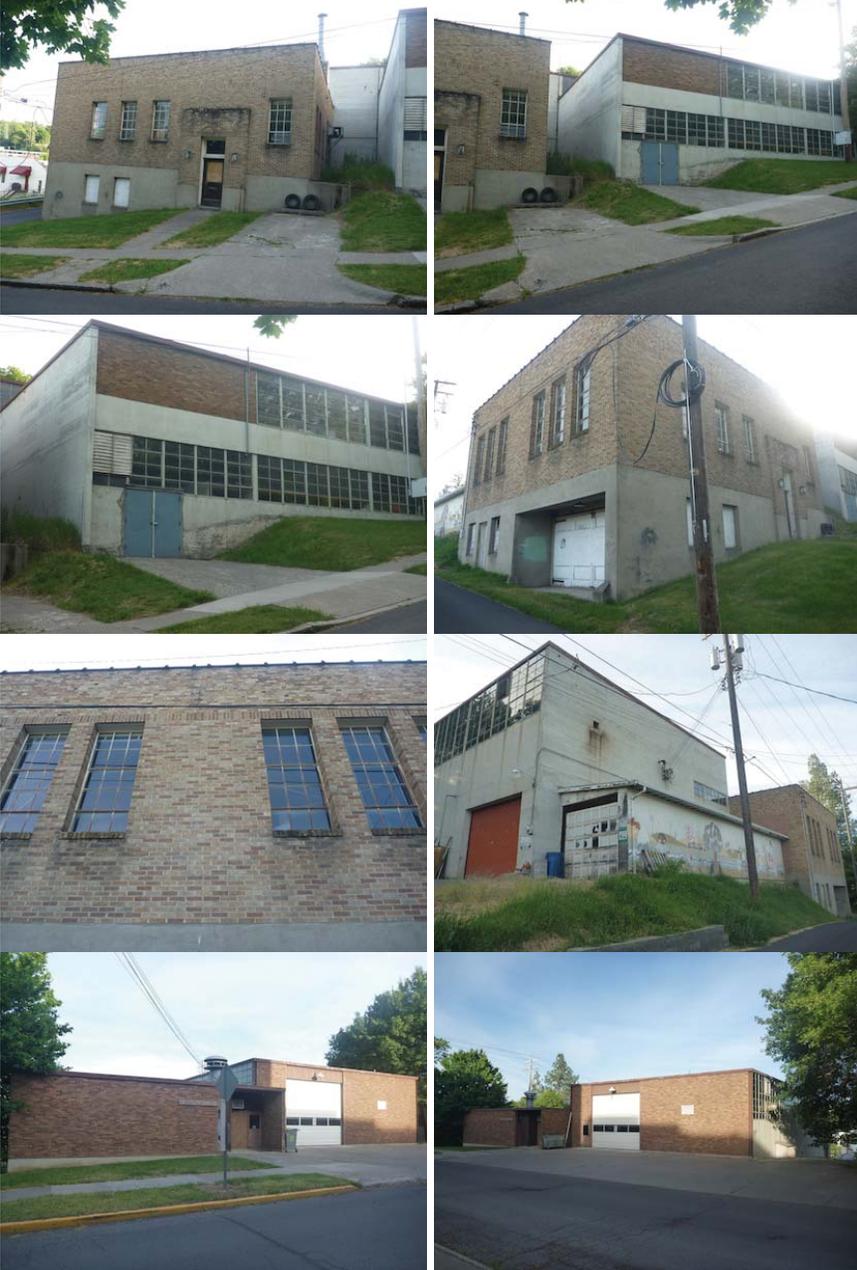
Survey Site Data	Site Photographs
<p>Site #: 89 HPI #: N/A Listing Status: Not Listed Date: 1938 105 NW Olsen Street & 135 Northwest State Street, Pullman School District Facility Operations (Automatic Telephone Exchange building) DoE: Eligible, contributing within a district Characteristics: Two buildings attached to each other at rear elevation. One is a two-story, brick veneer building with a heightened concrete foundation, metal-sash windows, parapet, and flat roof. The other building features a single story with basement, mid-century modern concrete construction. It exhibits a brick veneer exterior and expansive ribbons of windows.</p>

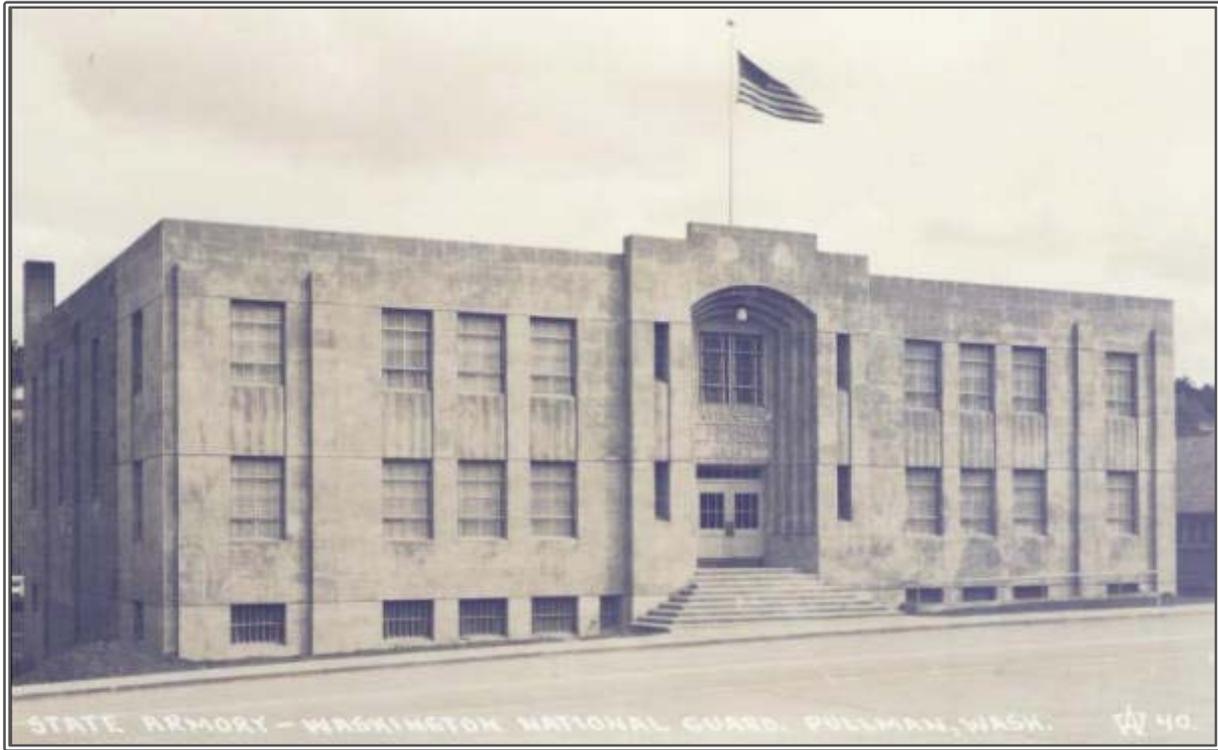
Figure 56: Armory (Site 1) (Ivan Shirrod Collection)

The survey area is anchored at the east by the Washington National Guard Building (Site 1) (Figure 56) and the Baptist Church/Belltower Events Venue (Site 56). These buildings both date ca. 1930, having been added slightly later on the outskirts of downtown.

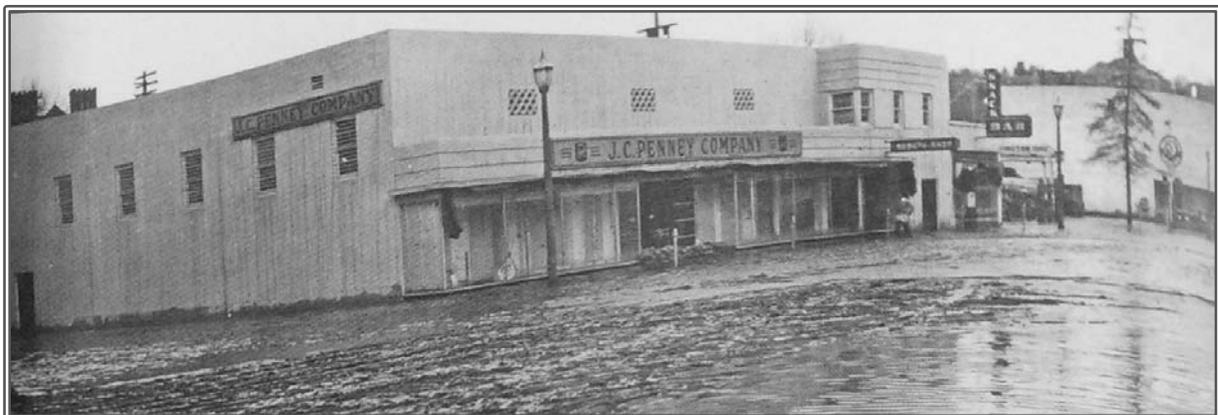
Survey Site Data	Site Photographs	
<p>Site #: 7 HPI #: N/A Listing Status: Not Listed Date: ca. 1930 410 E Main Street, Lily Bees Consignment Shop (Store) DoE: Eligible, contributing within a district Characteristics: Two-story, Art Deco-era commercial building with a storefront and flat awning attached along the original, wider awning spanning horizontally above the storefronts. Original decorative concrete vents are found on the second level. A historic image (Figure 57) indicates this building has changed little since its early days.</p>

<p>Site #: 8 HPI #: N/A Listing Status: Not Listed Date: ca. 1930 400 E Main Street, Thomas Hammer Coffee Roasters (Store) DoE: Eligible, contributing within a district Characteristics: Two-story, flat-roof, Art Deco-era commercial building. Storefront windows span most of the façade while a recessed entry is located on the southwest corner. A flat awning spans the façade on an original, larger awning spanning the façade horizontally. A nonhistoric side entry and original, second-level windows are found on the west side. A historic image (Figure 57) indicates this building has changed little since its early days.</p>

Figure 57: The former J. C. Penney's, constructed ca. 1930 at 410 E Main Street, shown here in the flood of 1948 (Site 7) (Luedeking)

Centrally located within the survey area, several noteworthy properties date between ca. 1880 and 1929 including: Power Smoke Shop & Indian Grocery (Site 6); Lily Bees Consignment (Site 7); Thomas Hammer Coffee (Site 8) (Figure 57); Seattle First National Bank/American

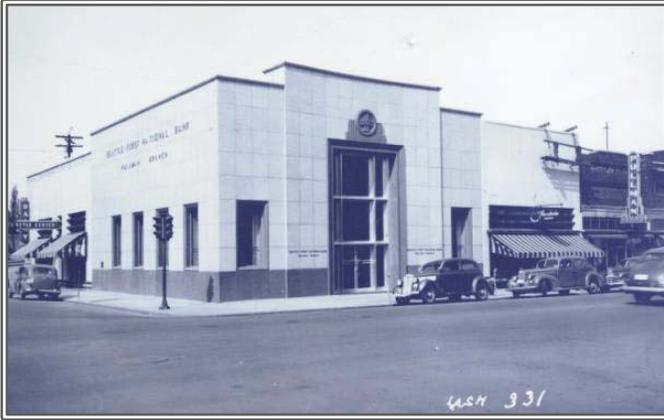
Survey Site Data	Site Photographs	
<p>Site #: 12 HPI #: N/A Listing Status: Not Listed Date: ca. 1940 300 E Main Street, American West Bank (Seattle First National Bank) DoE: Eligible, contributing within a district Characteristics: Single-story Seattle First National Bank building set on the original, ca. 1893 site of the Pullman State Bank. Despite alterations and a large metal awning, this building retains late Art Deco commercial elements including a prominent entry bay and framed entryway. The smooth finish with incised grid is a prominent element of this building's original design and type. Large windows are found on the façade and west side elevations. An off-centered, recessed entry is also on the façade. The building's form remains a strong representation of its original period and style. Seattle's First National Bank developed a building type for its properties, and this building continues to represent this type flawlessly aside from the awning (Figures 58–59). This building type is illustrated in Washington's "Anatomy of a Main Street Building" (Houser, slide 44). Furthermore this site has housed a bank since the city's earliest days and as such retains one of the strongest representations in the area of the city's historic context as related to commerce and finance.</p>

Figure 58: Seattle First National Bank, Pullman Branch (Site 12), undated image (Left) (Ivan Shirrod Collection)

West Bank (Site 12) (Figures 58–59); Design West Architects et al (Site 13) (Figure 60); the Webb Block/Combine Mall (Site 43) (Figure 38); and the Audian Theater and Basilio's (Site 52).

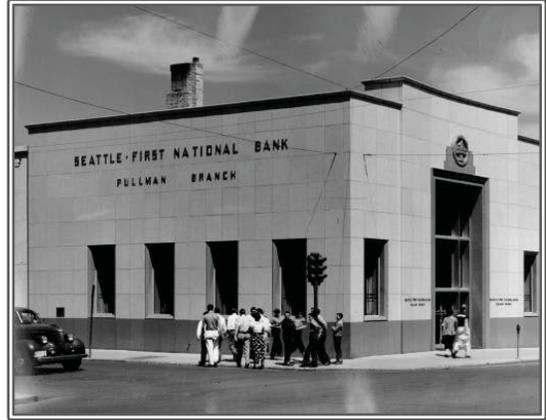
Figure 59: Seattle First National Bank, Pullman Branch (Site 12), 1950 (Right) (City of Pullman Image Collection)

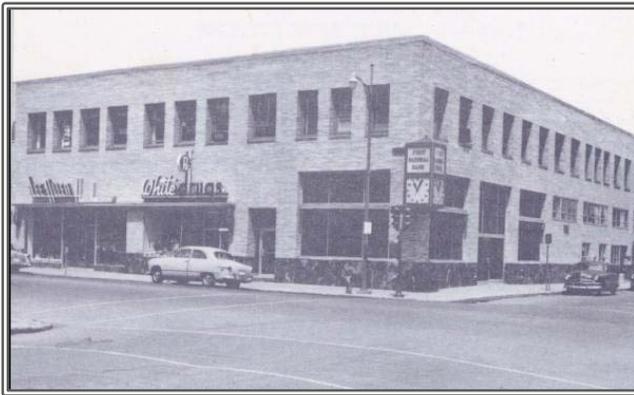
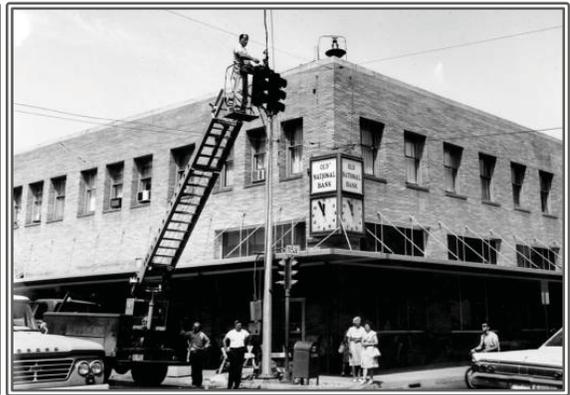
Survey Site Data	Site Photographs
<p>Site #: 13 HPI #: N/A Listing Status: Not Listed Date: ca. 1890 250-252-254 E Main Street, Design West Architects, Highland Property Management, Framing-It-Up Custom Frame Shop, Betty's Alterations (D. G. & Notions) DoE: Eligible, contributing within a district Characteristics: Large, two- story, L-shaped, commercial building set on the footprint of a ca. 1890s, single-story building in this location. This was originally a ca. 1910 bank building with modillions, dentils, and wide entablatures. It was renovated to a mid- century modern appearance in the mid- to late-1950s and now exhibits a blonde-brick veneer, replacement windows, marble knee walls, and a flat awning. Though the applied style has changed, the fenestration, location of entries and storefronts, the presence of a larger main entry, and the overall form and scale of the building all remain unchanged. The majority of the materials on the building today, including windows and the awning, appear to date to the period surrounding the mid-century renovation. See Figure 60 for historical representations of the building.</p>

Figure 60: Pullman's First National Bank Building (Site 13), 1954 (top, prior to renovation); 1959 (lower left); ca. 1960 (lower right) (Ivan Shirrod Collection)

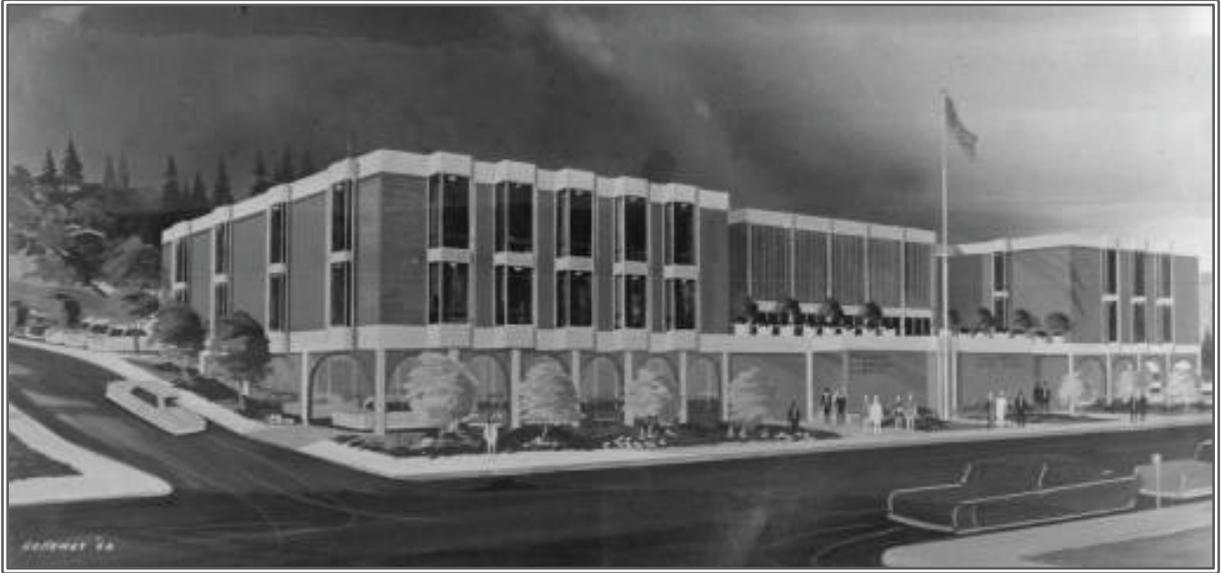
<p>Site #: 67 HPI #: N/A Listing Status: Not listed Date: 1970 325 SE Paradise Street, City Hall DoE: Not Eligible Characteristics: Two-story, central block with wings, modern, civic building atop an open parking garage. Original, round globe sconces light the garage. Wings feature brick veneer walls broken up by two-story window bays with dark glazing and white stucco bands. A wide, white, cornice band surrounds the building. The central block is set back with brick banding detail and low, dark windows. It is fronted by a balcony with a metal balustrade. This building may be eligible for the NRHP once it reaches the 50-year mark, as a locally significant example of late, mid-century modern, civic architecture (Figure 63).</p>

Figure 63: Conceptual sketch for new City Hall design, 1966 (Site 67) (City of Pullman Image Collection)
