440 Maiden Lane (Building 35)

This is a two-story multiple-family Colonial Revival built in 1938. It is on the east side of Maiden Lane, four lots north of its intersection with Maple Street (NW¼ NW¼ of Section 5, T. 14 N., R. 45 E., Pullman quadrangle, 1:24,000, 1964/1975). The building is on Lot 8 of Block 6 in Reaney’s Third Addition (Whitman County tax parcel 112400001080000). It is currently owned by Ralph Westermeyer of Bellevue, Washington. The address prior to 1972 was 1204 Maiden Lane.

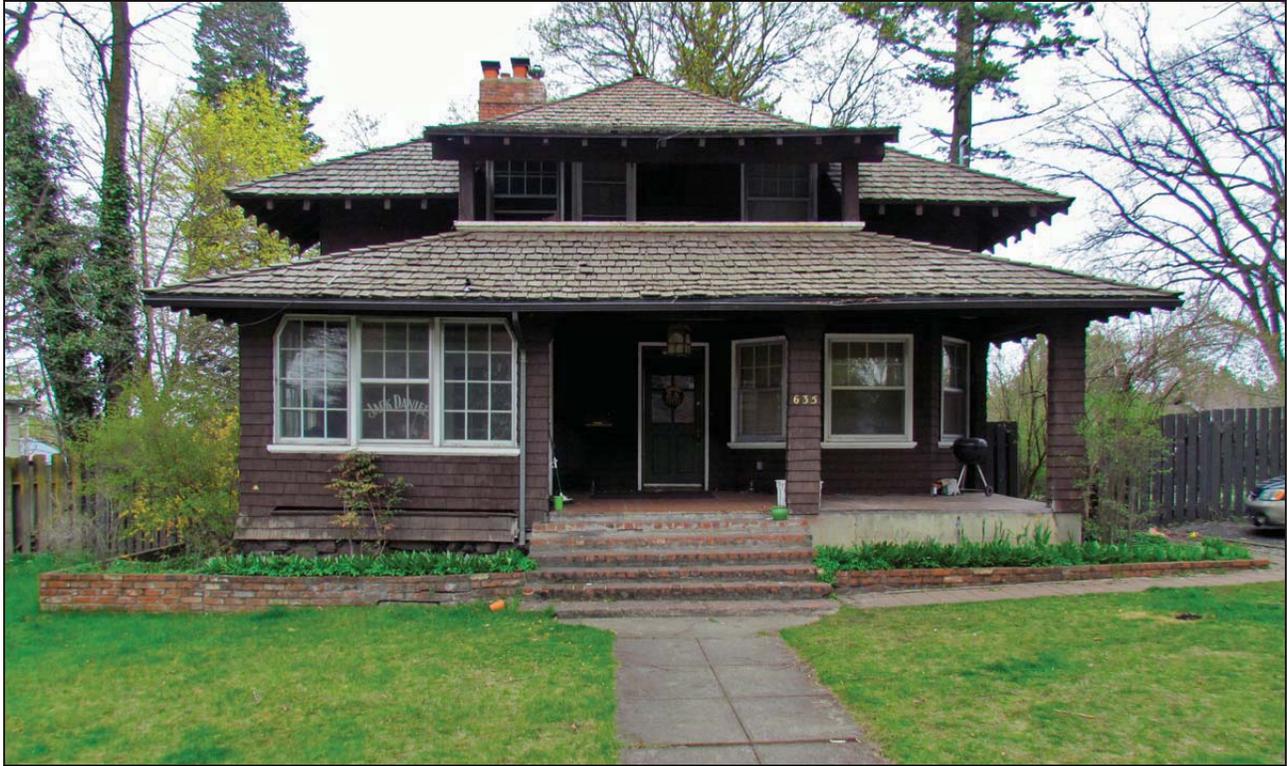
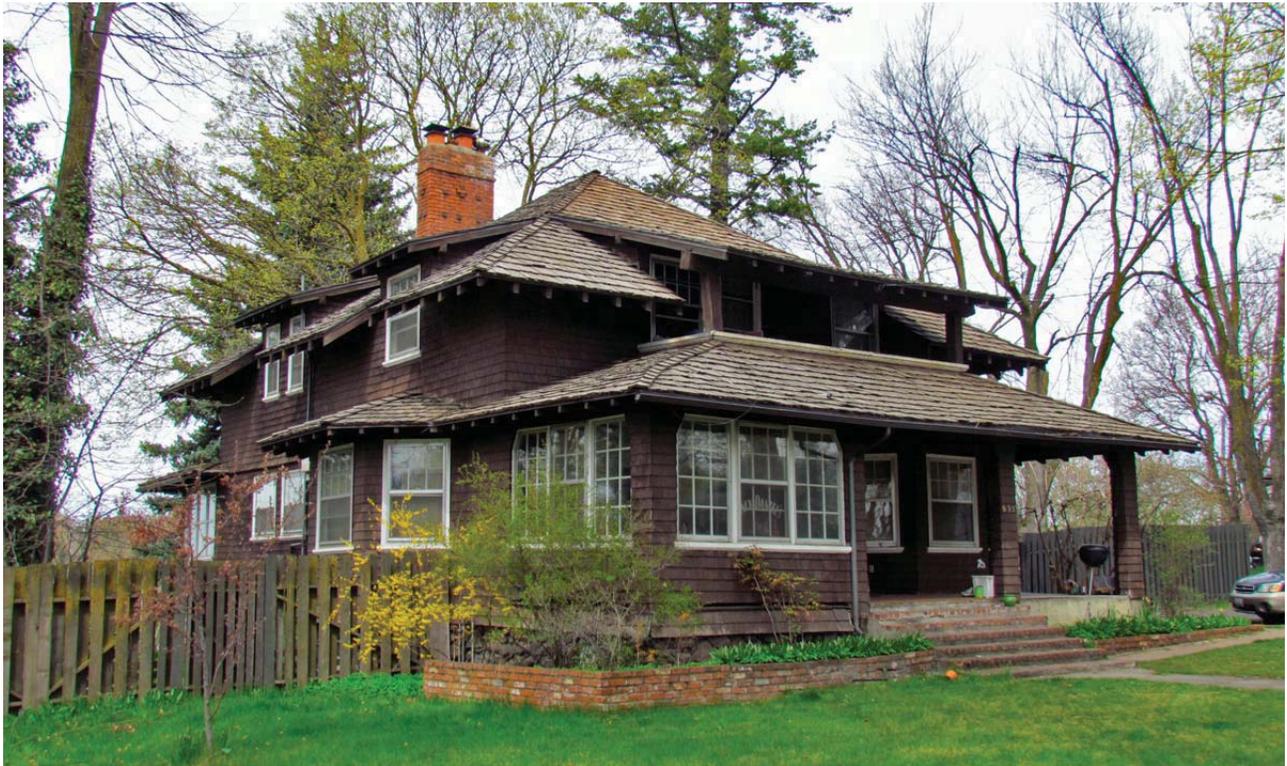
Figure 83. 635 Maple Street: (a) primary, southeast elevation, view to azimuth 300°; (b) three-quarter view of the southwest and southeast elevations, view to azimuth 350°.

The southeast elevation, which faces Maple Street, features an open porch right of center that has a hanging light fixture and flat wood planking ceiling (Figure 83). An enclosed porch is left of the door and features ventilation breaks on the southwest, southeast, and northeast elevations. A brick walkway leads to the poured concrete porch topped with red tile and the door is a plain-surround single-leaf two-panel with four stained glass lights. The enclosed porch has a second entrance flanked by two single-sash twelve pane windows, and the southeast elevation has three side-by-side single-sash twelve pane windows with bull nose in the upper right and left corners. These windows have a wooden slip sill but no trim. The east section of the elevation has a bay with three windows; the center window is a two-sash with the top sash having six panes. This center window is flanked by two double twelve-pane windows. The balcony has two double-hung windows with eight lights equally spaced and the door is same as the front door on the first story but left of center.

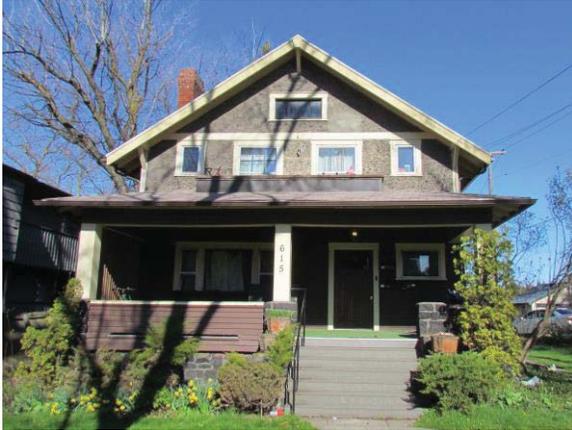
View to 308 TN
Front SE facade
2013

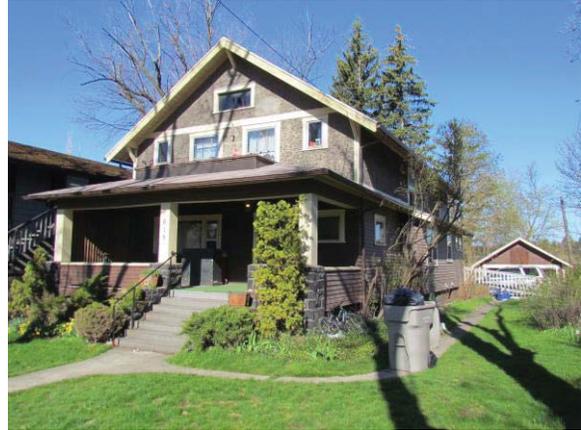
View to 270 TN
Front SE facade
2013

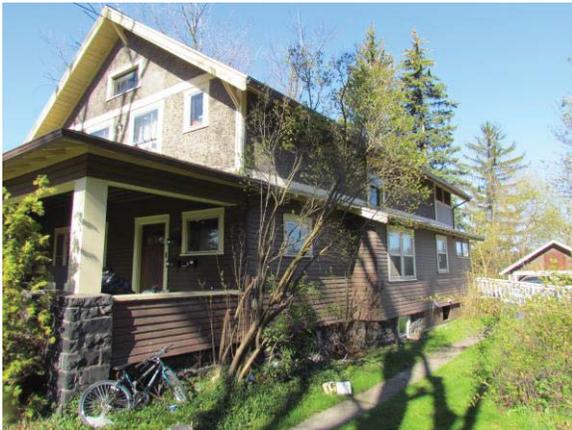
View to 280 TN
NE elevation
2013

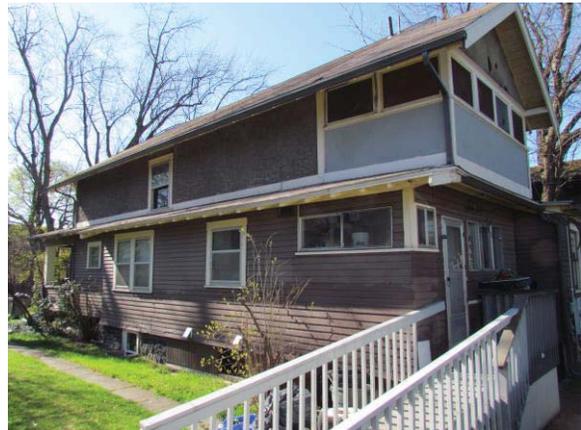
View to 175 TN
NE-NW elevations
2013

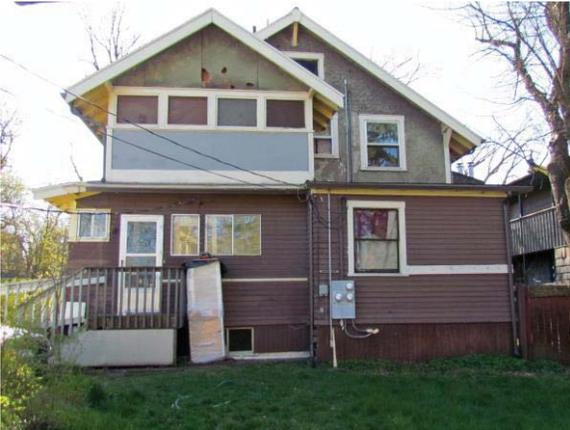
View to 120 TN
NW elevation
2013

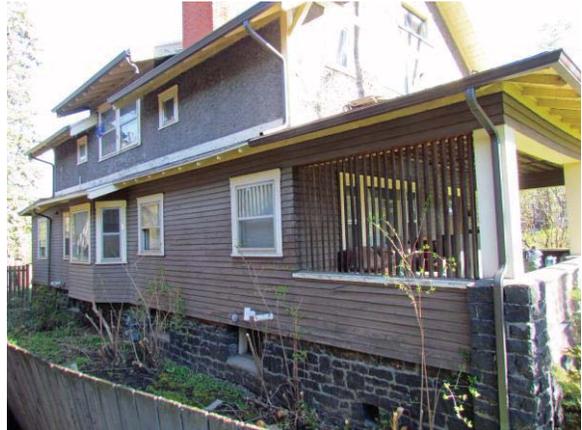
View to 335 TN
SW elevation
2013

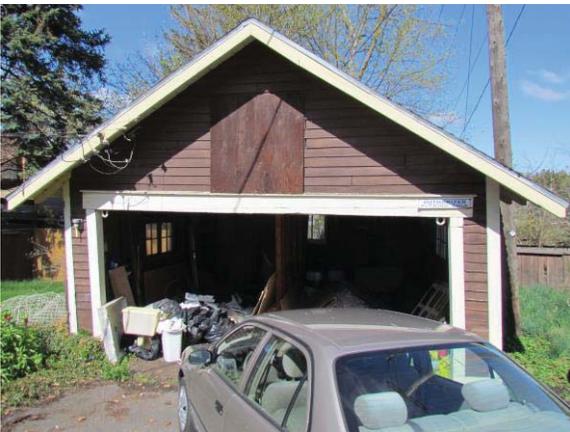
View to 100 TN
SE elev of garage
2013

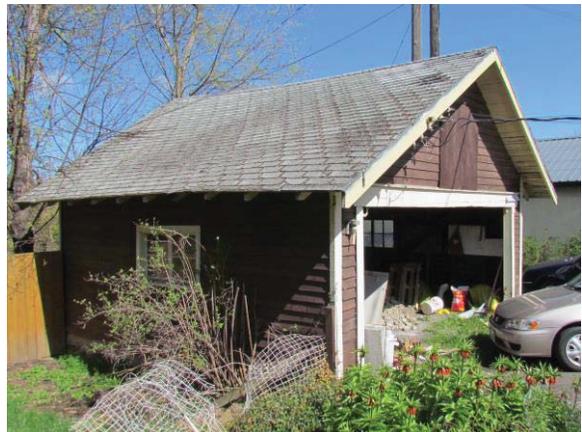
View to 5 TN
SE-SW elev of garage
2013

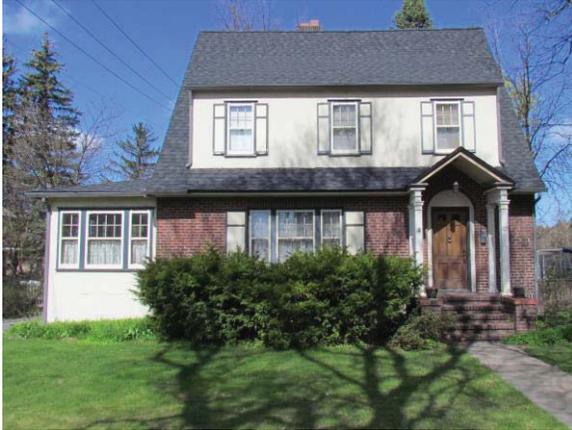
View to 300 TN
SE elevation
2013

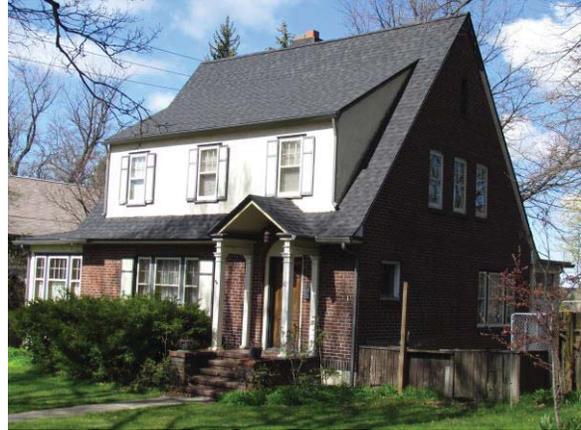
View to 270 TN
SE-NE elevations
2013

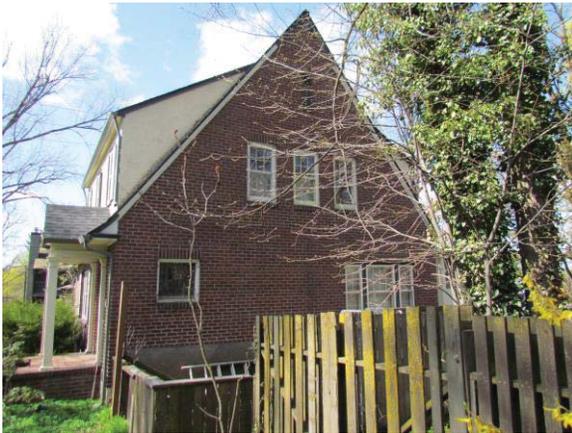
View to 250 TN
NE elevation
2013

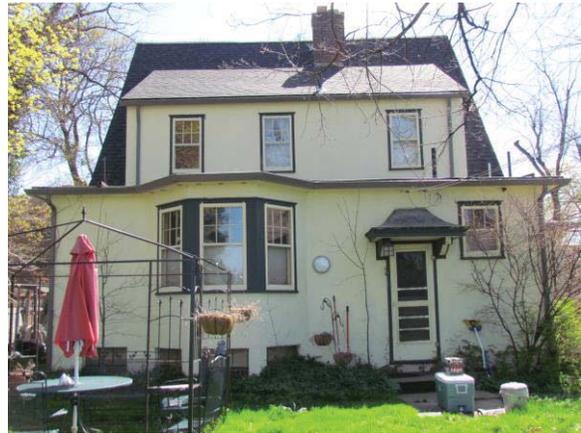
View to 140 TN
NW elevation
2013

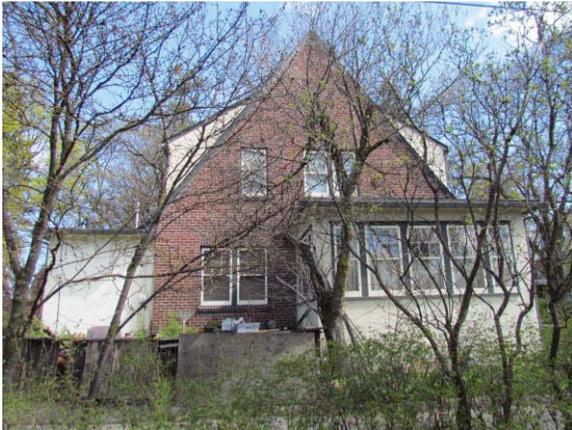
View to 50 TN
SW elevation
2013

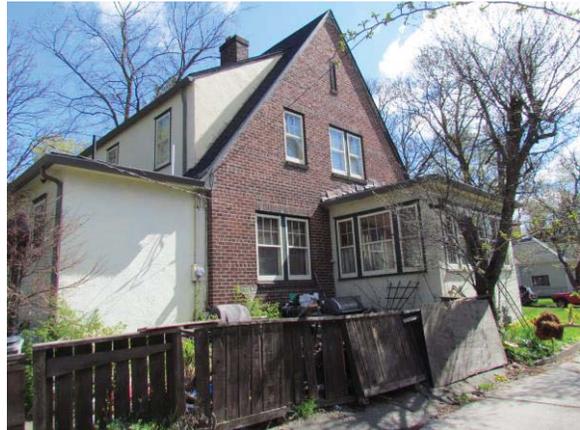
View to 85 TN
SW elevation
2013

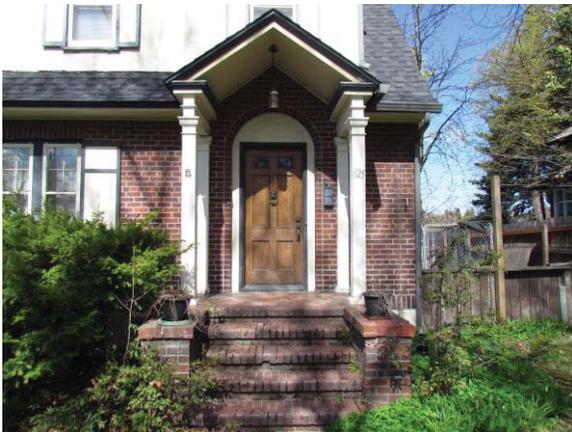
View to 100 TN
Entryway detail
2013

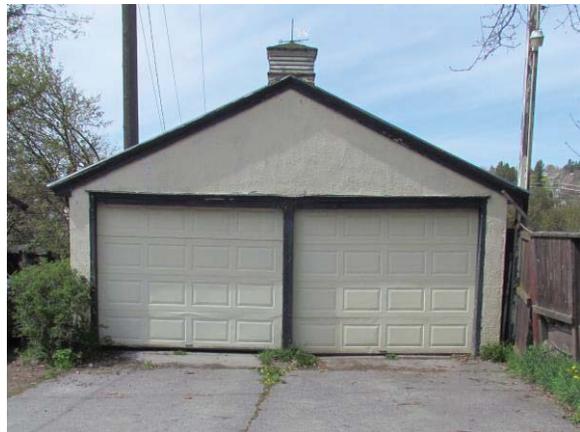
View to 308 TN
SE elev of garage
2013

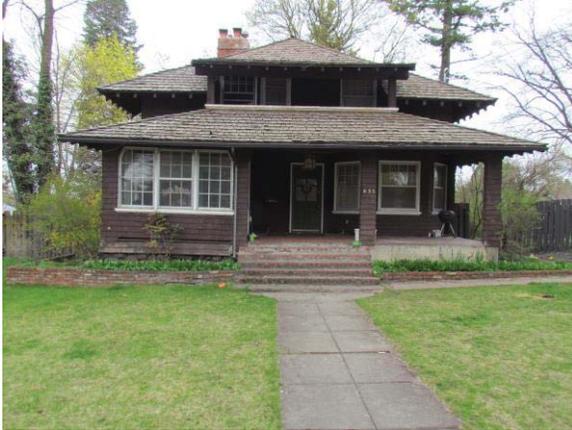
View to 300 TN
SE elevation
2013

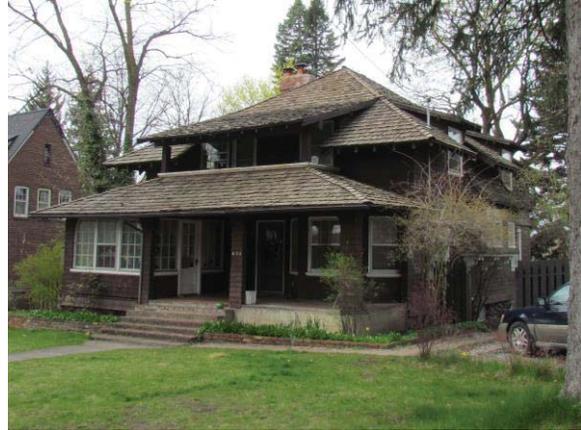
View to 280 TN
SE-NE elevations
2013

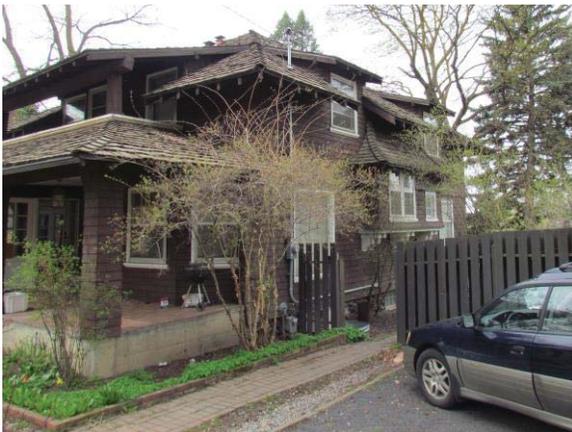
View to 280 TN
NE elevation
2013

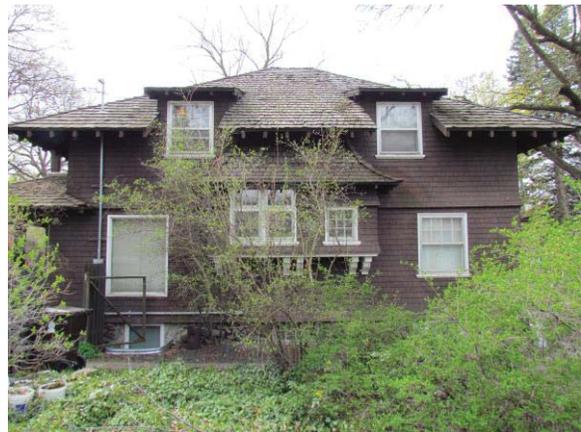
View to 212 TN
NE elevation
2013

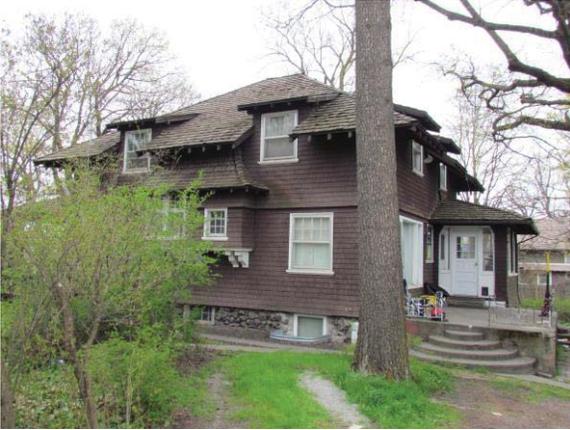
View to 178 TN
NE elevation
2013

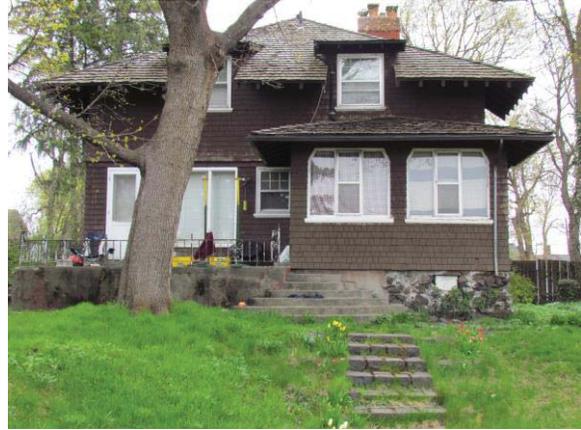
View to 130 TN
NW elevation
2013

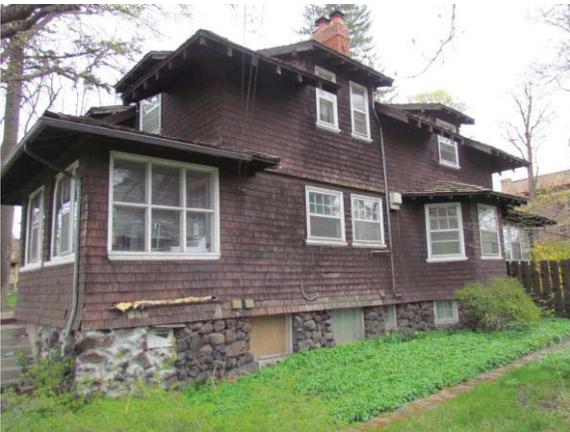
View to 94 TN
SW elevation
2013

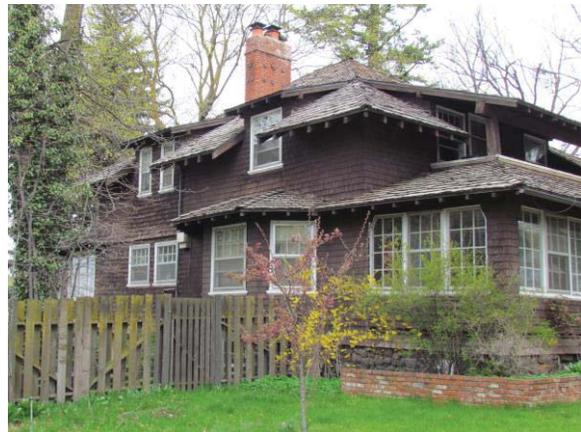
View to 355 TN
SW elevation
2013

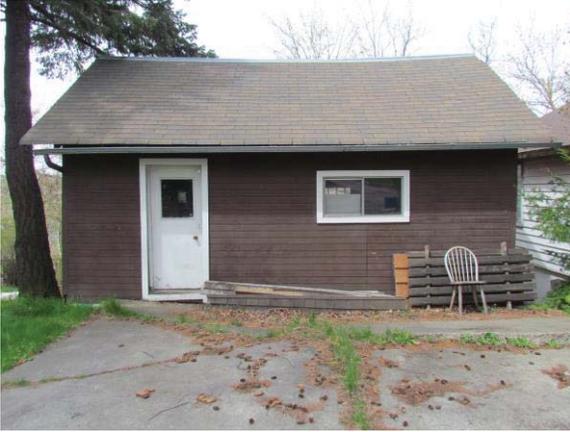
View to 308 TN
SE elevation
2013

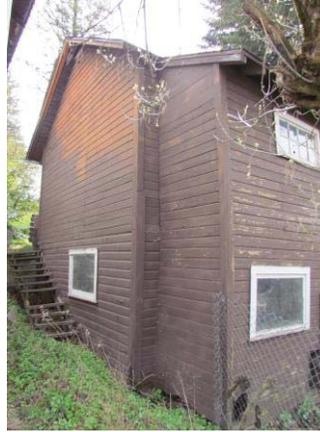
View to 160 TN
NE elevation
2013

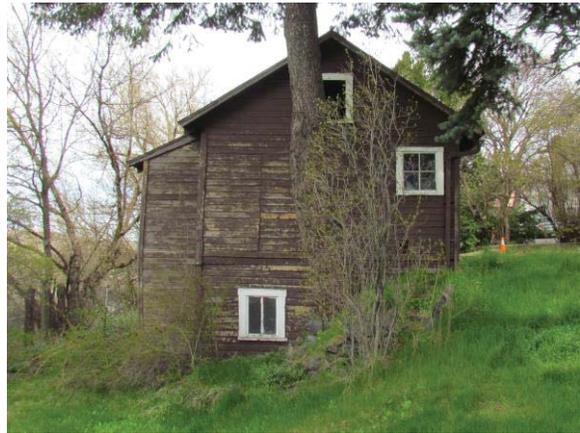
View to 70 TN
SW elevation
2013
